WOOD DESTROYING PESTS AND ORGANISMS INSPECTION REPORT

Building No. 865	Street Studding Sail Street	City Vacaville	Zip 95687	Date of Inspection October 12, 2021	Number of Pages 5

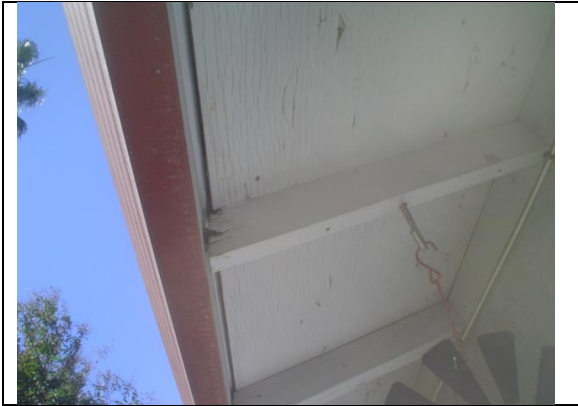
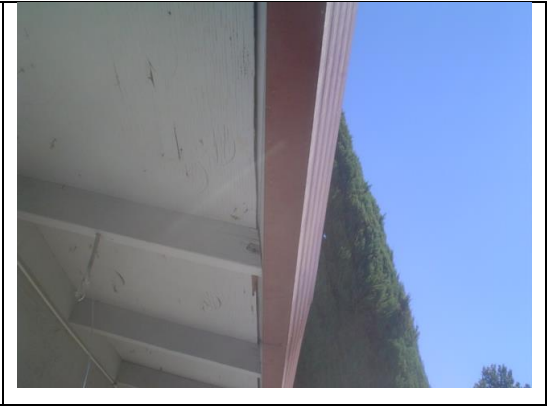
<p>Fig.1a</p>		<p>Fig.1b</p>

1 Finding: Fungi (wood-rot) damage found at rafter tails and fascia. Indicated on the diagram by “1”, and some areas shown in Fig.1 images on the back pages of this report.

Recommendation: Repair/replace fungi damaged wood members as needed.

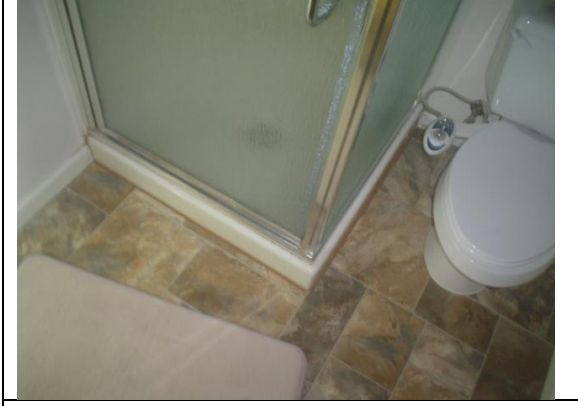
2 Finding: Evidence of moisture damage to the underlayment found at the master bathroom floor. Indicated on the diagram by “2”, and some areas shown in Fig.2 images on the back pages of this report.

Recommendation: Remove floor covering and damaged underlayment as needed. Install new underlayment and floor covering, reset toilet.

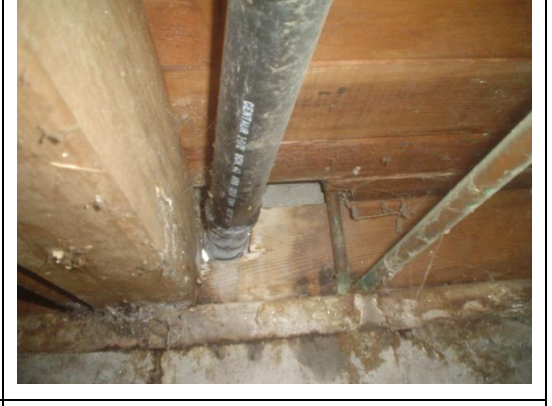
3 Finding: A leak at ABS drain pipe area of master bathroom noted. Fungi (wood-rot) damage found at floor joist. Indicated on the diagram by “3”, and some areas shown in Fig.3 images on the back pages of this report.

Recommendation: Repair plumbing as needed to eliminate leakage. Repair/replace damaged wood members as identified during our original inspection. Further inspect upon opening of enclosed areas.

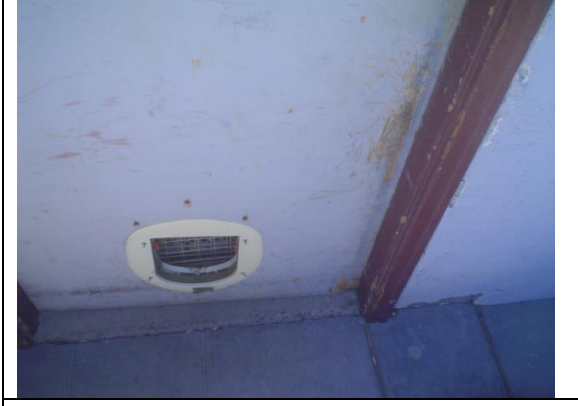
4 Finding: Exterior door is becoming delaminated. Indicated on the diagram by “4”, and some areas shown in Fig.4 images on the back pages of this report.

Recommendation: Replace door. ‘

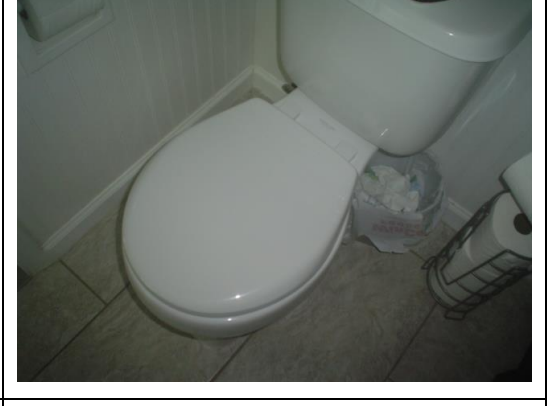
5 Finding: Loose toilet found in the hall bathroom. Indicated on the diagram by “5”, and some areas shown in Fig.5 images on the back pages of this report.

Recommendation: Reset toilet on new wax ring using new bolts. Further inspect upon opening of enclosed areas.

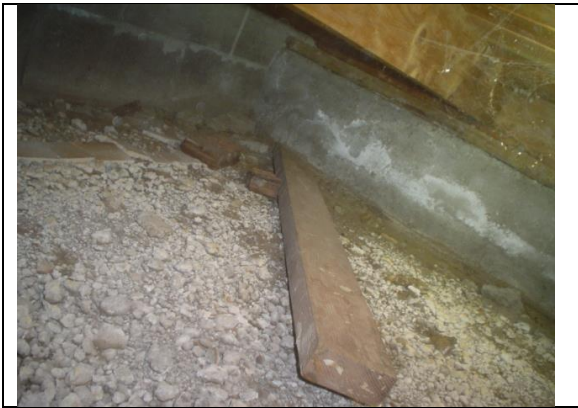
6 Finding: Cellulose debris (scrap wood, paper, etc.) found in the subarea. Indicated on the diagram by “6”, and some areas shown in Fig.6 images on the back pages of this report.

Recommendation: Remove all cellulose debris of size that can be raked.

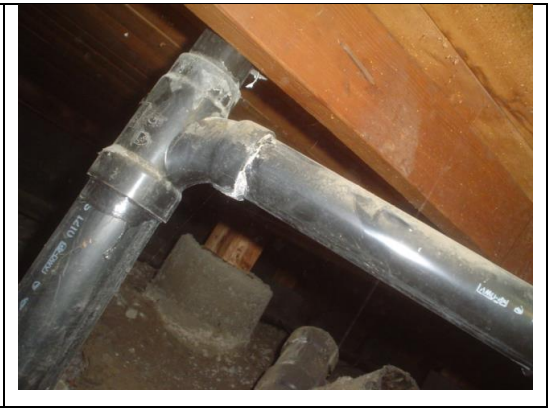
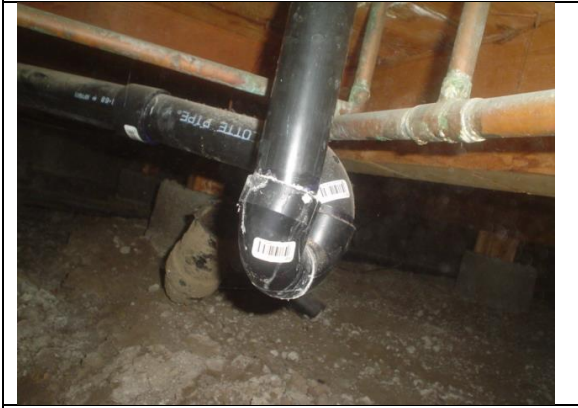
7 Finding: Leaks were found at ABS waste pipe areas under hall bathroom/bathtub areas. Indicated on the diagram by “7”, and some areas shown in Fig.7 images on the back pages of this report.

Recommendation: Repair plumbing as needed to eliminate leakage.
