**Twin Termite and Pest Control**

Property Billing Statement**Statement Date:** 05/03/2021**Report #:** 70385**Service Address:** 1501 Henry Street, Fairfield, CA 94533**Escrow #:****Closing Date:** 11/30/-0001

Report # 70385

| General Description: THIS PROPERTY CONSISTS OF A TWO STORY RESIDENCE WITH WOOD SIDING | | Inspection Tag Posted: GARAGE |

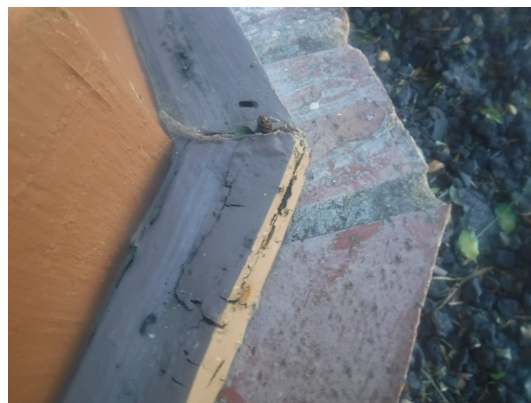
3A:

3A. FINDING: THERE IS WOOD DECAY FUNGI (DRY ROT) DAMAGE AT THE 2X4 TRIM .

RECOMMENDATION: REMOVE THE DAMAGED PORTION OF WOOD AND REPLACE WITH NEW MATERIAL. APPLY TIMBOR (ACTIVE INGREDIENT, DISODIUM OCTABORATE TETRAHYDRATE) TO THE ADJACENT INFECTED AREAS AS NECESSARY FOR THE CONTROL OF WOOD DECAY FUNGI (DRY ROT).

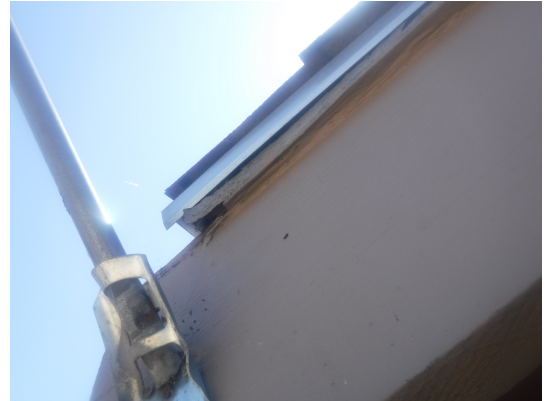
3B:

THERE IS WOOD DECAY FUNGI (DRY ROT) DAMAGE AT THE 1X2 SHINGLE MOLD .

REMOVE THE DAMAGED PORTION OF WOOD AND REPLACE WITH NEW MATERIAL. APPLY TIMBOR (ACTIVE INGREDIENT, DISODIUM OCTABORATE TETRAHYDRATE) TO THE ADJACENT INFECTED AREAS AS NECESSARY FOR THE CONTROL OF WOOD DECAY FUNGI (DRY ROT).

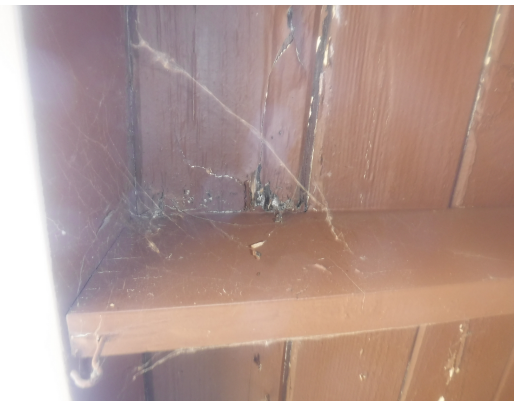
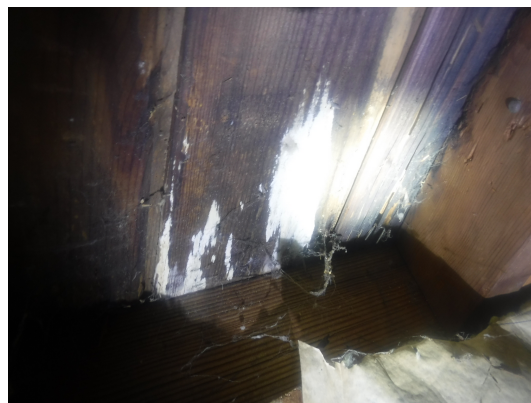
3C:

THERE IS EVIDENCE OF WOOD DECAY FUNGI (DRY ROT) DAMAGE AT THE V-RUSTIC OF THE ROOF OVERHANG.

REMOVE THE ROOF COVERING TO EXPOSE THE DAMAGED AREAS IF NECESSARY. REMOVE ALL STRUCTURALLY DAMAGED WOOD MEMBERS AND REPLACE WITH NEW MATERIAL. APPLY TIMBOR (ACTIVE INGREDIENT, DISODIUM OCTABORATE TETRAHYDRATE) ADJACENT TO THE INFECTED AREAS FOR THE CONTROL OF WOOD DECAY FUNGI AS NECESSARY. INSTALL ROOF COVERING TO THE EXPOSED AREAS ONLY. GUARANTEE APPLIES TO ROOF COVERING IN REPAIRED AREAS ONLY.

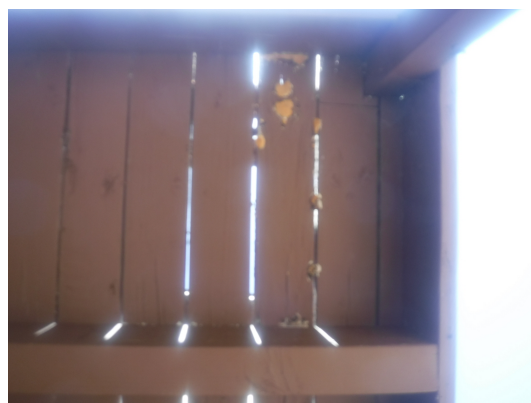
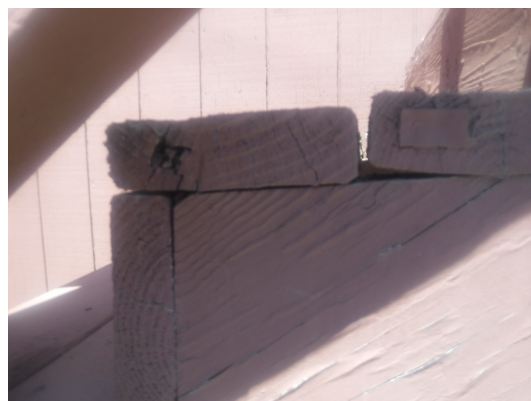
3D:

THERE IS WOOD DECAY FUNGI (DRY ROT) DAMAGE AT THE 2X6 DECK AND STAIR TREAD BOARDS .

REMOVE ALL DAMAGED WOOD AND REPLACE WITH NEW MATERIAL. APPLY TIMBOR (ACTIVE INGREDIENT, DISODIUM OCTABORATE TETRAHYDRATE) TO THE ADJACENT INFECTED AREAS AS NECESSARY FOR THE CONTROL OF WOOD DECAY FUNGI (DRY ROT).

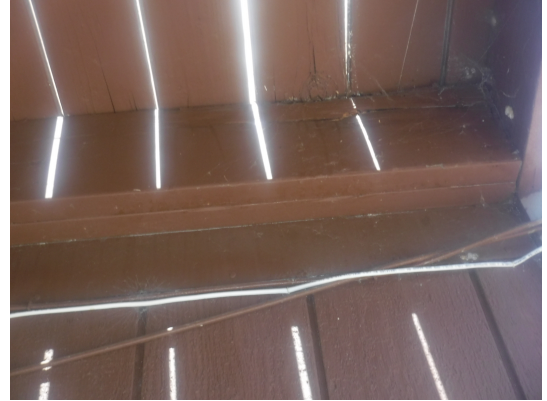
**3E:**

3E. FINDING: THERE IS WOOD DECAY FUNGI (DRY ROT) DAMAGE AT THE 2X8 LEDGER BOARD .

RECOMMENDATION: REMOVE ALL DAMAGED WOOD AND REPLACE WITH NEW MATERIAL. APPLY TIMBOR (ACTIVE INGREDIENT, DISODIUM OCTABORATE TETRAHYDRATE) TO THE ADJACENT INFECTED AREAS AS NECESSARY FOR THE CONTROL OF WOOD DECAY FUNGI (DRY ROT).

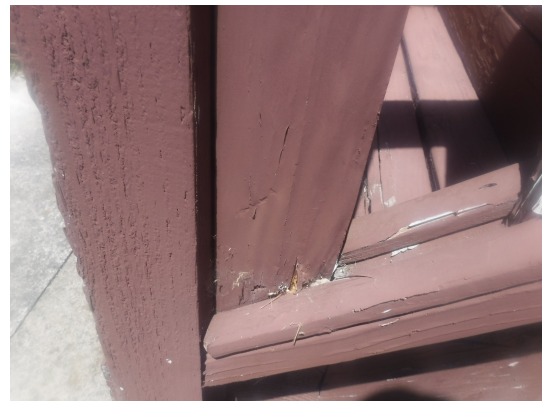
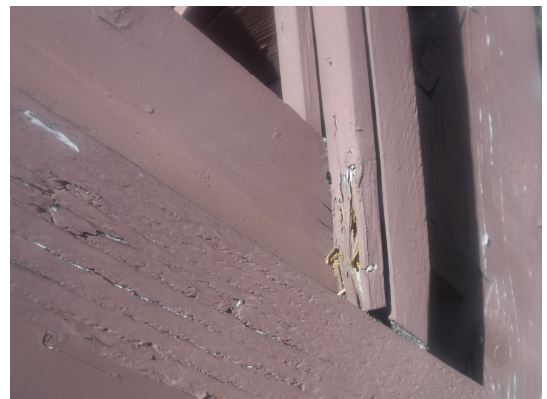
**3F:**

3F. FINDING: THERE IS WOOD DECAY FUNGI (DRY ROT) DAMAGE AT THE 1X4 HAND RAIL PICKETS AND 1X2 FRAMING .

RECOMMENDATION: REMOVE THE DAMAGED PORTION OF WOOD AND REPLACE WITH NEW MATERIAL. APPLY TIMBOR (ACTIVE INGREDIENT, DISODIUM OCTABORATE TETRAHYDRATE) TO THE ADJACENT INFECTED AREAS AS NECESSARY FOR THE CONTROL OF WOOD DECAY FUNGI (DRY ROT).

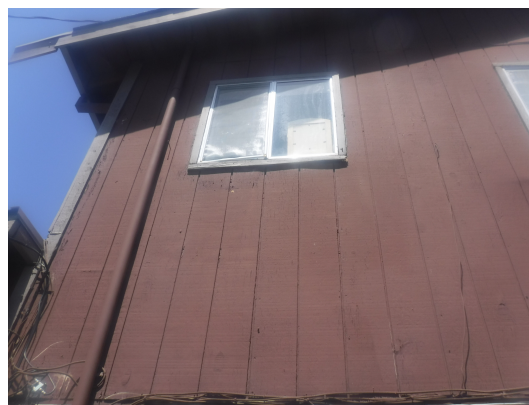
**3G:**

3G. FINDING: THERE IS WOOD DECAY FUNGI (DRY ROT) DAMAGE AT THE T1-11 8"OC SIDING AND TRIM.

RECOMMENDATION: REMOVE TRIM AS NECESSARY. REMOVE AND REPLACE THE DAMAGED SIDING USING COMPLETE SHEETS (TO MATCH AS CLOSE AS SUPPLIES PERMIT) AND RE-INSTALL TRIM. APPLY TIMBOR (ACTIVE INGREDIENT, DISODIUM OCTABORATE TETRAHYDRATE) ADJACENT TO THE INFECTED AREAS FOR THE CONTROL OF WOOD DECAY FUNGI AS NECESSARY.

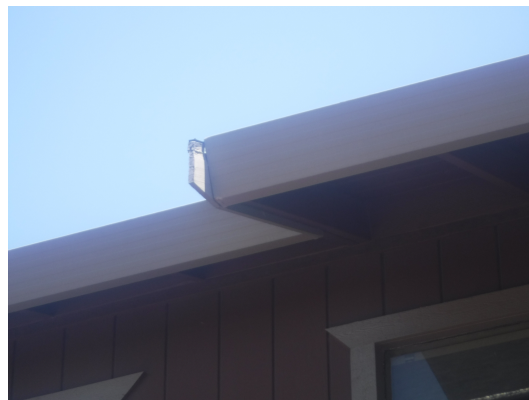
**3H:**

3H. FINDING: THERE IS WOOD DECAY FUNGI (DRY ROT) DAMAGE AT THE 1X8 BARGE RAFTER .

RECOMMENDATION: REMOVE THE DAMAGED PORTION OF WOOD AND REPLACE WITH NEW MATERIAL. APPLY TIMBOR (ACTIVE INGREDIENT, DISODIUM OCTABORATE TETRAHYDRATE) TO THE ADJACENT INFECTED AREAS AS NECESSARY FOR THE CONTROL OF WOOD DECAY FUNGI (DRY ROT).

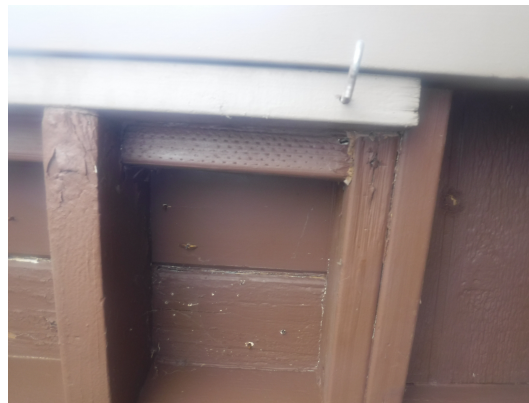
3I:

THERE IS WOOD DECAY FUNGI (DRY ROT) DAMAGE AT THE 2X4 RAFTER TAIL .

REMOVE THE DAMAGED PORTION OF WOOD AND REPLACE WITH NEW MATERIAL.
APPLY TIMBOR (ACTIVE INGREDIENT, DISODIUM OCTABORATE TETRAHYDRATE)
TO THE ADJACENT INFECTED AREAS AS NECESSARY FOR THE CONTROL OF
WOOD DECAY FUNGI (DRY ROT).

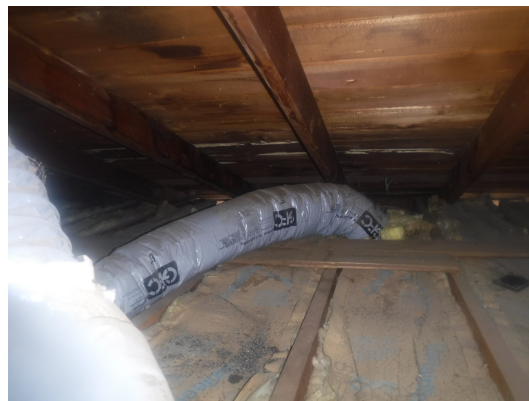
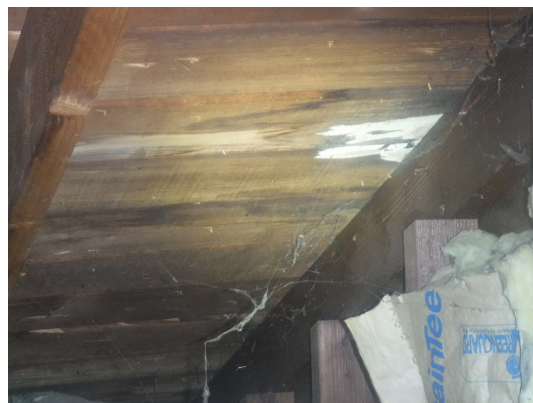
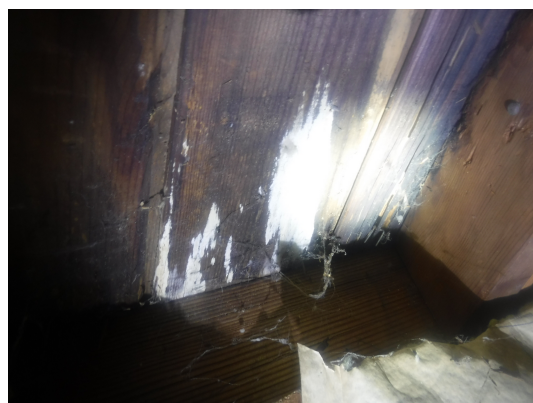
3J:

FUNGI GROWTHS (SURFACE FUNGUS) ARE VISIBLE AT THE V-RUSTIC ROOFING
AS VIEWED FROM THE ATTIC .

SCRAPE ALL VISIBLE FUNGI GROWTHS ON SURFACE OF WOOD MEMBERS AND
APPLY TIMBOR (ACTIVE INGREDIENT: SODIUM OCTOBORATE) TO THE INFECTED
AREAS FOR THE CONTROL OF WOOD DECAY FUNGI.

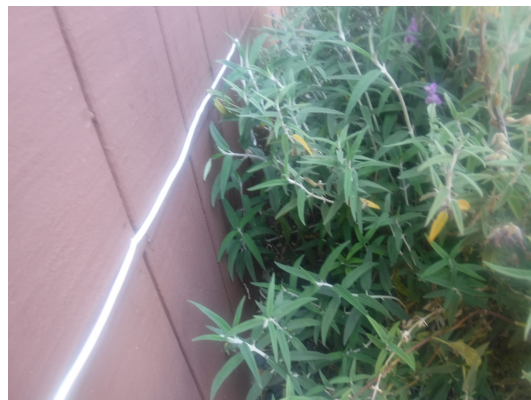
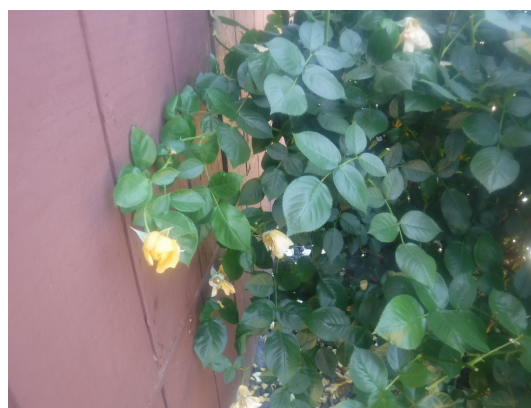
4B:

4B. FINDING: THERE IS CONTACT BETWEEN THE TREES AND/OR FOLIAGE AND THE RESIDENCE CAUSING POSSIBLE MOISTURE INTRUSION.

RECOMMENDATION: CUT BACK TREES/FOLIAGE TO CORRECT CONDITION. IF ADDITIONAL DAMAGE IS FOUND A SUPPLEMENTAL REPORT WILL BE ISSUED REFLECTING ALL FINDINGS.

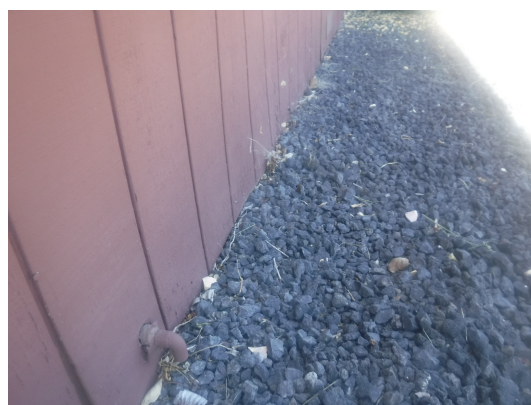
4C:

4C. FINDING: THERE IS A FAULTY GRADE AND/OR EARTH TO WOOD CONTACT AT THE EXTERIOR SIDING.

RECOMMENDATION: REGRADE SOIL TO PROVIDE A MINIMUM OF THREE (3) INCHES OF CLEARANCE BETWEEN THE TOP OF THE FOUNDATION AND ADJACENT WOOD WORK.

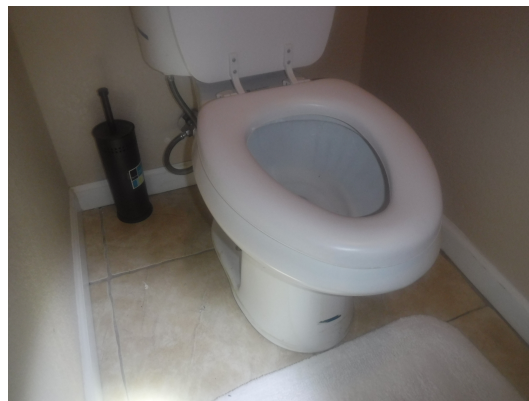
**4D:**

4D. FINDING: THE COMMODE IS LOOSE IN THE MASTER BATHROOM.

RECOMMENDATION: REMOVE THE COMMODE FOR FURTHER INSPECTION. IF NO ADDITIONAL FINDINGS OR ISSUES ARE NOTED AT THE EXPOSED AREA THEN RESET THE COMMODE ON A NEW WAX RING.
