PAUL E. JONES
NAPI CERT. # 30667

INSPECTION DATE: May 9, 2023

REPORT NUMBER: A71271

PROPERTY INSPECTED: 107 Glacier Cir
Vacaville, CA 95687

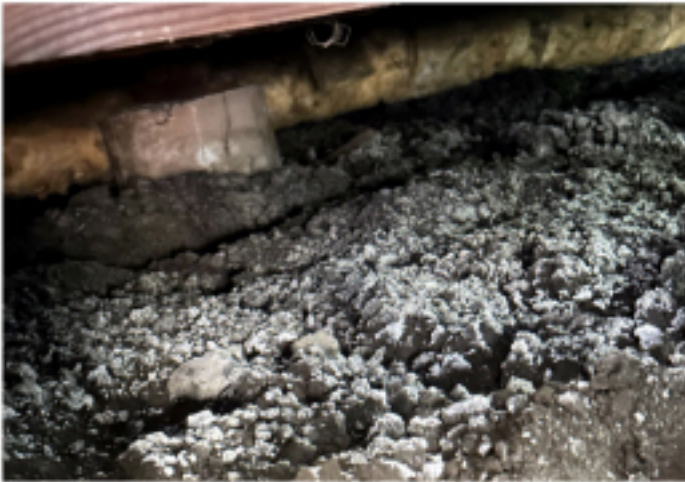
PHOTO #1

1. The inspection of the sub area was limited due to a low clearance between the floor framing and soil floor of the sub area and areas were inaccessible. Suggest the soil be excavated by a qualified licensed contractor as found needed to provide clearance and the sub area be further inspected. (See Photo #1)

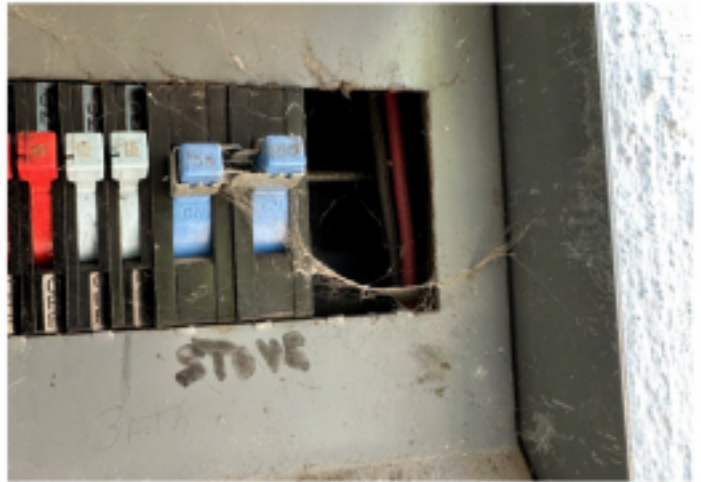
PHOTO #2

1. Two knock out plates are missing from the inner cover of the service entrance panel exposing the bus bar. Suggest the cover openings be sealed with knock out replacements by a qualified licensed contractor. (Safety Concern, See Photo #2)

TWO KNOCK OUT PLATES ARE MISSING FROM THE INNER COVER OF THE SERVICE PANEL.

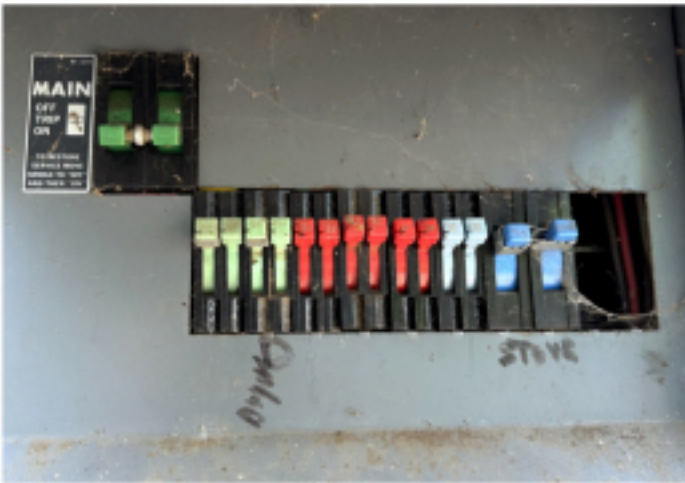
PHOTO #3

2. The circuit breakers at the service entrance panel are partially labeled for identification. Suggest the circuit breakers be labeled by a qualified licensed contractor as found needed. (Safety Concern, See Photo #3)

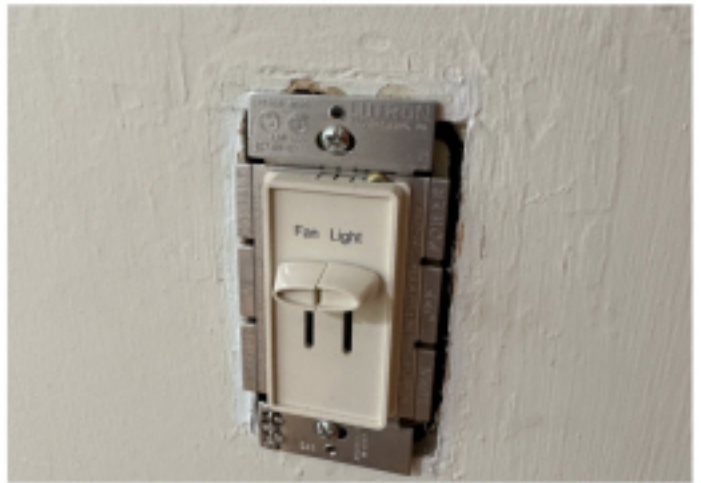
PHOTO #4

3. The faceplate to the wall switch at the North Bedroom is missing. Suggest a faceplate be installed by a qualified licensed contractor. (Safety Concern, See Photo #4)

COMMENTS
THE FAUSE PLATE TO THE WALL SWITCH IS MISSING

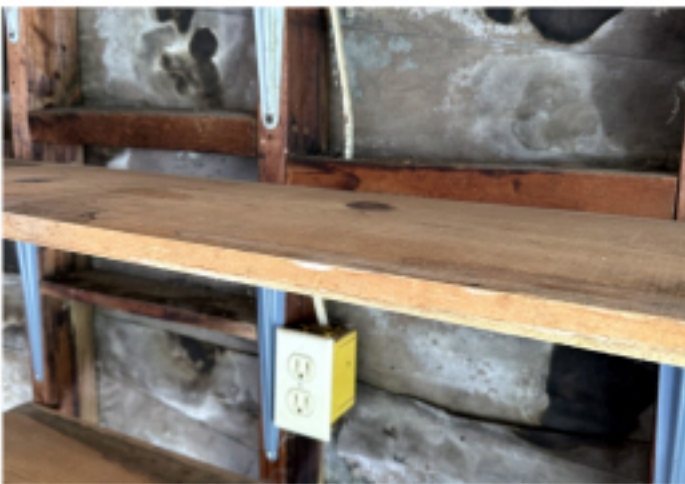
PHOTO #5

4. ROMEX wiring is exposed at the East wall of the garage interior. Suggest the wiring within 7 feet of the garage floor be housed within a protective raceway (behind wallboard) by a qualified licensed contractor to protect the wiring from physical damage. (Safety Concern, See Photo #5)

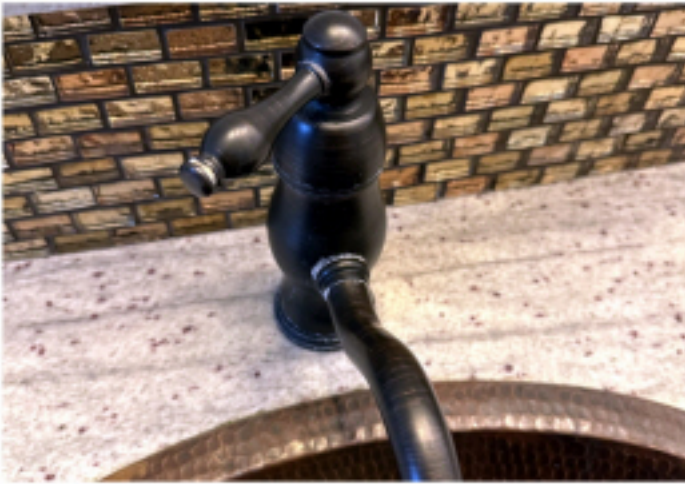
PHOTO #7

2. The bathroom sink faucet mixer valve is inoperable. Suggest the sink faucet be repaired or replaced by a qualified licensed contractor as found needed. (See Photo #7)
3. The bathtub faucet valve appears improperly installed and is difficult to operate. Suggest the bathtub faucet be repaired or replaced by a qualified licensed contractor as found needed. (See Photo #8)
4. The seams at the base of the bathtub surround are poorly sealed near the bathtub faucet. Suggest the seams be sealed with grout by a qualified licensed contractor as found needed. (See Photo #9)

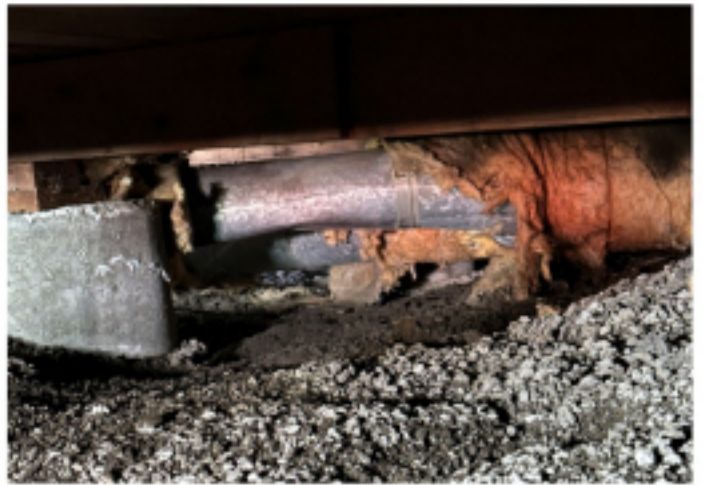
PHOTO #10

1. Sections of insulation at the ductwork in the sub area are torn and missing. Suggest the ductwork be further inspected by a licensed HVAC contractor and be repaired as found needed. (See Photo #10)

SECTIONS OF THE
DUCTWORK INSULATION
ARE TORN/MISSING

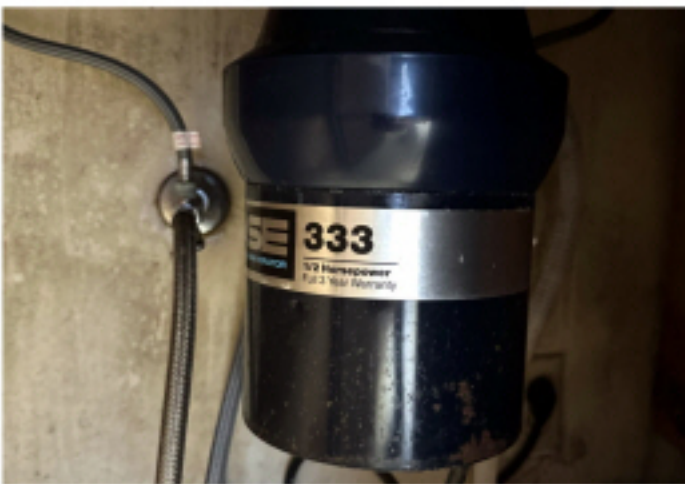
PHOTO #11

1. The garbage disposal unit leaks and is inoperable. Suggest the garage disposal unit be replaced by a qualified licensed contractor. (See Photo #11)
2. The sink cabinet side panels and floor in the cabinet opening below the sink basin appear moisture damaged. Please refer to the structural pest report for additional comments and recommendations, if any. (See Photo #12)

THE GARBAGE DISPOSAL UNIT LEAKS AND IS INOPERABLE

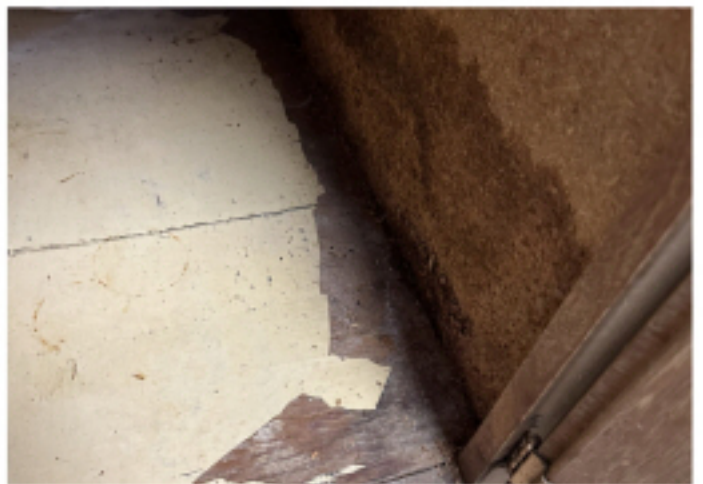
PHOTO #12

THE SINK CABINET SIDE PANELS AND SHELF BELOW THE SINK APPEAR MOISTURE DAMAGED

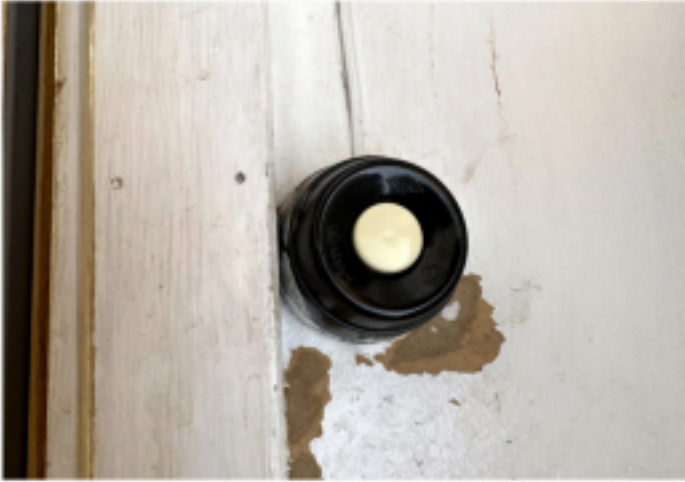
PHOTO #13

1. The garage door opener operating switch is difficult to operate (push button components appear worn). Suggest the operating switch be replaced by a qualified licensed contractor. (See Photo #13)

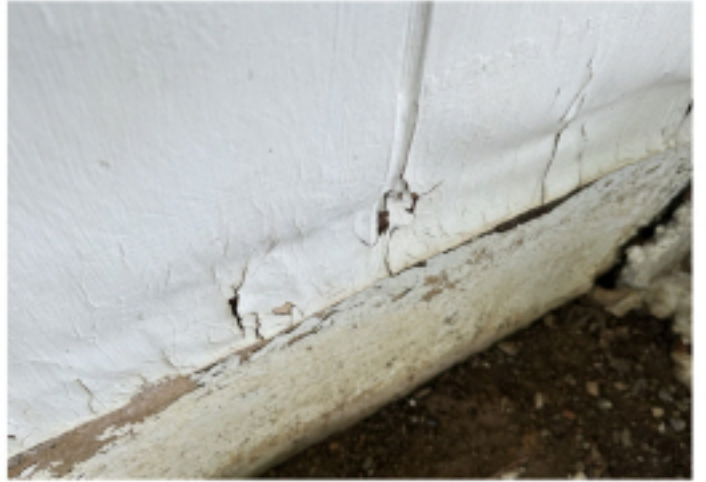
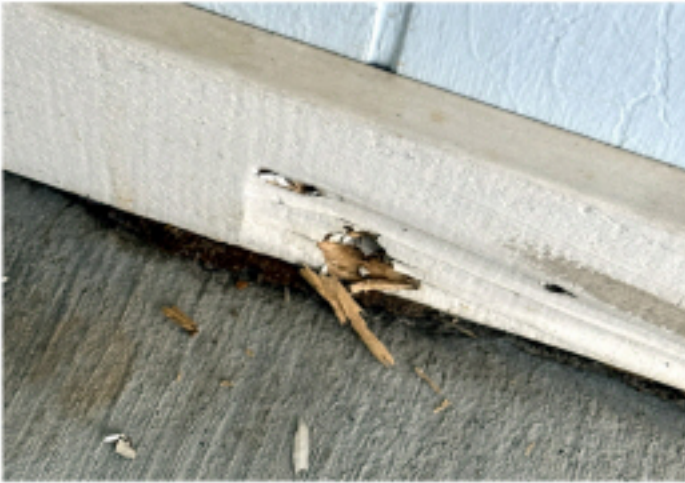
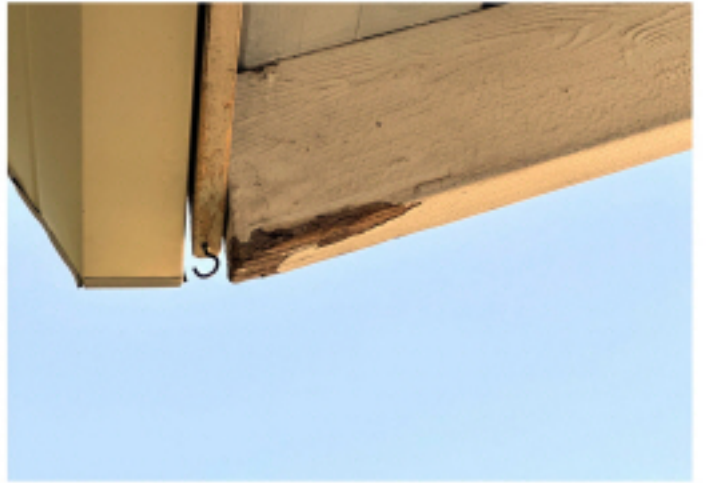
1. The wood siding, trim and roof eaves appear moisture damaged at various locations. Please refer to the structural pest report for additional comments and recommendations, if any. (See Photo #14, Photo #15 and Photo #16)

THE WOOD SIDING, TRIM AND ROOF EAVES APPEAR MOISTURE DAMAGED

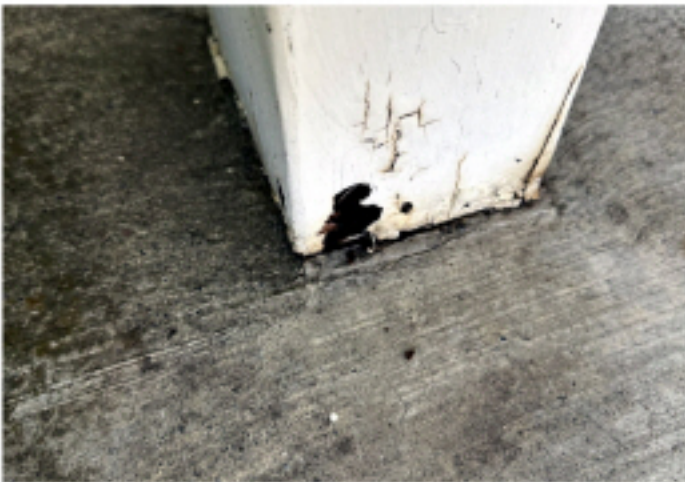
PHOTO #17

2. The base of the support posts at the porch roof cover and roof cover above the overhead garage door appear moisture damaged. Please refer to the structural pest report for additional comments and recommendations, if any. (See Photo #17)

THE BASE OF THE POSTS AT THE PORCH ROOF COVER AND ROOF COVER ABOVE THE OVERHEAD GARAGE DOOR APPEAR MOISTURE DAMAGED

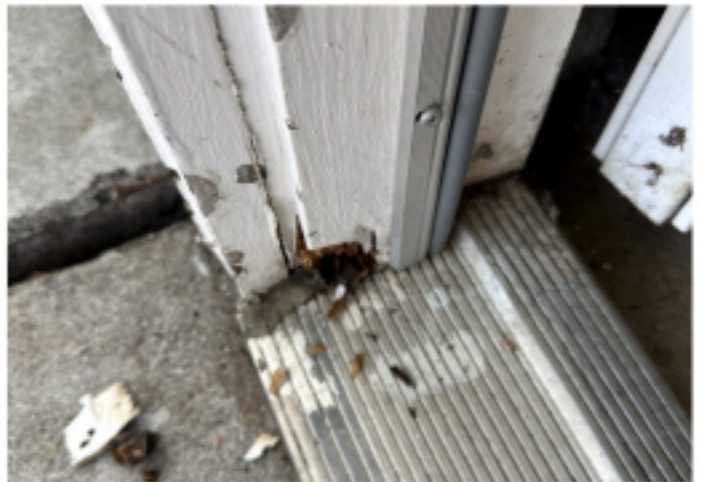
PHOTO #18

3. The base of the door jamb to the garage pedestrian door appears moisture damaged. Please refer to the structural pest report for additional comments and recommendations, if any. (See Photo #18)

FLOOR Common cracks Large/unusual cracks Heaving/settling
THE BASE OF THE DOOR JAMB TO THE PED. DOOR APPEARS MOISTURE DAMAGED

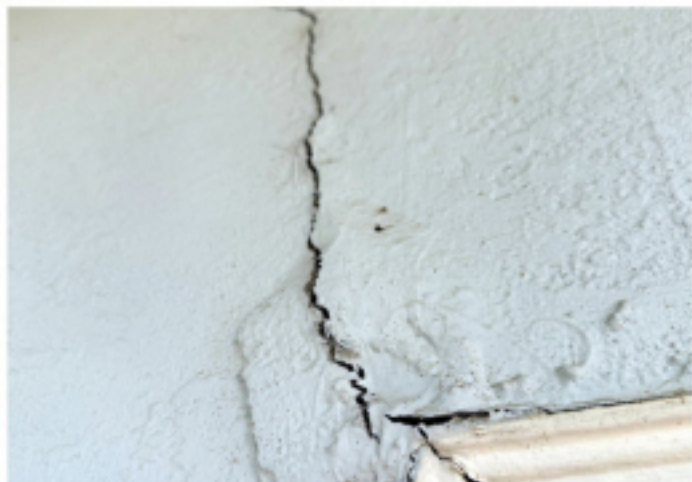
PHOTO #19

4. The stucco above the sliding glass door and garage pedestrian door is cracked from apparent common settling. Suggest the cracks be sealed with an exterior grade caulking material by a qualified licensed contractor. (See Photo #19)

THE STUCCO ABOVE THE SLIDING GLASS DOOR AND GARAGE PEDESTRIAN DOOR IS CRACKED
