WOOD DESTROYING PESTS AND ORGANISMS INSPECTION REPORT

Building No. 107	Street Glacier Circle	City Vacaville	Zip 95687	Date of Inspection May 9, 2023	Number of Pages 6
---------------------	--------------------------	-------------------	--------------	--	----------------------

Company Report
 # R9510

General Description: Single story home on raised foundation with attached garage.	Inspection Tag Posted: Garage
	Other Tags Posted:

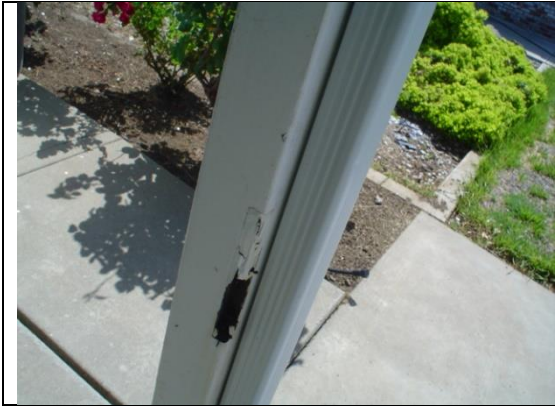
Fig.1a

1 Finding: Fungi (wood-rot) damage found at posts. Indicated on the diagram by “1”, and some areas shown in Fig.1 images on the back pages of this report.

Recommendation: Replace posts.

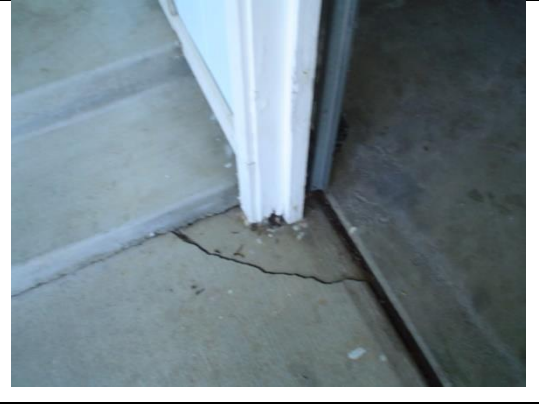
2 Finding: Fungi (wood-rot) damage found in the base of garage door jamb. Indicated on the diagram by “2”, and some areas shown in Fig.2 images on the back pages of this report.

Recommendation: Repair/replace fungi damaged wood members as needed.

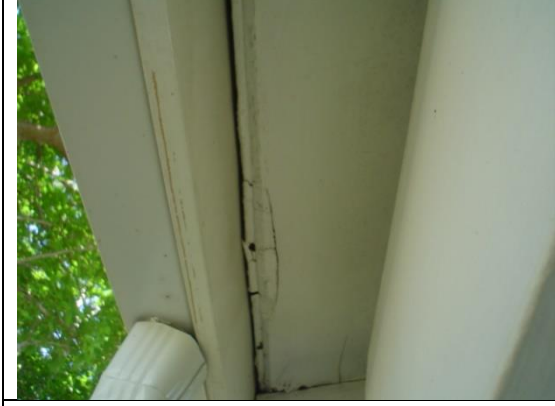
3 Finding: Fungi (wood-rot) damage found in the roof eaves. Indicated on the diagram by “3”, and some areas shown in Fig.3 images on the back pages of this report.

Recommendation: Remove roof covering as needed. Remove and replace damaged wood members as needed. Reinstall roof covering.

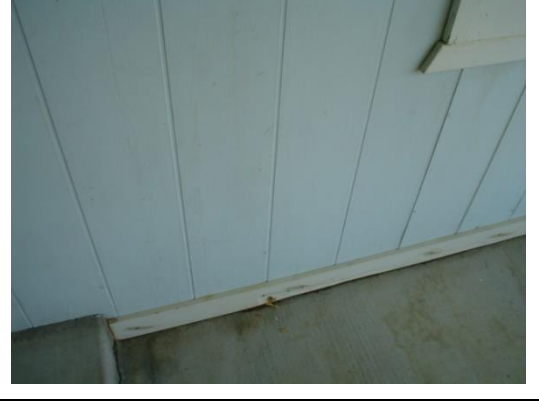
4 Finding: Fungi (wood-rot) damage found in the exterior trim. Indicated on the diagram by “4”, and some areas shown in Fig.4 images on the back pages of this report.

Recommendation: Replace damage areas of trim.

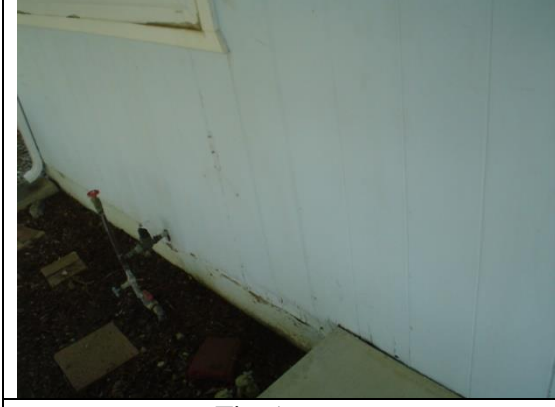
Fig.5a

5 Finding: Fungi (wood-rot) damage found in the exterior siding. Indicated on the diagram by “5”, and some areas shown in Fig.5 images on the back pages of this report.

Recommendation: Replace damaged siding as identified during our original inspection. Further inspect upon opening of enclosed areas. If removal of concrete is found necessary, a supplemental report shall be issued.

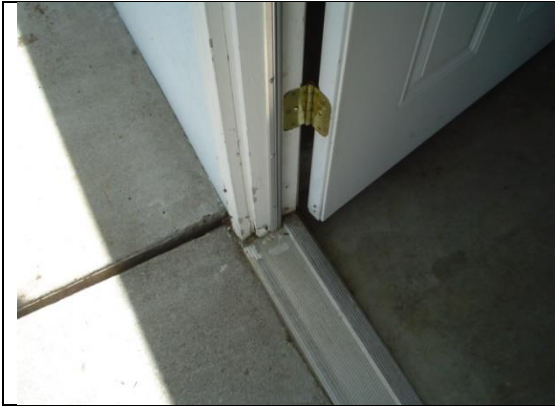
6 Finding: Fungi (wood-rot) damage found at exterior door jamb. Indicated on the diagram by “6”, and some areas shown in Fig.6 images on the back pages of this report.

Recommendation: Repair/replace fungi damaged wood members as needed.

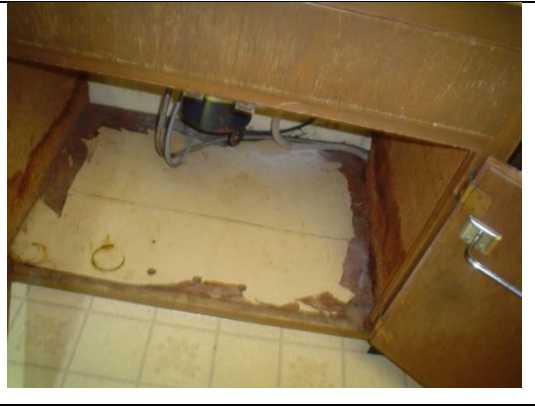
7 Finding: Moisture damage found at the inner cabinet sidewall areas. Indicated on the diagram by “7”, and some areas shown in Fig.7 images on the back pages of this report.

Recommendation: Repair/replace inner cabinet area as identified during our original inspection.

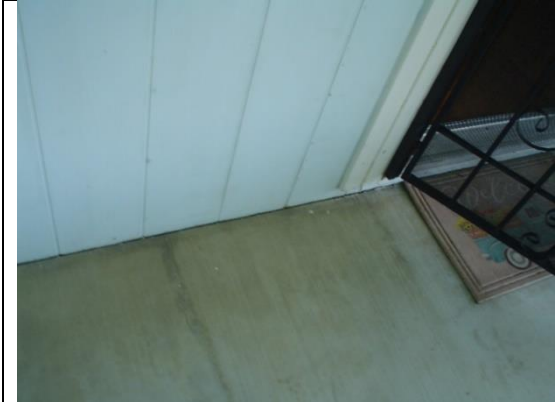
8 Finding: Concrete porch lacks a proper flashing between concrete and structure. Indicated on the diagram by “8”, and some areas shown in Fig.8 images on the back pages of this report.

Recommendation: Owner should employ others to remove concrete as needed, install flashing, and install new concrete.

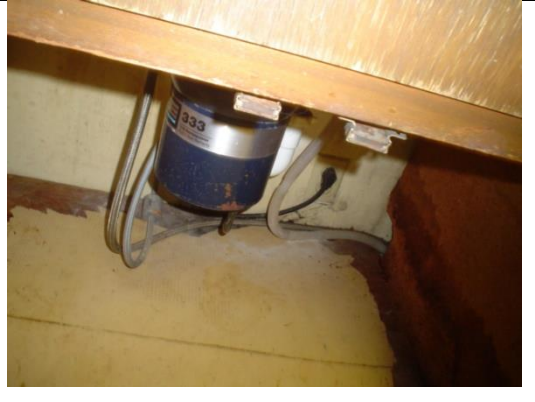
9 Finding: Garbage disposal leaks. Indicated on the diagram by “9”, and some areas shown in Fig.9 images on the back pages of this report.

Recommendation: Replace garbage disposal.

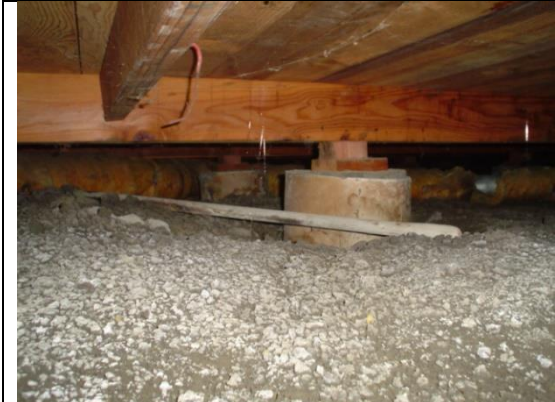
10 Finding: Insufficient clearance prevents full access of subarea. Rigid ducting was also noted, which would appear to prevent access of areas. A visual inspection revealed the presence of cellulose debris (scrap wood) at soil. Indicated on the diagram by “10”, and some areas shown in Fig.10 images on the back pages of this report.

Recommendation: Owner should employ others to excavate soil in all substructure areas to gain at least 12 inches of clearance between bottoms of joists and soil, replace rigid ducting with flex ducting as needed to allow full access of all substructure areas, and remove all cellulose debris of size that can be raked. A further inspection should be performed once all substructure areas have been made accessible.
