# Roof Inspection/111 Glacier Circle, Vacaville

# GOVEA ROOFING CO.

**ROOF INSPECTION  
 REPORT & ESTIMATE**  
 Inspection Date:  
 09-14 -2023

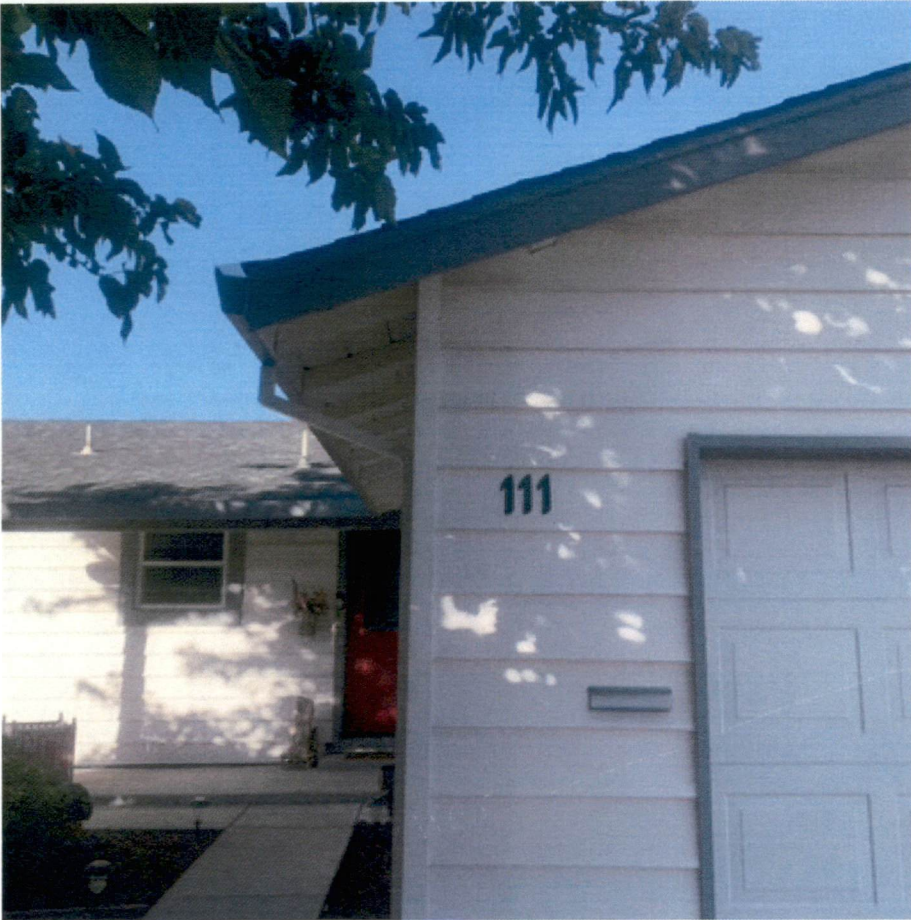
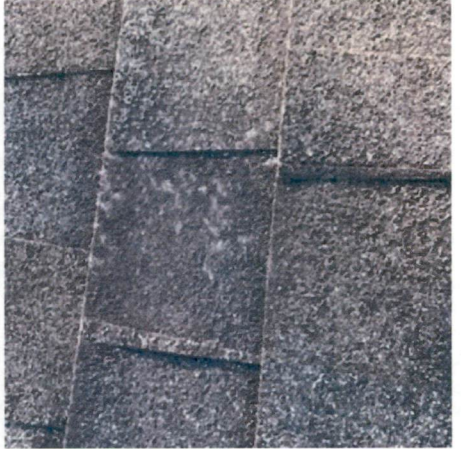
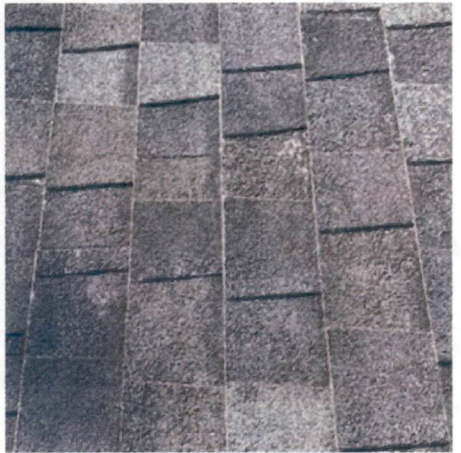
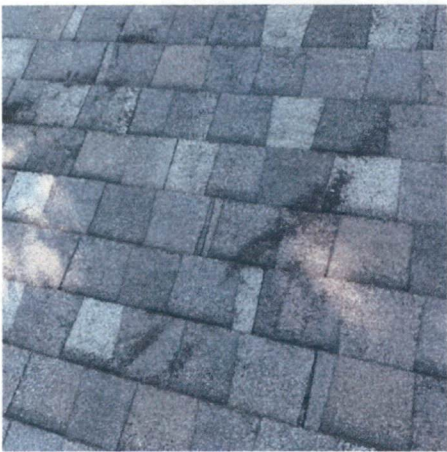
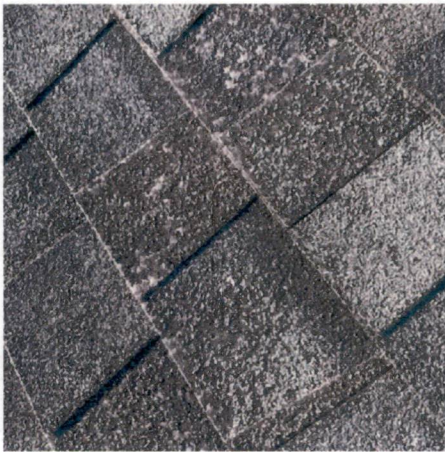
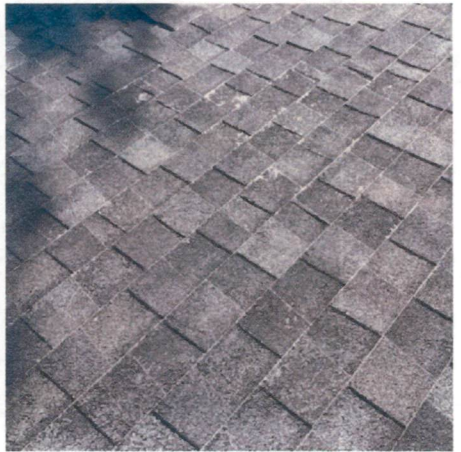
(16) Existing roof has lost excessive amount of roofing granules, showing fiberglass, some patches have been done.

-From our own opinion, this roof is due for replacement and needs to be replaced.

**ESTIMATE FOR REPLACING THE ENTIRE ROOF: \$13,200 taxes included.**
