PAUL E. JONES NAPI CERT. # 30667 P.O. BOX 981071 W. SACRAMENTO, CA 95798 (916) 752-0275 e-mail: pjones21@comcast.net

INSPECTION DATE: November 16, 2022 **REPORT NUMBER:** A12621

PROPERTY INSPECTED: 131 Chevy Chase Ct

The property inspected is a 2 bedroom, 2 bath mobile home. The weather at the commencement of the inspection was clear with a temperature reading of approximately 59 degrees Fahrenheit.

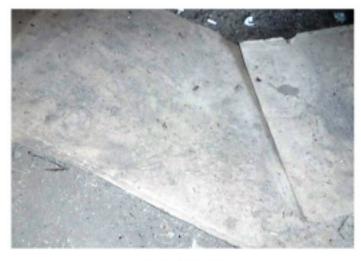
PHOTO #1

1. Wood debris with apparent wood destroying insects was found on the soil floor of the sub area. Please refer to the structural pest report for additional comments and recommendations, if any. (See Photo #1)

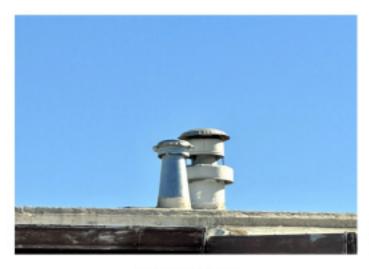
PHOTO #2

- 1. The seams at the roof jacks appear poorly sealed and the ceilings at the Family Room and West Bedroom are stained from apparent past roof leakage. Suggest the roof be further inspected by a licensed roofing contractor and be repaired as found needed. (See Photo #2 and Photo #3)
- 2. The downspouts are poorly secured to the walls and are loose, the downspout at NW corner of the mobile home is missing and the downspout at the NE corner of the mobile home is damaged. Suggest downspouts be repaired, replaced and installed by a qualified licensed contractor as found needed. (See Photo #4, Photo #5 and Photo #6)

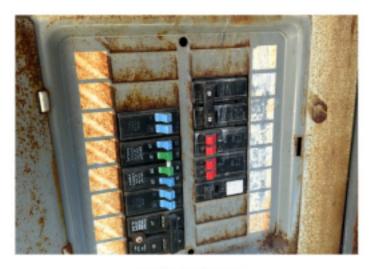
PHOTO #7

1. The circuit breakers at the service entrance panel are not labeled for identification. Suggest the circuit breakers be labeled by s qualified licensed contractor. (Safety Concern, See Photo #7)

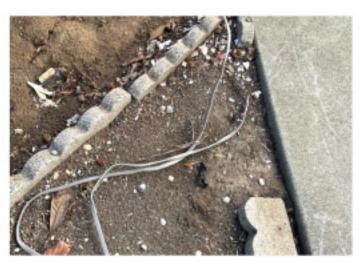
PHOTO #8

- 2. Open-ended ROMEX wiring is exposed at the ground near the South wall of the mobile home. Suggest the wiring be removed by a qualified licensed contractor. (Safety Concern, See Photo #8)
- 3. The cover plate to the junction box at the Family Room is missing exposing electrical wiring. Suggest a cover plate be installed by a qualified licensed contractor. (Safety Concern, See Photo #9)
- 4. The faceplate to one electrical outlet at the Master Bedroom is missing. Suggest a faceplate be installed by a qualified licensed contractor. (Safety Concern, See Photo #10)

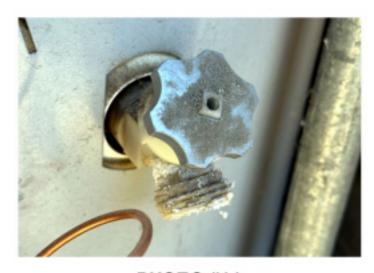
PHOTO #11

The water heater drain valve leaks. Suggest the drain valve be repaired or replaced by a qualified licensed contractor as found needed. (See Photo #11)

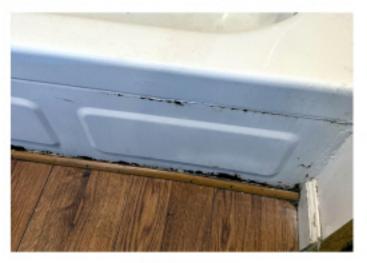
PHOTO #12

1. The floor underlayment appears moisture damaged near the bathtub. Please refer to the structural pest report for additional comments and recommendations, if any. (See Photo #12)

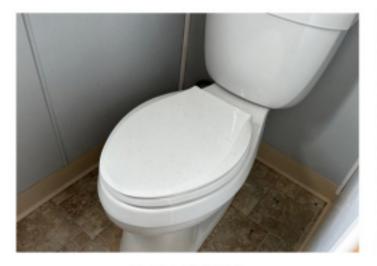
PHOTO #13

1. The toilet is loosely secured to the floor. Suggest the toilet be reset with a new wax seal by a qualified licensed contractor. (See Photo #13)

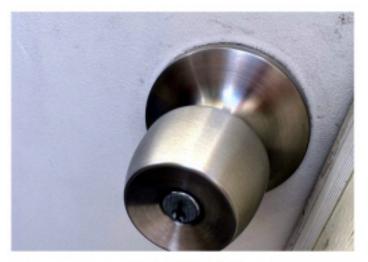
PHOTO #15

1. The doorknob assembly to the entry door is broken and difficult to operate. Suggest the doorknob assembly be replaced by a qualified licensed contractor. (See Photo #15)

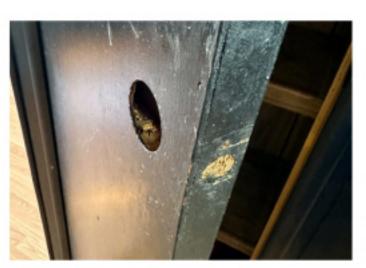
PHOTO #16

The doorknob assembly to the pantry closet door is missing. Suggest a doorknob assembly be installed by a qualified licensed contractor. (See Photo #16)

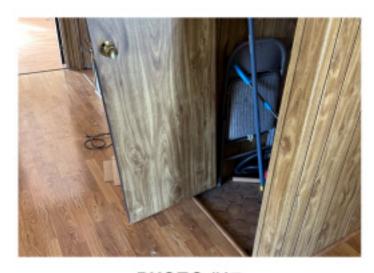
PHOTO #17

1. One door hinge to the closet door is detached from the door casing. Suggest the door be repaired by a qualified licensed contractor. (See Photo #17)

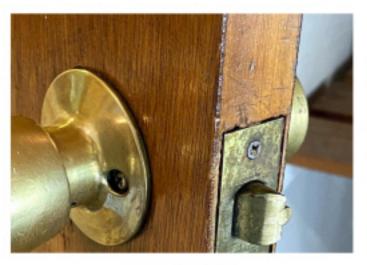
PHOTO #18

- The side of the entry door rubs against the door jamb and is difficult to open and close. Suggest the door be repaired by a qualified licensed contractor. (See Photo #18)
- Condensation stains were noted between the glass panes of one sliding window from an apparent failed vacuum seal. Suggest the glass panes be replaced by a licensed window contractor. (Stationary Side, See Photo #19)

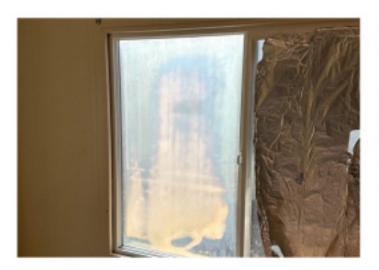
1. Condensation stains were noted between the glass panes of the sliding window from an apparent failed vacuum seal. Suggest the glass panes be replaced by a licensed window contractor. (Sliding Side, See Photo #20)
