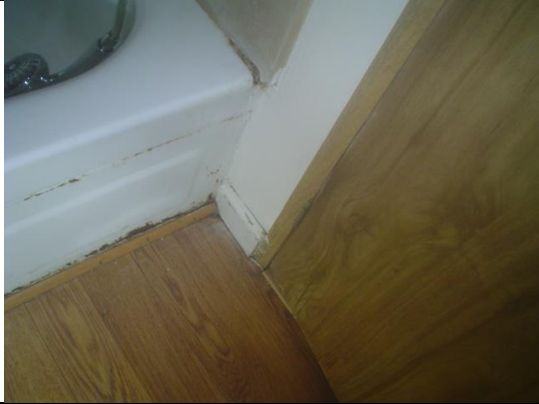
**1 Finding:** Moisture damaged flooring noted in hall bathroom. Indicated on the diagram by “1”, and some areas shown in Fig.1 images on the back pages of this report.

**Recommendation:** Replace flooring. Reset toilet on new wax ring using new bolts. Further inspect upon opening of enclosed areas. Replaced materials may not match existing.

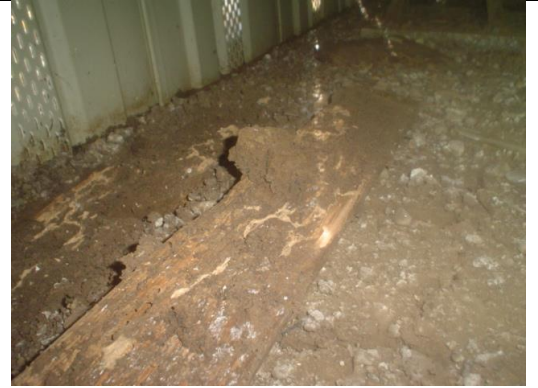
**2 Finding:** Evidence of subterranean termites in cellulose debris (scrap wood, paper, etc.) found in the subarea, including live activity. Indicated on the diagram by “2”, and some areas shown in Fig.2 images on the back pages of this report.

**Recommendation:** Remove all cellulose debris of size that can be raked. Chemically treat the soil as needed in accordance with the pesticide label to control infestation. Remove or cover all accessible termite shelter tubes.

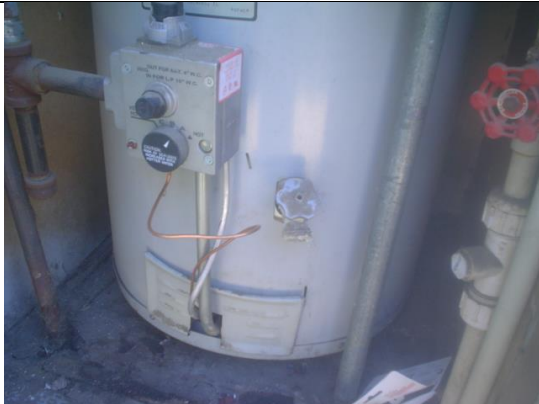
**3 Finding:** Water heater drain valve leaks. Indicated on the diagram by “3”, and some areas shown in Fig.3 images on the back pages of this report.

**Recommendation:** Install cap at valve outlet to eliminate dripping/leaking.

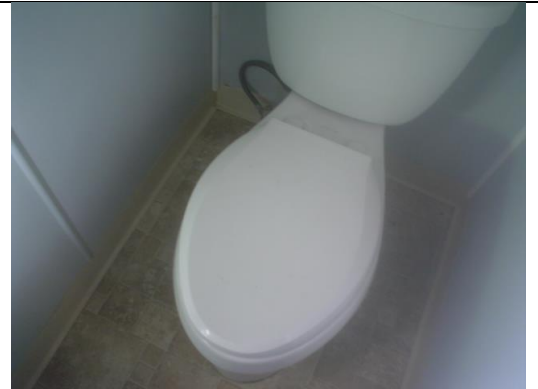
**4 Finding:** Loose toilet found in the master bathroom. Indicated on the diagram by “4”, and some areas shown in Fig.4 images on the back pages of this report.

**Recommendation:** Reset toilet on new wax ring using new bolts. Further inspect upon opening of enclosed areas.

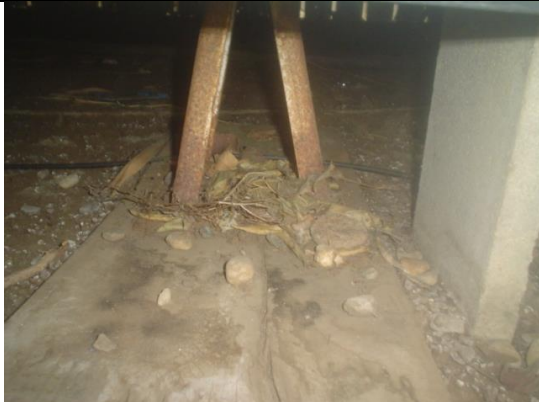
**5 Finding:** Wooden pier pads are in contact with soil in the substructure area. Indicated on the diagram by “5”, and some areas shown in Fig.5 images on the back pages of this report.

**Recommendation:** This type of condition is commonly found with this type of structure. (Wood members appear to be pressure treated lumber.) Correcting these conditions does not appear to be practical. A periodic inspection is advised.
