1725 Landana Drive unit #2, Concord , CA 94519  
Inspection prepared for: Patricia Ballisteri  
Date of Inspection: 9/16/2022

Inspector: Scott Schildknecht  
InterNACHI#NACHI22051815  
1485 Maria Avenue , Concord , CA 94518  
Phone: (707)649-8700  
Email: [scott@northbayinspection.com](mailto:scott@northbayinspection.com)  
[Northbayinspection.com](http://Northbayinspection.com)

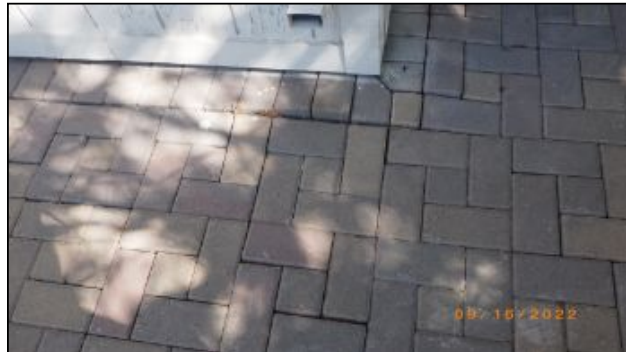
The pavers at the right front side are uneven and settling, this is likely the result of a poorly prepared base. This is primarily a cosmetic issue at this time. Over time this settlement can become worse and become a trip hazard. We advise monitoring this area and to consider having a qualified contractor make the appropriate repairs.

pavers uneven

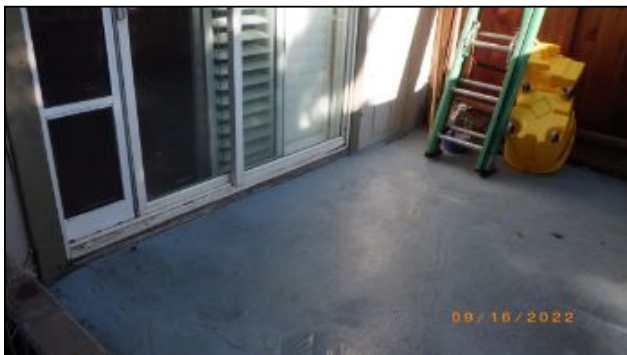
There are indications of significant settlement at the right patio or flat work. There are several large cracks and/or displacements visible. The cause of this settlement is unknown but could be the result of improper lot drainage, inadequate construction, and/or preparation of the lot. It is possible that this settlement will continue requiring the replacement of this concrete work. We recommend further evaluation by a qualified drainage and concrete contractor or an experienced structural engineer.

onging settlement

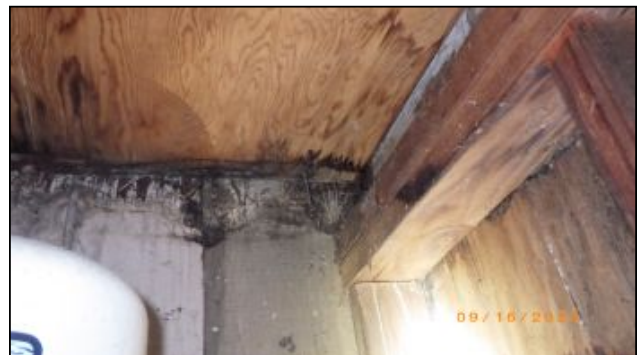
The outbuilding/shed is moisture/fungus damaged at several places. This damage can spread to areas and cause this deck to become unstable or even unsafe over time. For more information we recommend further evaluations and inspections by a Class Three Structural Pest firm.

moisture damage

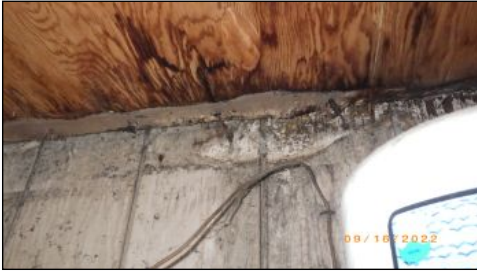
**The siding at the right side is moisture and/or fungus damaged. This damage can spread to areas adjacent to the siding, including framing. We recommend further evaluation and repairs by a qualified licensed Class Three Structural Pest firm.**

moisture damage

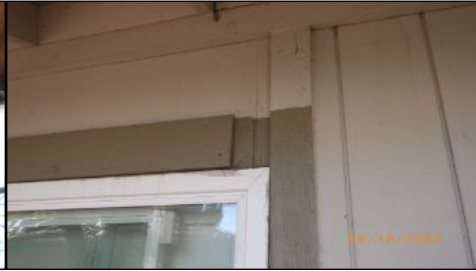
missing trim

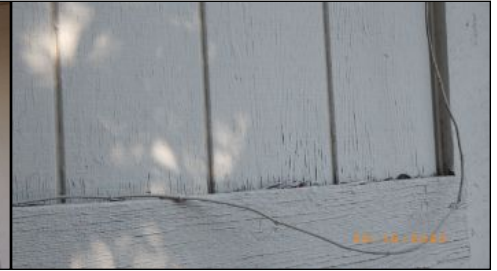
There is plywood siding that shows signs of delamination. The cause of the delamination, whether related to moisture inside the exterior walls or simply weathering, needs to be investigated and the damage needs to be repaired by an experienced carpenter or siding installer.

delaminated siding

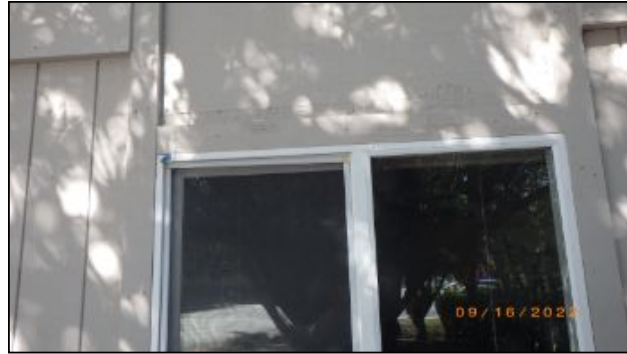
worn siding

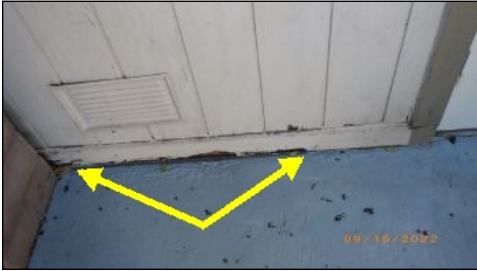
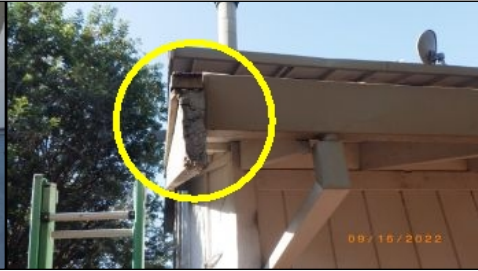
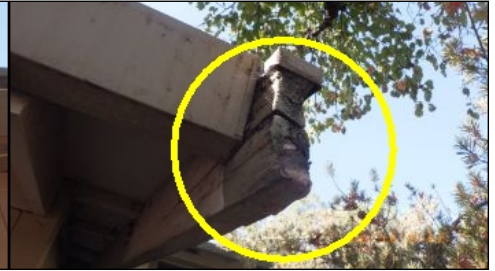
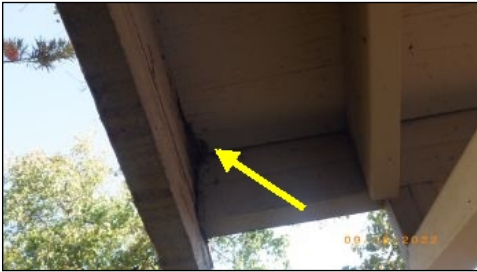
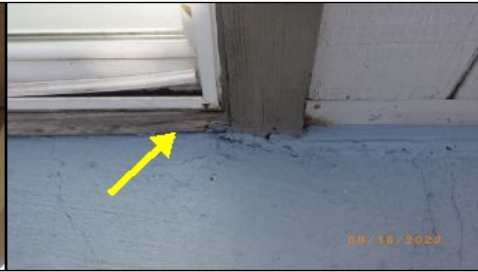
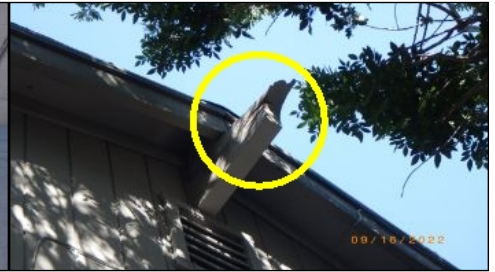
There are moisture/fungus damaged exposed beam(s) end(s). Wood beams and rafter tails that protrude beyond the eaves are exposed to harsh weather and therefore prone to moisture related damage. We recommend further evaluation and repairs by a class three structural licensed pest firm. Note: These beams can sometimes be simply cut shorter then properly primed and sealed with paint. To prevent future damage on exposed beams it is worthwhile and a relatively inexpensive upgrade to have sheet metal caps installed on the tops of these beams.

moisture damage

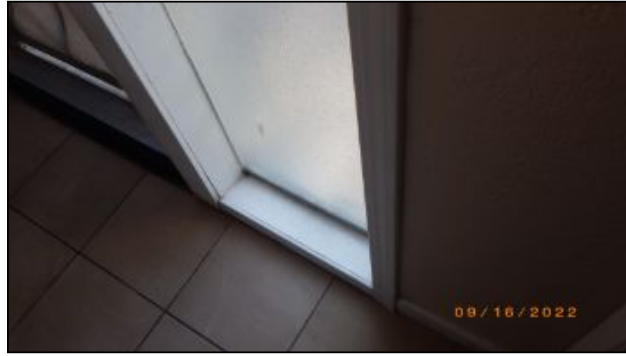
There is at least one window at the entryway that is less than 24 inches from a door that is not believed to be safety glass. Glass windows close to the floor are more likely to be hit or kicked accidentally. Non-safety glass breaks into large shards that can cause serious harm to persons. We recommend all glass within 24-inches of a doorway be protected or consider having them replaced with approved glass.

non tempered glass

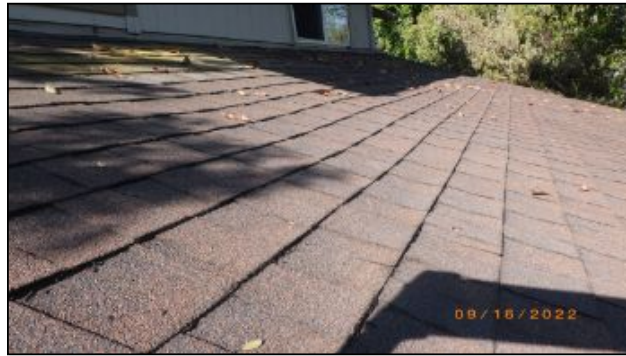
**The exterior closet/shed roof is near or at the end of its service life. Temporary repairs may keep it waterproof for now but it will need to be replaced soon. We recommend obtaining bids for replacement of this roof from qualified roofing contractors.**

moderately worn

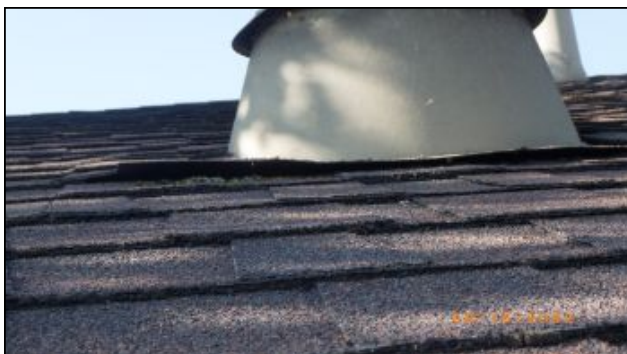
The roof flashings are leaking at the exterior closet/shed. This condition will cause moisture related damage to this home. Repair/replacement is recommended. We recommend immediate further evaluation and repairs by a qualified roofing contractor.

lifted flashings

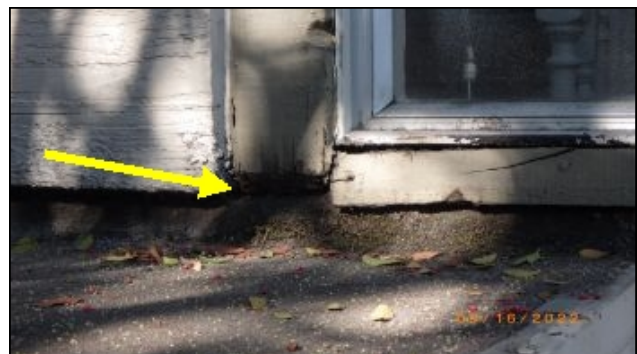
improperly integrated

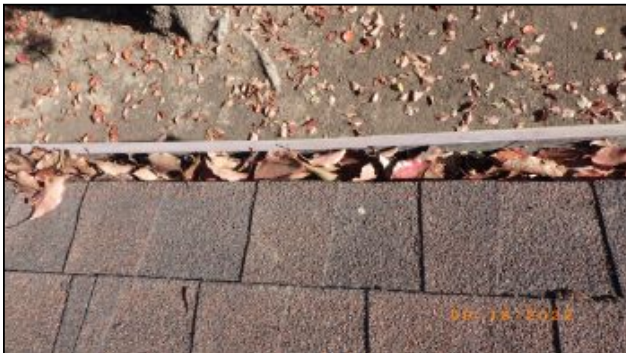
The gutters at the garage and home are generally worn and at or near the end of their service life. These gutters may need replacement soon. Consultation with several gutter installers to discuss various options and determine replacement cost is recommended. Note: The most cost effective time to replace gutters is when replacing this roof.

debris in gutters

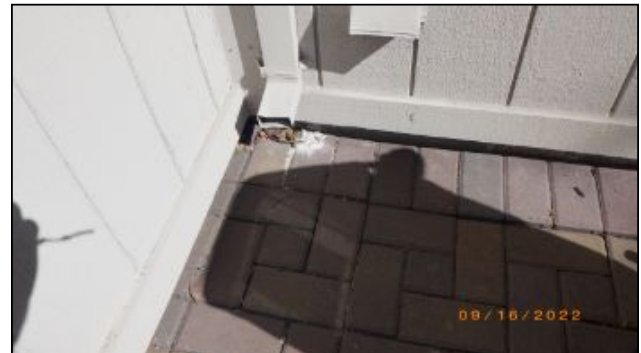
extend downspouts

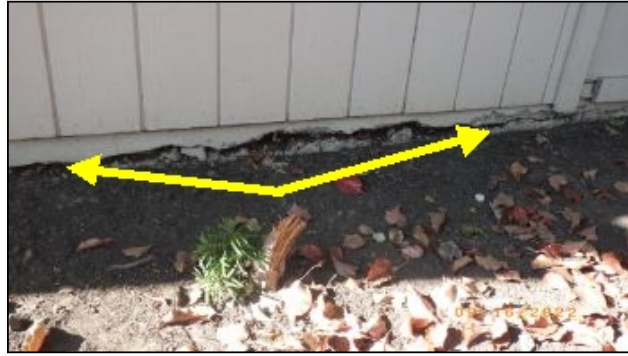
The foundation at the rear side has significant horizontal cracking visible. This inspector does not anticipate any rapid changes and does not significantly reduce the strength of the foundation. In this region of the country this is often caused by reinforcing steel being placed too close to the surface of the concrete allowing water and air to rust/oxidize the steel. The rust expands causing the concrete to spall. Often the loose concrete can be removed, the steel cleaned and chemically treated, and then the void is patched with mortar or patching concrete. For more information we recommend further evaluation and repairs by a specialized concrete contractor or structural engineer.

horizontal cracking

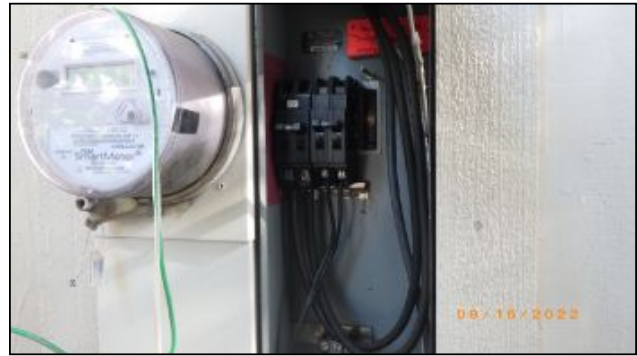
**The inner protective panel is missing on the main panel. This is a potential safety hazard as persons could touch the energized interior of the service box. We recommend having a qualified electrician install the missing inner panel on this device.**

missing inner cover

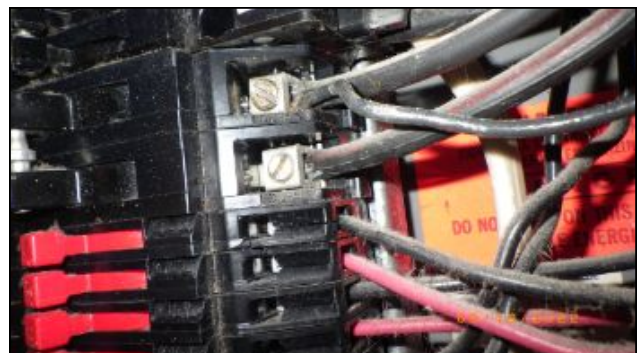
There is at least one double-lugged breaker inside the electrical sub panel. Double lugging is where more than one branch circuit is connected to a single circuit breaker. The breakers in this panel are not designed to accommodate more than one circuit. There is presently only one brand of breaker that is. We recommend correction by a qualified electrician.

double tap

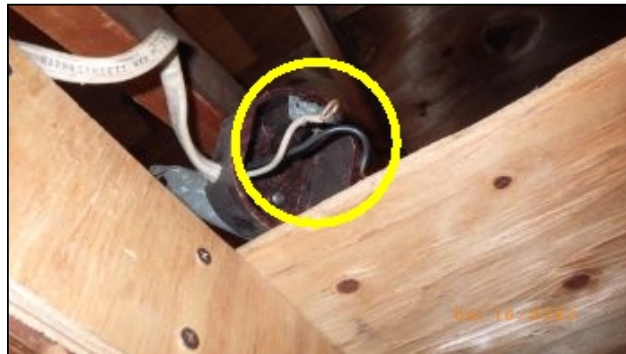
**There is at least one wire in the garage that is energized and not capped or properly terminated in a junction box. This is a significant fire and safety hazard now, we recommend immediate further evaluation and repair by a qualified electrician.**

live uncapped wires

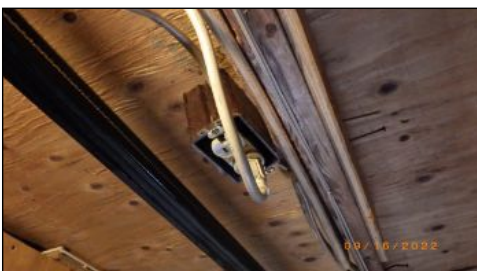
missing covers

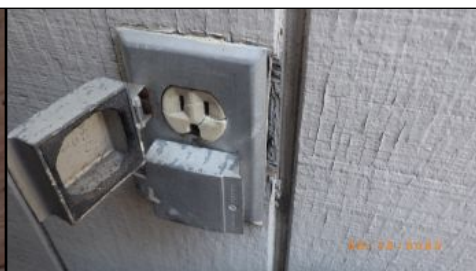
damaged outlet

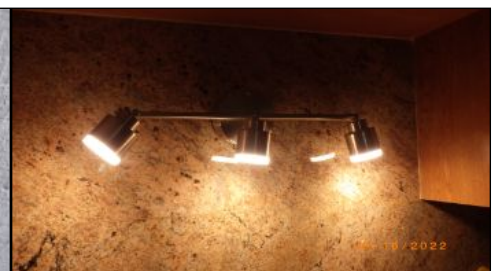
**The light fixture in the kitchen above the sink is loose, loose light fixtures can be a hazard due to their weight. We recommend having a qualified handy person or electrician properly tighten or remount this fixture.**

loose fixture

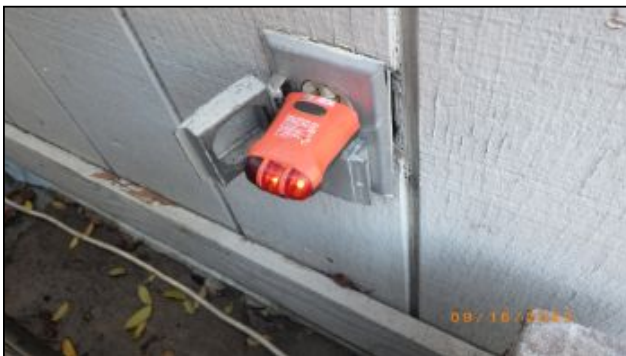
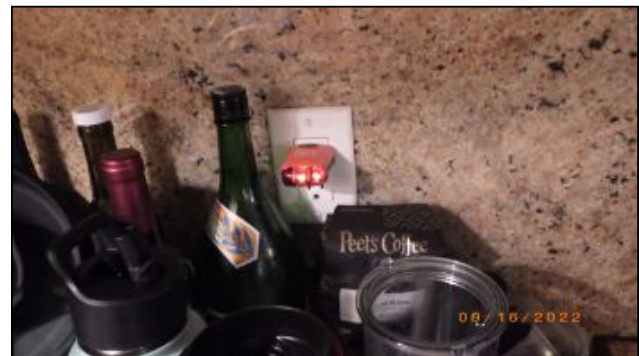
Ground fault circuit interrupter (GFCI) protected outlets are missing at the exterior, upstairs bathrooms and kitchen. This is a potential safety hazard. Because electrical work was likely done recently and/or this is a modern home - outlets near plumbing fixtures and or near damp or potentially wet locations are required to be protected. We recommend further evaluation and repairs by a qualified electrician.

missing GFCI protection

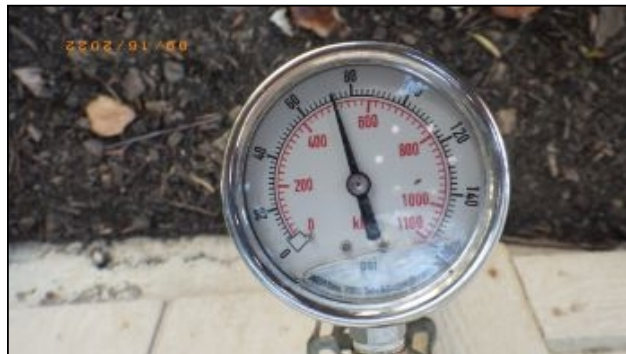
Note: Water pressure between 45 and 65 PSI is considered normal. Pressure in excess of about 80 PSI is considered excessive.

water pressure 72 PSI

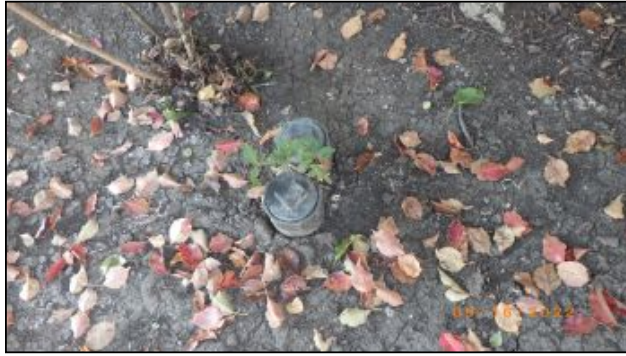
There are large trees on this lot and the home has an older waste line system. According to others there has been previous issues with clogs in the main sewer line. There were no obvious blockages at the time of this inspection. We recommend asking the owner the extent of the issues and what if any repairs were performed. Our standard recommendation for older homes or homes with large trees on the lot is to consider having the waste lines checked with a video camera for breakage, roots, or deterioration. Note: There are several plumbing companies who specialize in waste line video inspections.

sewer clean out

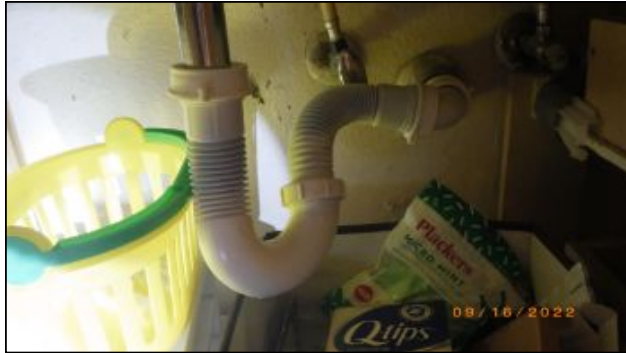
At least one sink in this home uses a flexible accordion type waste below a sink. This type of drain line is often an indication that non plumbers have done work to this sink. Normally professionals use solid sections of either plastic or metal waste lines. The accordion type units tend to clog quickly and do not have a long service life. For more information we recommend further evaluation by a qualified plumber.

flex pipe used

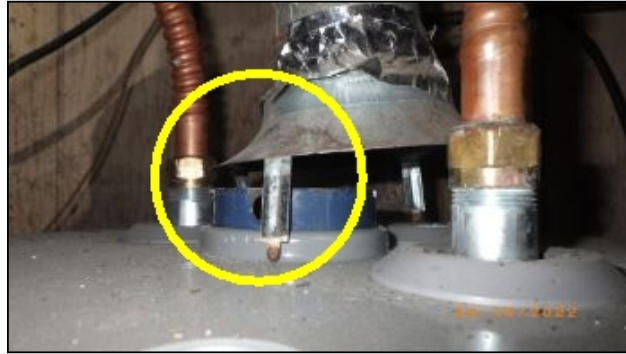
At least one water heater flue is disconnected in the exterior closet\shed. This condition is allowing hot and deadly gases to enter the structure - an immediate fire and health hazard. Deadly carbon monoxide gases can enter the home. We recommend having a qualified plumber immediately perform further evaluation and repairs.

diconnected flue

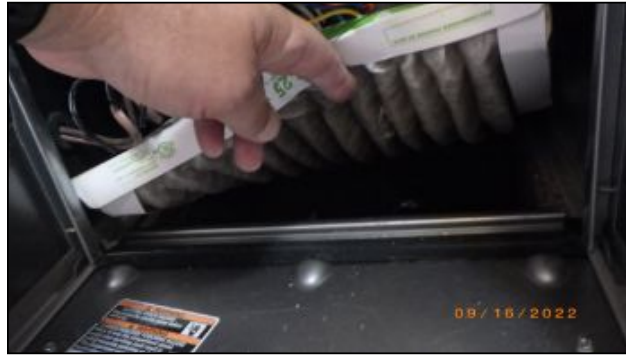
The filter for the air handling system is the wrong size. Unfiltered air can improperly bypass the filter. We recommend carefully measuring the filter flange and purchasing the correct size.

dirty and wrong size

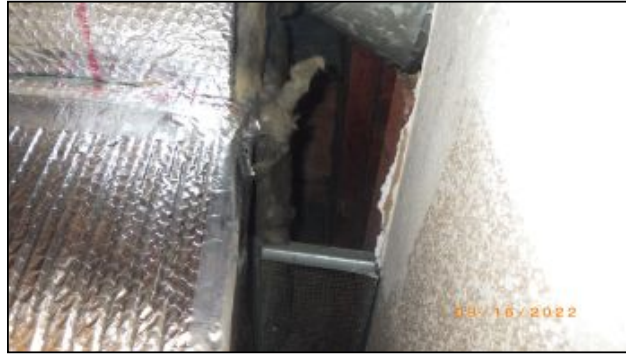
The furnace is located at an interior closet and does not have the required fire protection. Current standards require adjacent areas of the furnace closet to have conforming fire resistant sheet rock in the case of a fire so it does not spread to the rest of the home as quickly. We recommend the missing fire wall be repaired for additional fire safety. Due to the age of the home this might not have been a requirement when the home was built.

missing fire wall

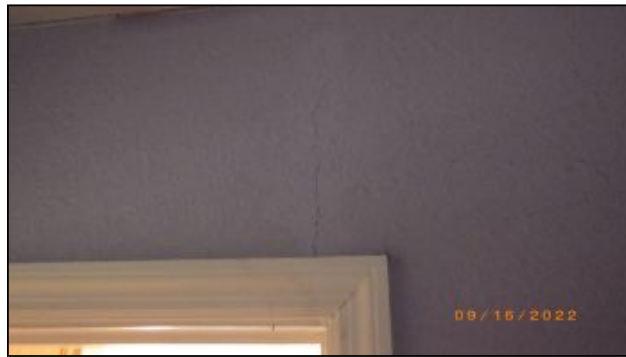
There are cracks in the interior wall/ceiling surfaces that we believe are the result of structural movement caused by settling. The cracks are unsightly and should be repaired. This inspector does not anticipate any rapid changes barring sudden impacts (construction, earthquakes, etc.). Please read the structural section of this report carefully for more information about settlement.

typical settlement cracks

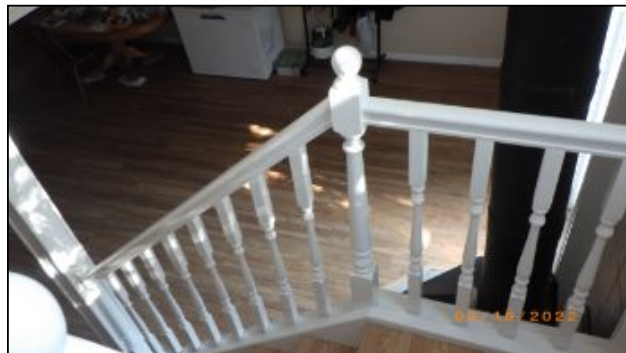
openings too big

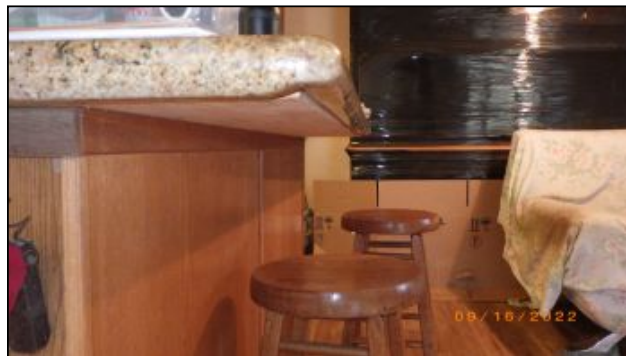
The stone counter top in the kitchen does not appear to have adequate support where it cantilevers out beyond the base cabinet. There was no damage visible at the time of this inspection. This material although very strong can crack when forced to bend. Simply leaning heavily on it, placing heavy objects, sudden blows, or sitting on this can crack it. We recommend having a qualified contractor install proper supports below this counter top. Note: Simply installing properly secured purpose built brackets can add significant rigidity.

not supported

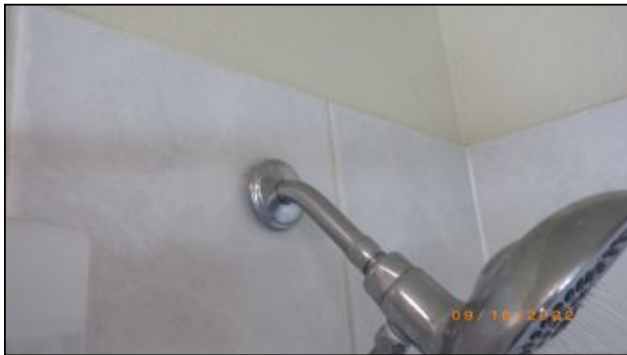
loose assembly

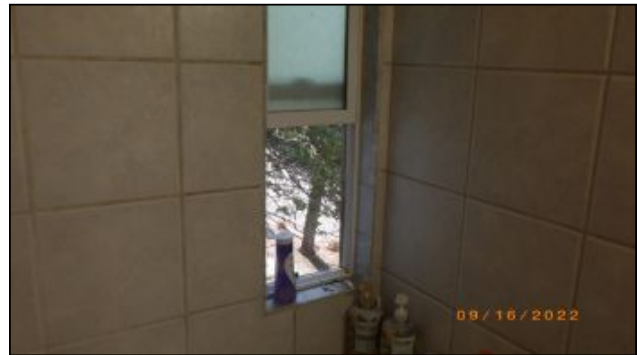
There is likely non safety glass near or in the shower area of the primary bathroom. This is a significant safety hazard as persons can easily break this window causing large shards of glass to fall - extremely hazardous to bare flesh. Improperly sealed window frames or sills can allow water to enter the framing causing substantial moisture/fungus damage. We recommend removing this window making it higher or installing tempered glass. Note: This condition is also conducive to creating moisture and insect related damage as the sill is continuously wet.

non tempered window

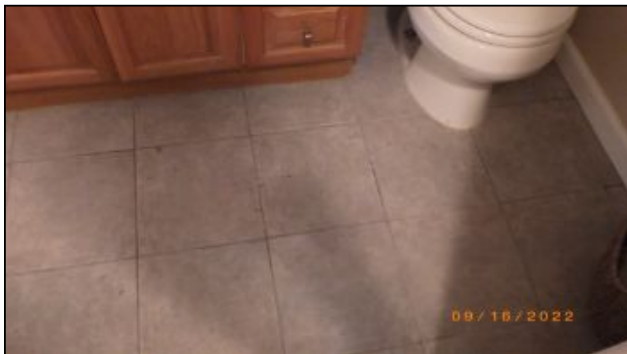
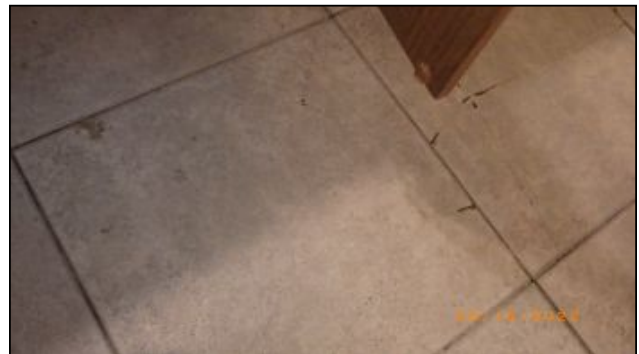
Some tiles on the floor are cracked in the primary bathroom. The exact cause of the cracking is unknown but likely due to factors including but not limited to: foundation settlement, seismic activity, framing movement, improper installation, heavy object dropped, or damage below floor. We recommend further evaluation and repairs by a qualified tile contractor.

cracked tiles

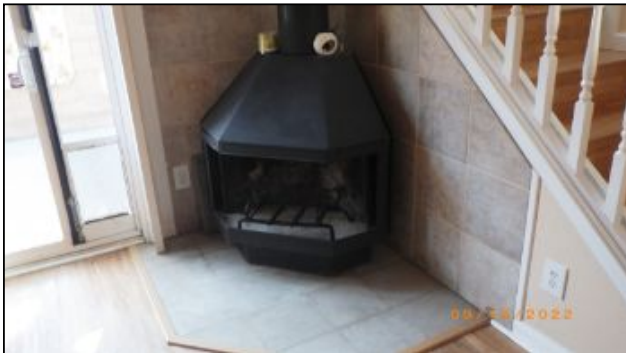
missing screen

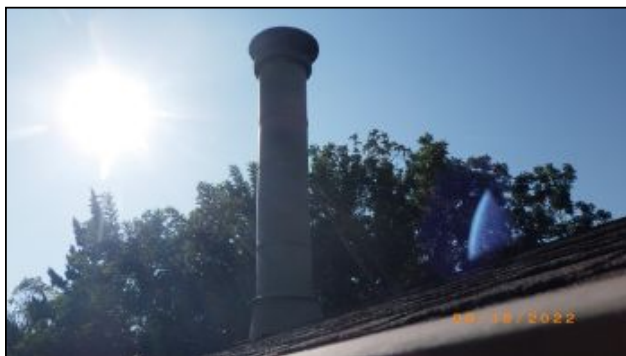
Adequate inspection of the crown and flue of the chimney could not be conducted because of the presence of a spark arrestor, the stack was simply too high or existing weather or chimney conditions made conducting such an inspection dangerous. This chimney is therefore excluded from the scope of this inspection. The National Fire Prevention Association (NFPA) recommends that a Level II inspection, with fiber-optic video camera, be conducted prior to buying/selling a home. It is recommended that the client(s) have this done prior to closing by a sweep certified by the Chimney Safety Institute of America (CSIA) or equivalent organization.

no view of flue interior

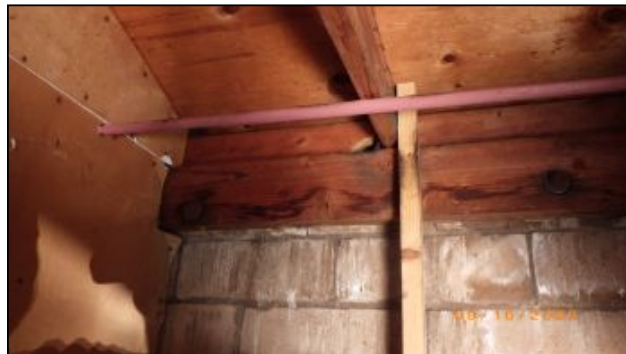
The framing in the garage is water stained at several places. The areas were dry at the time of this inspection. The source of the moisture may have been repaired or is intermittent. We recommend having this area monitored. Note: Only water testing can determine if there are active roof leaks.

dry stains

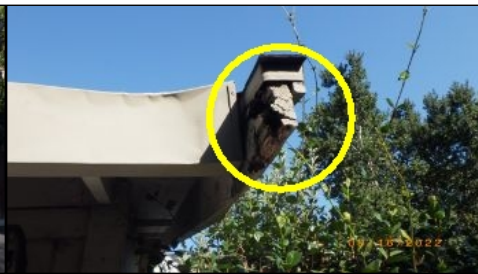
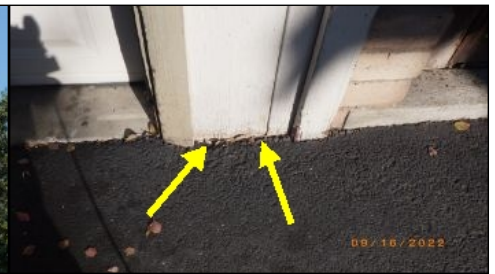
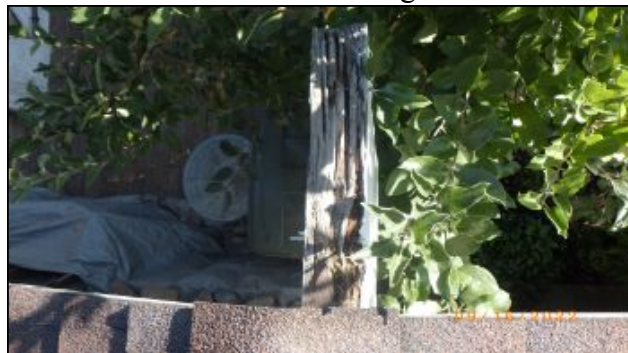
There is scattered moisture/fungus damage at the exterior of this garage at several places. We recommend further evaluation and repairs by a Class 3 Structural Pest Control Operator.

moisture damage

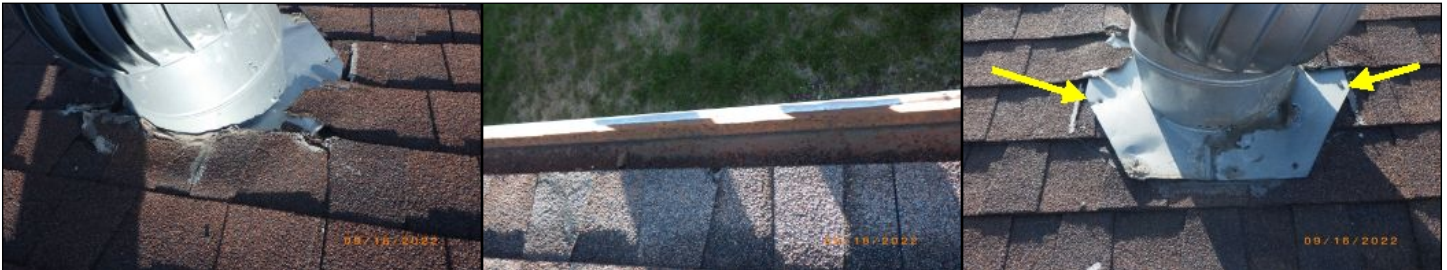
We found that the roof cover has sustained physical damage. If not corrected this issue could eventually result in significant structural damage to other parts of the structure through rainwater infiltration. Immediate correction by a qualified roofer is recommended.

physical damage

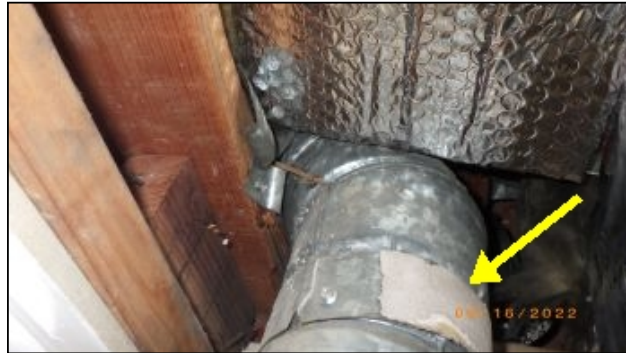
Most people exposed to small amounts of asbestos, as we all are in our daily lives, do not develop these health problems. However, if disturbed, asbestos material may release asbestos fibers, which can be inhaled into the lungs. The fibers can remain there for a long time, increasing the risk of disease. Asbestos material that would crumble easily if handled or that has been sawed, scraped, or sanded into a powder is more likely to create a health hazard.”

possible asbestos material
