THIS DISCLOSURE STATEMENT CONCERNS THE REAL PROPERTY SITUATED IN THE CITY OF Concord, COUNTY OF Contra Costa, STATE OF CALIFORNIA, DESCRIBED AS 1725 Landana Dr #2, Concord, CA 94519-1447

1725 Landana Drive unit #2, Concord , CA 94519
Inspection prepared for: Patricia Ballisteri
Date of Inspection: 9/16/2022

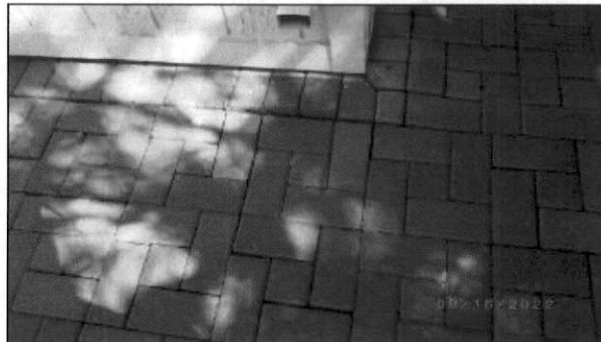
The pavers at the right front side are uneven and settling, this is likely the result of a poorly prepared base. This is primarily a cosmetic issue at this time. Over time this settlement can become worse and become a trip hazard. We advise monitoring this area and to consider having a qualified contractor make the appropriate repairs.

pavers uneven

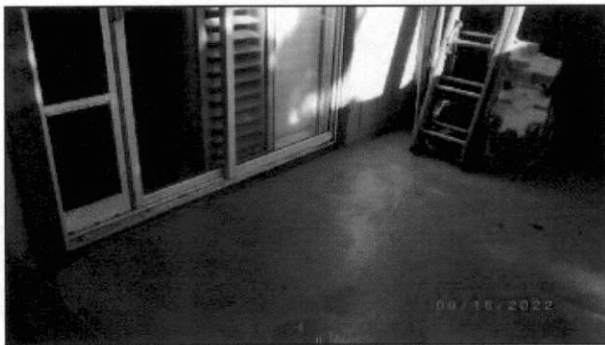
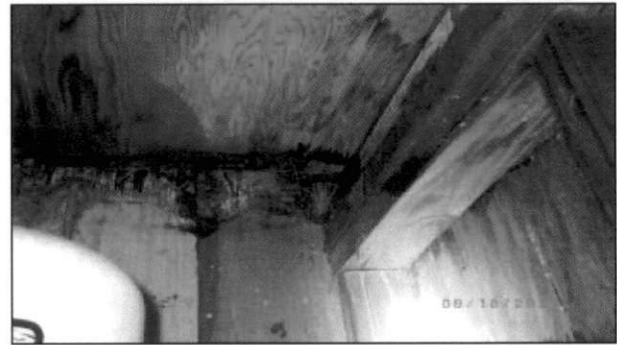
The outbuilding/shed is moisture/fungus damaged at several places. This damage can spread to areas and cause this deck to become unstable or even unsafe over time. For more information we recommend further evaluations and inspections by a Class Three Structural Pest firm.

onging settlement

moisture damage

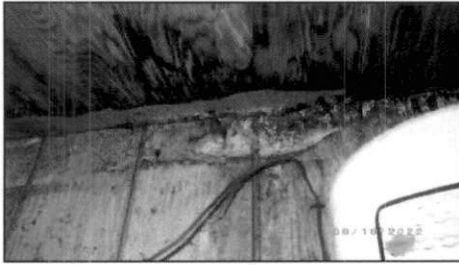
The siding at the right side is moisture and/or fungus damaged. This damage can spread to areas adjacent to the siding, including framing. We recommend further evaluation and repairs by a qualified licensed Class Three Structural Pest firm.

moisture damage

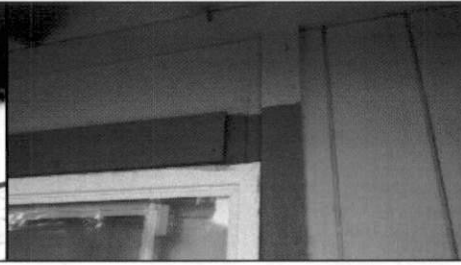
missing trim

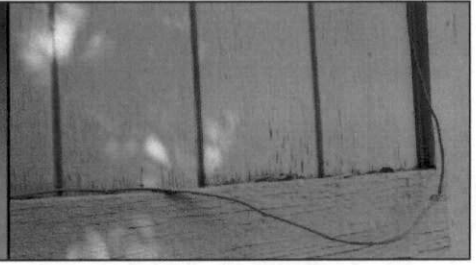
delaminated siding

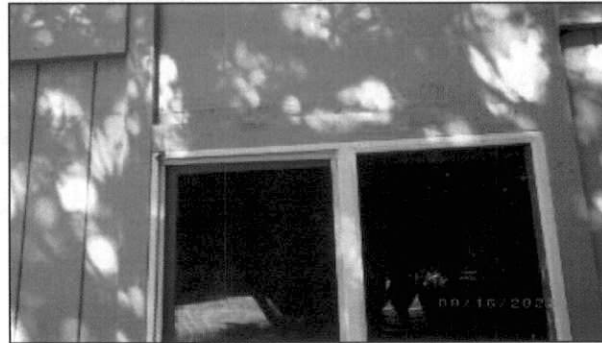
worn siding

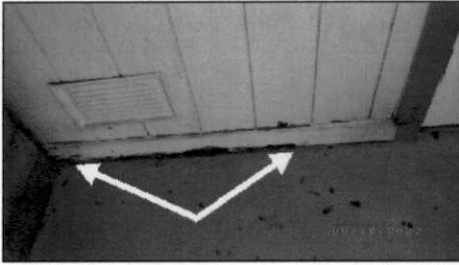
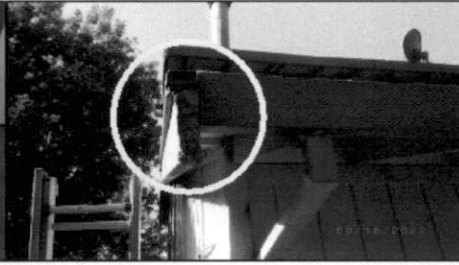
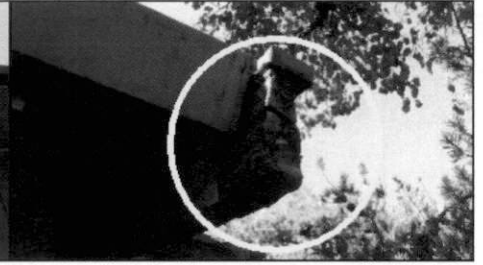
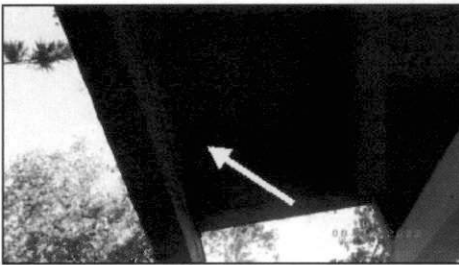
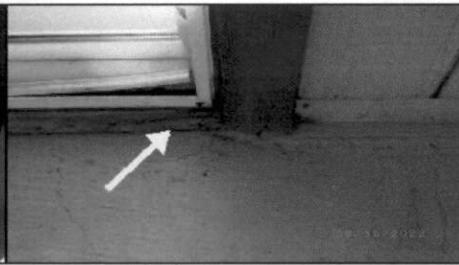
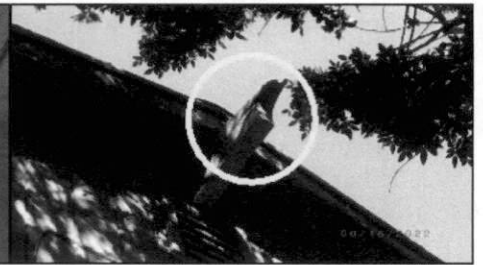
There are moisture/fungus damaged exposed beam(s) end(s). Wood beams and rafter tails that protrude beyond the eaves are exposed to harsh weather and therefore prone to moisture related damage. We recommend further evaluation and repairs by a class three structural licensed pest firm. Note: These beams can sometimes be simply cut shorter then properly primed and sealed with paint. To prevent future damage on exposed beams it is worthwhile and a relatively inexpensive upgrade to have sheet metal caps installed on the tops of these beams.

moisture damage

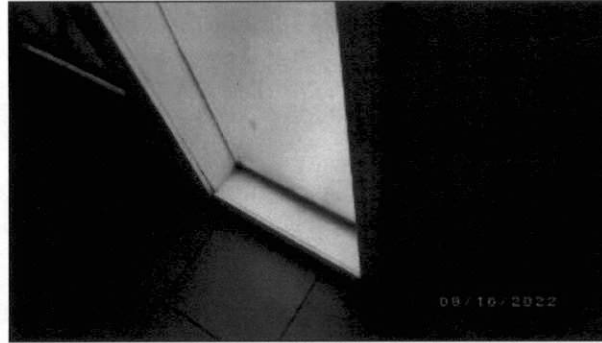
There is at least one window at the entryway that is less than 24 inches from a door that is not believed to be safety glass. Glass windows close to the floor are more likely to be hit or kicked accidentally. Non-safety glass breaks into large shards that can cause serious harm to persons. We recommend all glass within 24-inches of a doorway be protected or consider having them replaced with approved glass.

non tempered glass

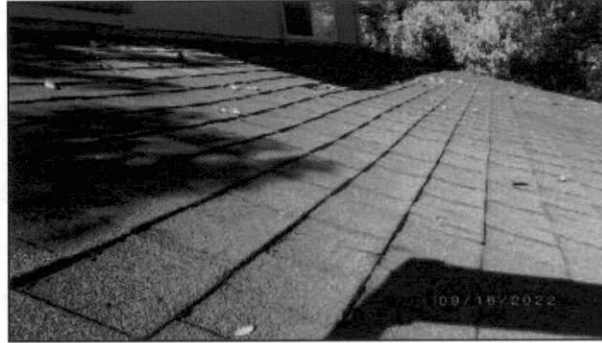
The exterior closet/shed roof is near or at the end of its service life. Temporary repairs may keep it waterproof for now but it will need to be replaced soon. We recommend obtaining bids for replacement of this roof from qualified roofing contractors.

moderatley worn

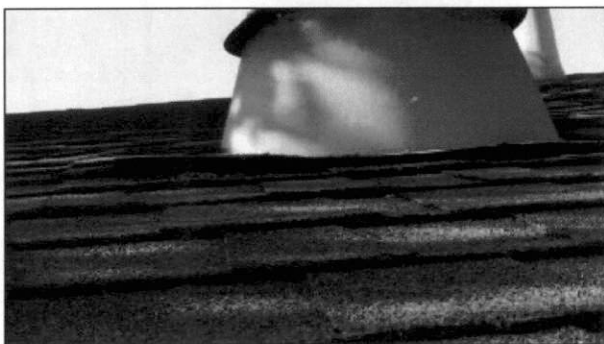
The roof flashings are leaking at the exterior closet shed. This condition will cause moisture related damage to this home. Repair/replacement is recommended. We recommend immediate further evaluation and repairs by a qualified roofing contractor.

lifted flashings

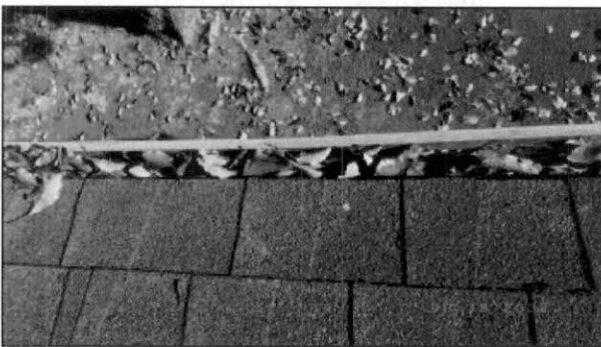
The gutters at the garage and home are generally worn and at or near the end of their service life. These gutters may need replacement soon. Consultation with several gutter installers to discuss various options and determine replacement cost is recommended. Note: The most cost effective time to replace gutters is when replacing this roof.

debris in gutters

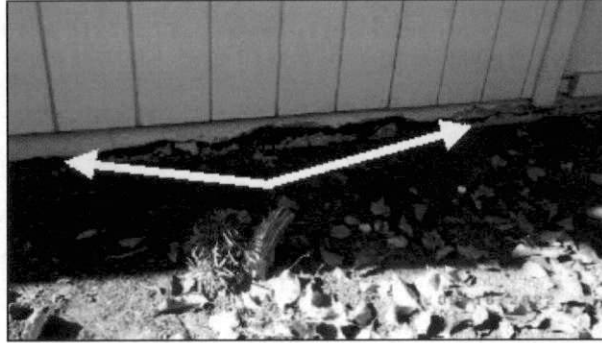
The foundation at the rear side has significant horizontal cracking visible. This inspector does not anticipate any rapid changes and does not significantly reduce the strength of the foundation. In this region of the country this is often caused by reinforcing steel being placed too close to the surface of the concrete allowing water and air to rust/oxidize the steel. The rust expands causing the concrete to spall. Often the loose concrete can be removed, the steel cleaned and chemically treated, and then the void is patched with mortar or patching concrete. For more information we recommend further evaluation and repairs by a specialized concrete contractor or structural engineer.

horizontal cracking

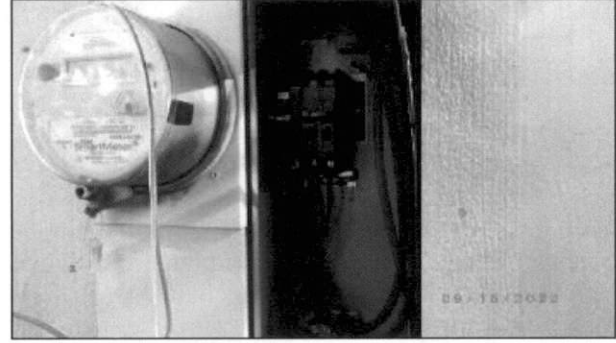
The inner protective panel is missing on the main panel. This is a potential safety hazard as persons could touch the energized interior of the service box. We recommend having a qualified electrician install the missing inner panel on this device.

missing inner cover

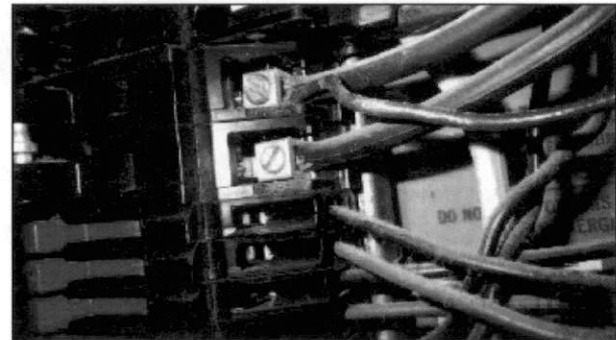
There is a least one double-lugged breaker inside the electrical sub panel. Double lugging is where more than one branch circuit is connected to a single circuit breaker. The breakers in this panel are not designed to accommodate more than one circuit. There is presently only one brand of breaker that is. We recommend correction by a qualified electrician.

double tap

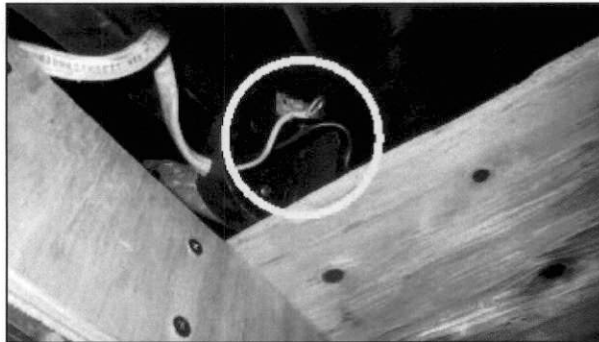
There is at least one wire in the garage that is energized and not capped or properly terminated in a junction box. This is a significant fire and safety hazard now, we recommend immediate further evaluation and repair by a qualified electrician. ✱

live uncapped wires

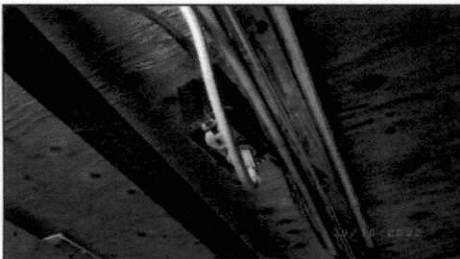
missing covers

has covers now

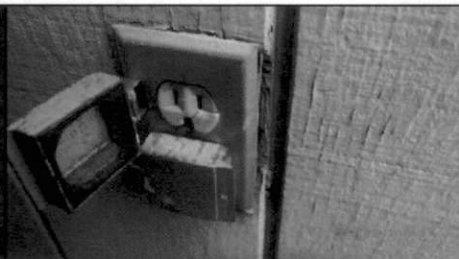
damaged outlet

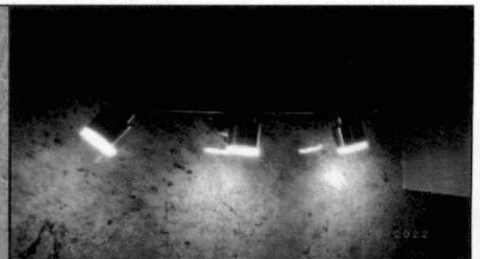
The light fixture in the kitchen above the sink is loose, loose light fixtures can be a hazard due to their weight. We recommend having a qualified handy person or electrician properly tighten or remount this fixture.

loose fixture

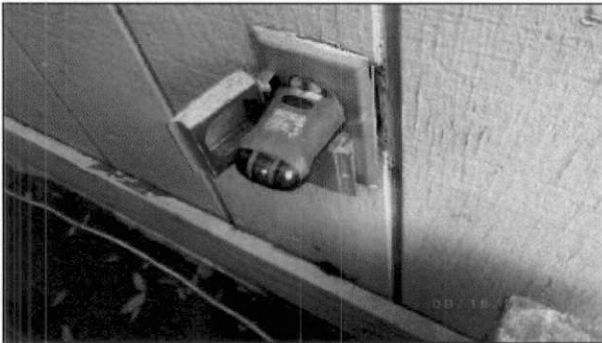
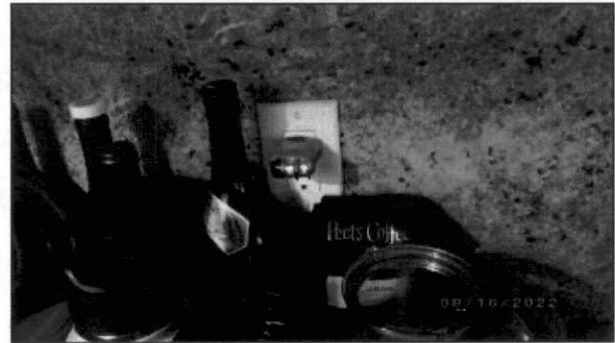
Ground fault circuit interrupter (GFCI) protected outlets are missing at the exterior, upstairs bathrooms and kitchen. This is a potential safety hazard. Because electrical work was likely done recently and/or this is a modern home - outlets near plumbing fixtures and or near damp or potentially wet locations are required to be protected. We recommend further evaluation and repairs by a qualified electrician.

missing GFCI protection

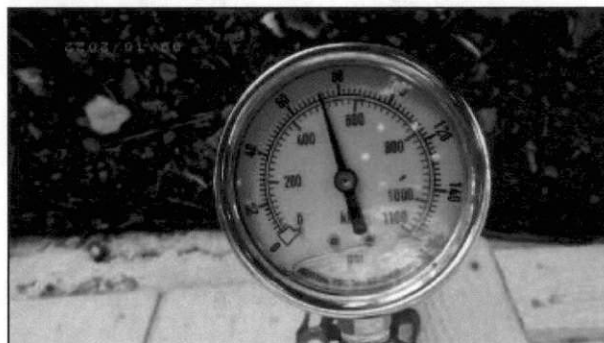
water pressure 72 PSI

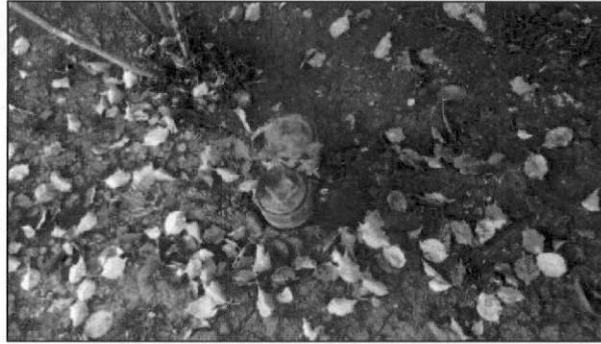
There are large trees on this lot and the home has an older waste line system. According to others there has been previous issues with clogs in the main sewer line. There were no obvious blockages at the time of this inspection. We recommend asking the owner the extent of the issues and what if any repairs were performed. Our standard recommendation for older homes or homes with large trees on the lot is to consider having the waste lines checked with a video camera for breakage, roots, or deterioration. Note: There are several plumbing companies who specialize in waste line video inspections.

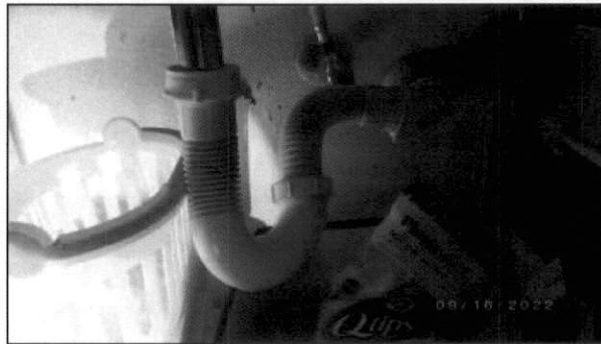
At least one sink in this home uses a flexible accordion type waste below a sink. This type of drain line is often an indication that non plumbers have done work to this sink. Normally professionals use solid sections of either plastic or metal waste lines. The accordion type units tend to clog quickly and do not have a long service life. For more information we recommend further evaluation by a qualified plumber.

flex pipe used

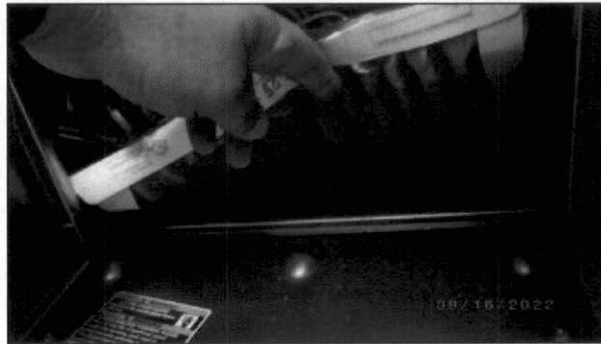
The filter for the air handling system is the wrong size. Unfiltered air can improperly bypass the filter. We recommend carefully measuring the filter flange and purchasing the correct size.

dirty and wrong size

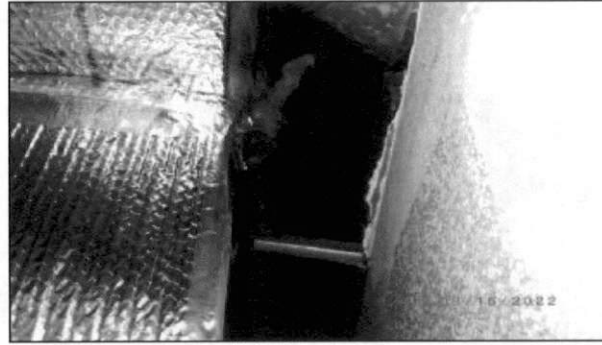
The furnace is located at an interior closet and does not have the required fire protection. Current standards require adjacent areas of the furnace closet to have conforming fire resistant sheet rock in the case of a fire so it does not spread to the rest of the home as quickly. We recommend the missing fire wall be repaired for additional fire safety. Due to the age of the home this might not have been a requirement when the home was built.

missing fire wall

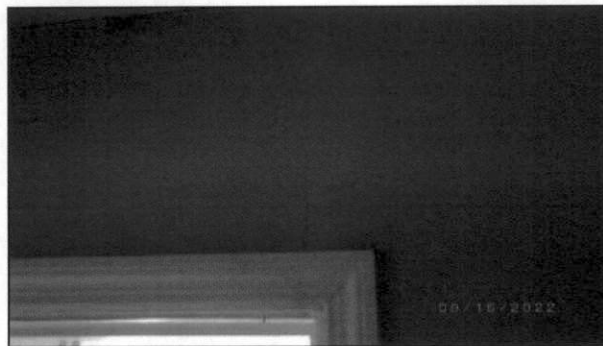
There are cracks in the interior wall/ceiling surfaces that we believe are the result of structural movement caused by settling. The cracks are unsightly and should be repaired. This inspector does not anticipate any rapid changes barring sudden impacts (construction, earthquakes, etc.). Please read the structural section of this report carefully for more information about settlement.

typical settlement cracks

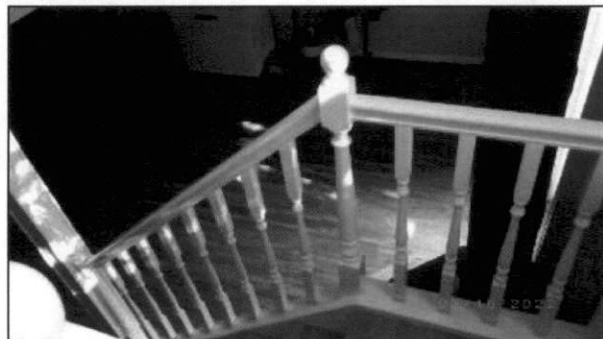
openings too big

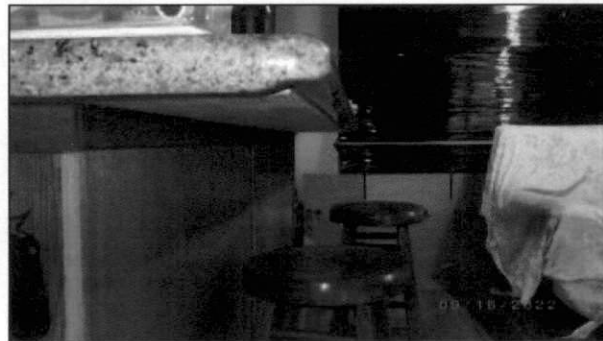
The stone counter top in the kitchen does not appear to have adequate support where it cantilevers out beyond the base cabinet. There was no damage visible at the time of this inspection. This material although very strong can crack when forced to bend. Simply leaning heavily on it, placing heavy objects, sudden blows, or sitting on this can crack it. We recommend having a qualified contractor install proper supports below this counter top. Note: Simply installing properly secured purpose built brackets can add significant rigidity.

not supported

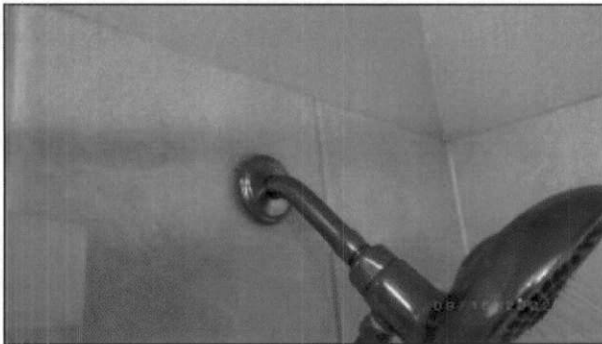
loose assembly

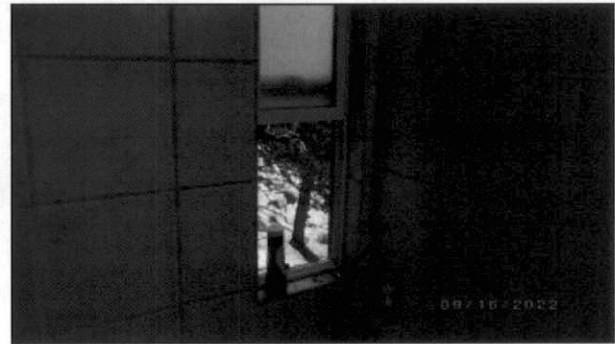
There is likely non safety glass near or in the shower area of the primary bathroom. This is a significant safety hazard as persons can easily break this window causing large shards of glass to fall - extremely hazardous to bare flesh. Improperly sealed window frames or sills can allow water to enter the framing causing substantial moisture/fungus damage. We recommend removing this window making it higher or installing tempered glass. Note: This condition is also conducive to creating moisture and insect related damage as the sill is continuously wet.

non tempered window

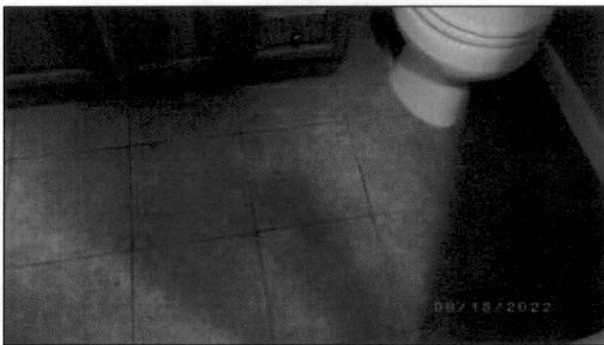
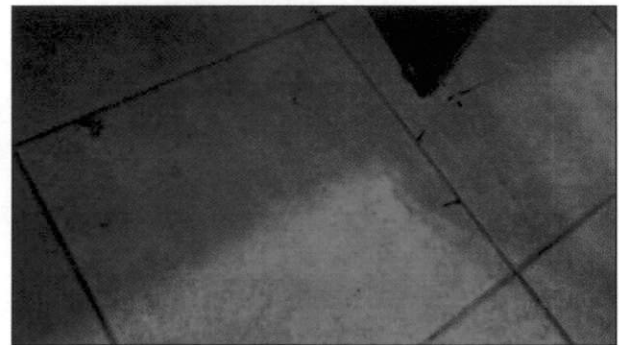
Some tiles on the floor are cracked in the primary bathroom. The exact cause of the cracking is unknown but likely due to factors including but not limited to: foundation settlement, seismic activity, framing movement, improper installation, heavy object dropped, or damage below floor. We recommend further evaluation and repairs by a qualified tile contractor.

cracked tiles

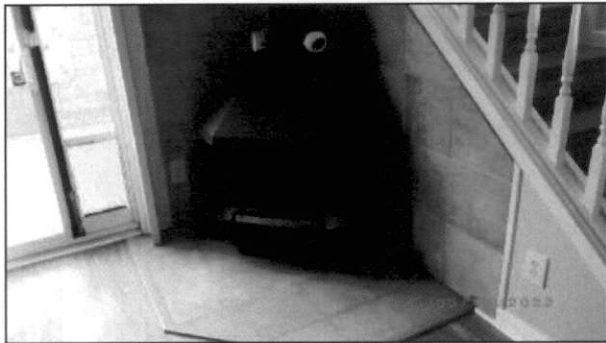
missing screen

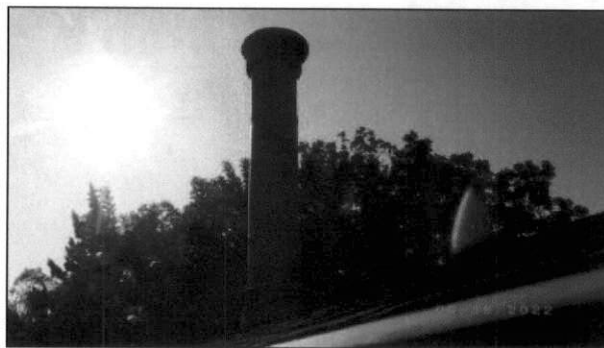
Adequate inspection of the crown and flue of the chimney could not be conducted because of the presence of a spark arrestor, the stack was simply too high or existing weather or chimney conditions made conducting such an inspection dangerous. This chimney is therefore excluded from the scope of this inspection. The National Fire Prevention Association (NFPA) recommends that a Level II inspection, with fiber-optic video camera, be conducted prior to buying/selling a home. It is recommended that the client(s) have this done prior to closing by a sweep certified by the Chimney Safety Institute of America (CSIA) or equivalent organization.

no view of flue interior

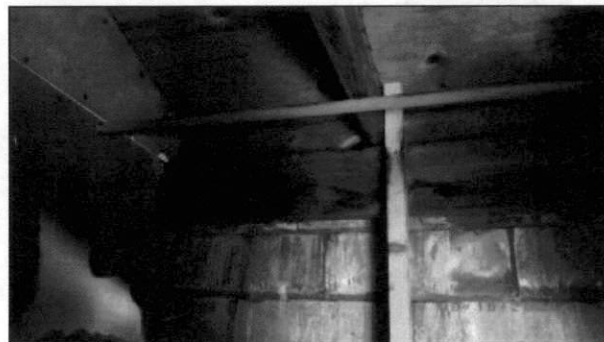
The framing in the garage is water stained at several places. The areas were dry at the time of this inspection. The source of the moisture may have been repaired or is intermittent. We recommend having this area monitored. Note: Only water testing can determine if there are active roof leaks.

dry stains

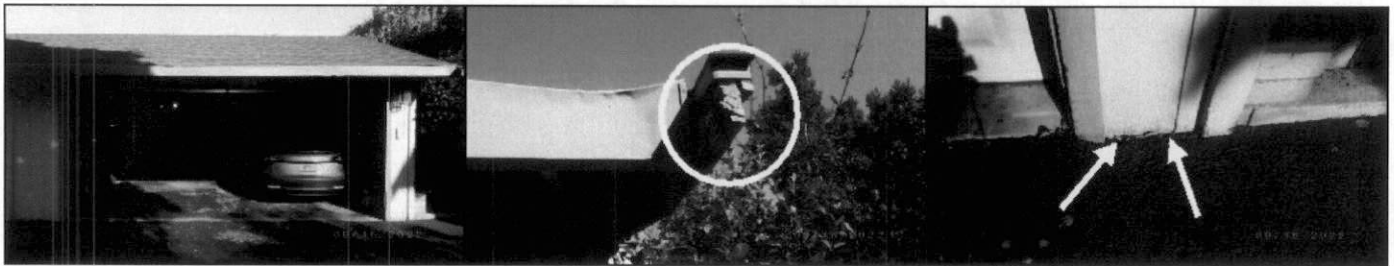
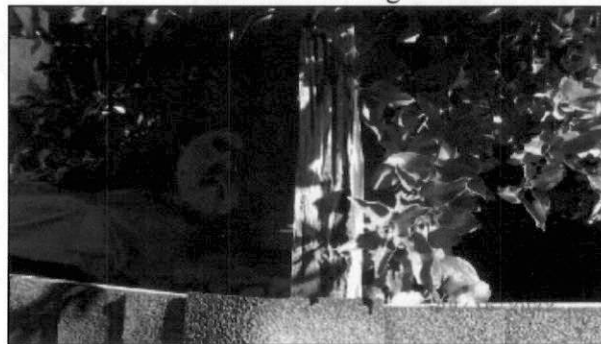
detached garage

There is scattered moisture/fungus damage at the exterior of this garage at several places. We recommend further evaluation and repairs by a Class 3 Structural Pest Control Operator.

moisture damage

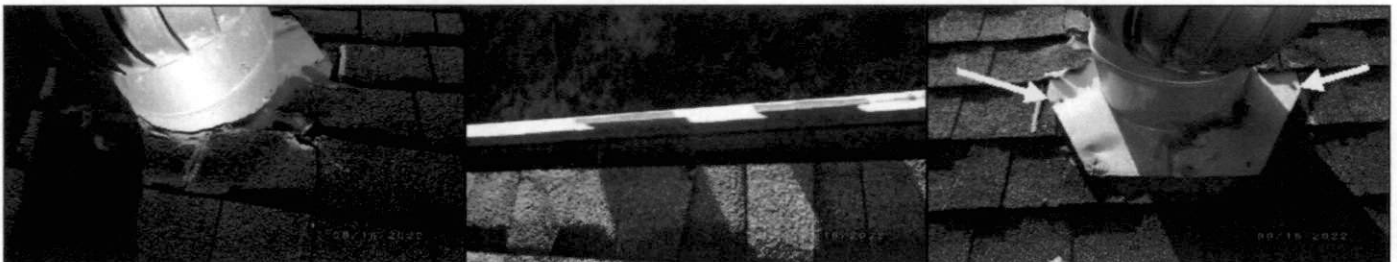
We found that the roof cover has sustained physical damage. If not corrected this issue could eventually result in significant structural damage to other parts of the structure through rainwater infiltration. Immediate correction by a qualified roofer is recommended.

physical damage

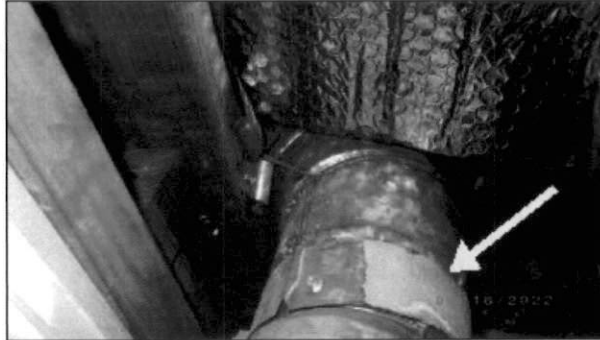
possible asbestos material

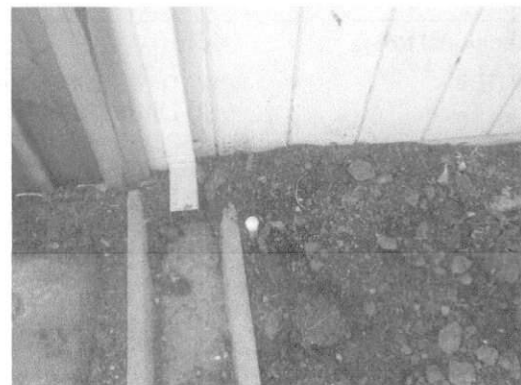
4B:

4B. FINDING: EARTH TO WOOD CONTACT EXISTS AT THE BASE OF THE SIDING.
RECOMMENDATION: REGRADE SOIL AND/OR LANDSCAPE MATERIAL WHERE PRACTICAL.
