# SELLER PROPERTY QUESTIONNAIRE

Seller makes the following disclosures with regard to the real property or manufactured home described as 1725 Landana Dr #2, Assessor's Parcel No. 114-660-002-6, situated in Concord, County of Contra Costa California ("Property").

1725 Landana Drive unit #2, Concord , CA 94519  
Inspection prepared for: Patricia Ballisteri  
Date of Inspection: 9/16/2022

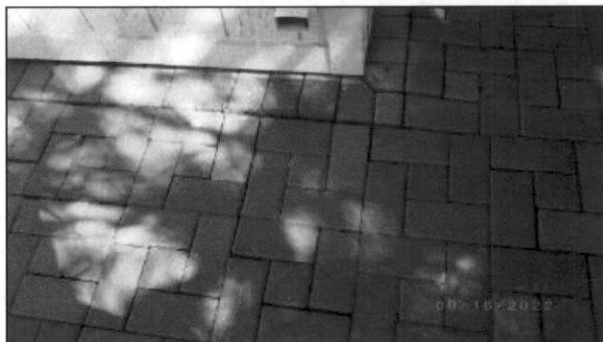
The pavers at the right front side are uneven and settling, this is likely the result of a poorly prepared base. This is primarily a cosmetic issue at this time. Over time this settlement can become worse and become a trip hazard. We advise monitoring this area and to consider having a qualified contractor make the appropriate repairs.

pavers uneven

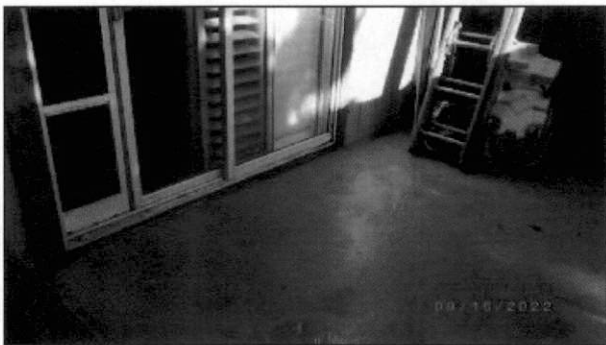
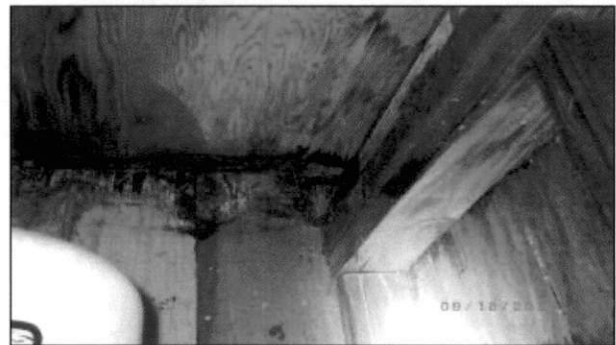
The outbuilding/shed is moisture/fungus damaged at several places. This damage can spread to areas and cause this deck to become unstable or even unsafe over time. For more information we recommend further evaluations and inspections by a Class Three Structural Pest firm.

ongoing settlement

moisture damage

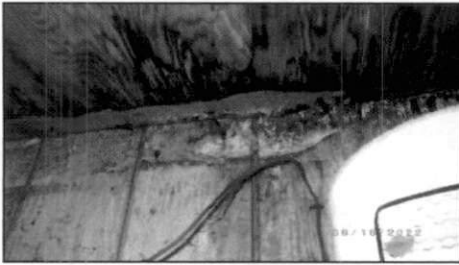
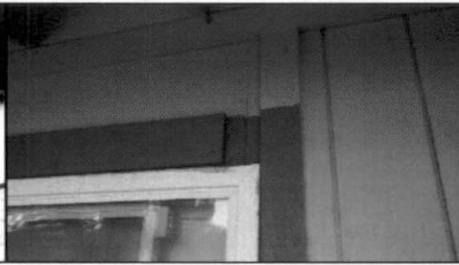
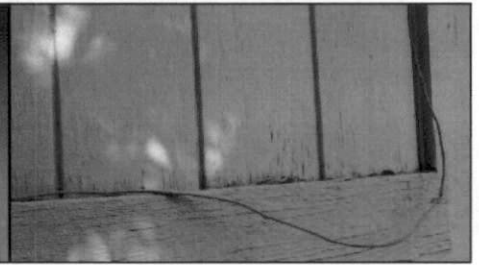
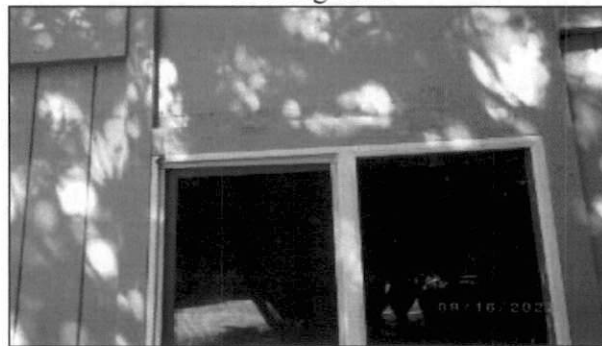
The siding at the right side is moisture and/or fungus damaged. This damage can spread to areas adjacent to the siding, including framing. We recommend further evaluation and repairs by a qualified licensed Class Three Structural Pest firm.

moisture damage

missing trim

delaminated siding

worn siding

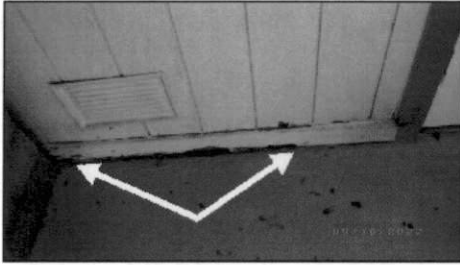
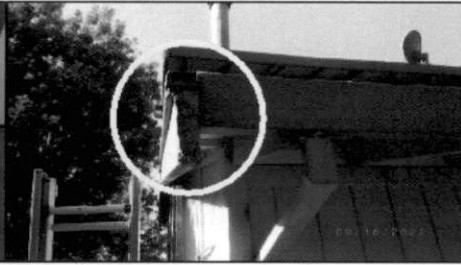
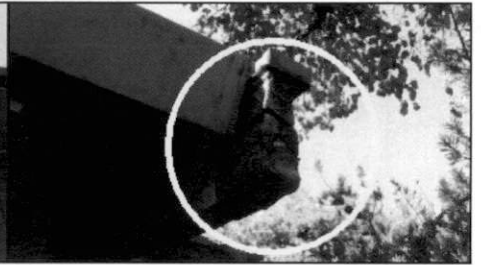
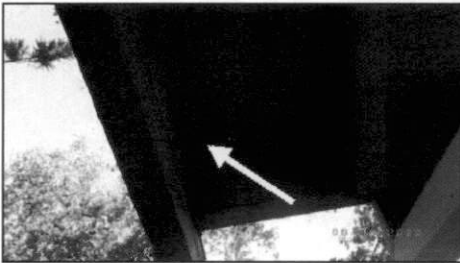
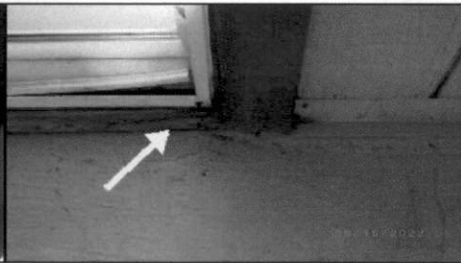
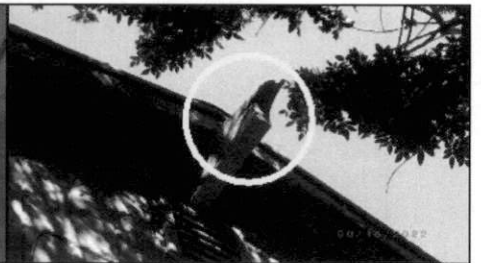
There are moisture/fungus damaged exposed beam(s) end(s). Wood beams and rafter tails that protrude beyond the eaves are exposed to harsh weather and therefore prone to moisture related damage. We recommend further evaluation and repairs by a class three structural licensed pest firm. Note: These beams can sometimes be simply cut shorter then properly primed and sealed with paint. To prevent future damage on exposed beams it is worthwhile and a relatively inexpensive upgrade to have sheet metal caps installed on the tops of these beams.

moisture damage

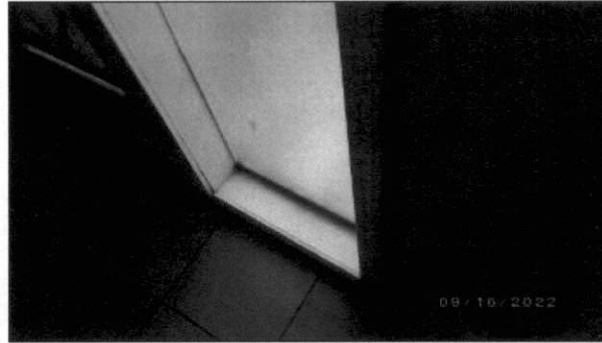
There is at least one window at the entryway that is less than 24 inches from a door that is not believed to be safety glass. Glass windows close to the floor are more likely to be hit or kicked accidentally. Non-safety glass breaks into large shards that can cause serious harm to persons. We recommend all glass within 24-inches of a doorway be protected or consider having them replaced with approved glass.

non tempered glass

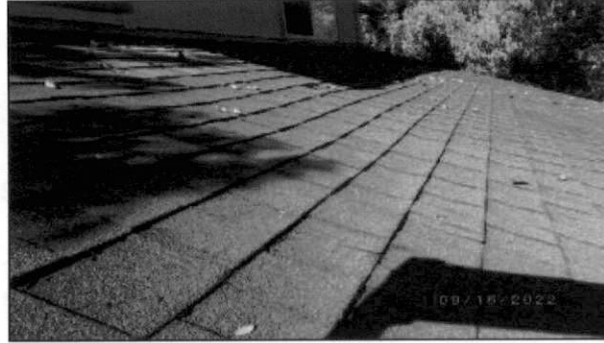
The exterior closet\shed roof is near or at the end of its service life. Temporary repairs may keep it waterproof for now but it will need to be replaced soon. We recommend obtaining bids for replacement of this roof from qualified roofing contractors.

moderatley worn

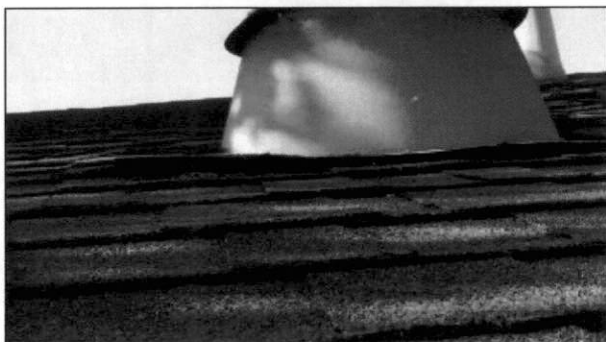
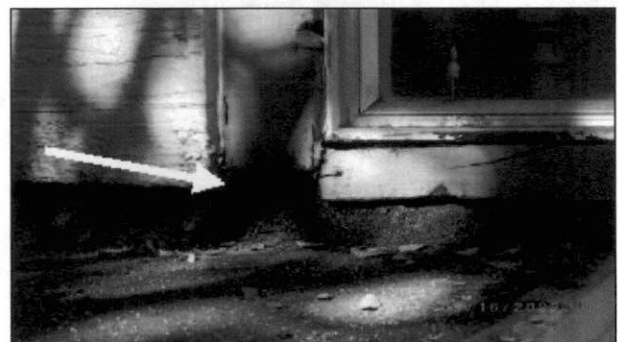
The roof flashings are leaking at the exterior closet/shed. This condition will cause moisture related damage to this home. Repair/replacement is recommended. We recommend immediate further evaluation and repairs by a qualified roofing contractor.

lifted flashings

improperly integrated

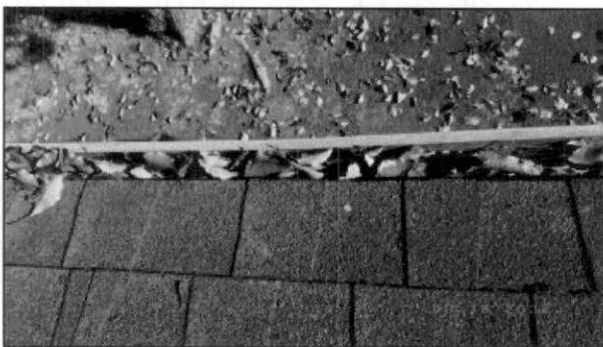
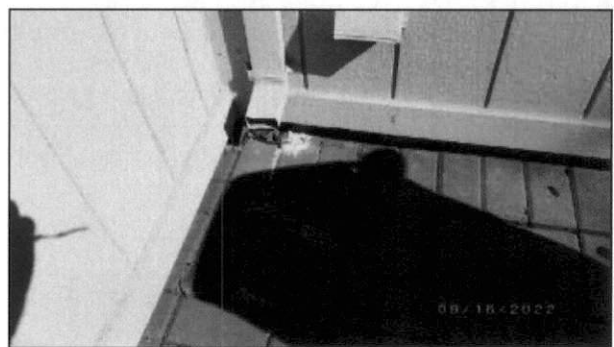
The gutters at the garage and home are generally worn and at or near the end of their service life. These gutters may need replacement soon. Consultation with several gutter installers to discuss various options and determine replacement cost is recommended. Note: The most cost effective time to replace gutters is when replacing this roof.

debris in gutters

extend downspouts

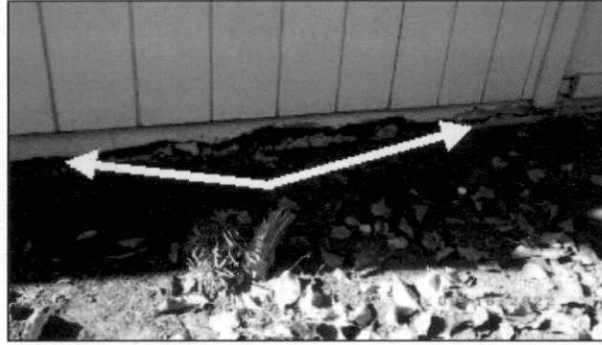
The foundation at the rear side has significant horizontal cracking visible. This inspector does not anticipate any rapid changes and does not significantly reduce the strength of the foundation. In this region of the country this is often caused by reinforcing steel being placed too close to the surface of the concrete allowing water and air to rust/oxidize the steel. The rust expands causing the concrete to spall. Often the loose concrete can be removed, the steel cleaned and chemically treated, and then the void is patched with mortar or patching concrete. For more information we recommend further evaluation and repairs by a specialized concrete contractor or structural engineer.

horizontal cracking

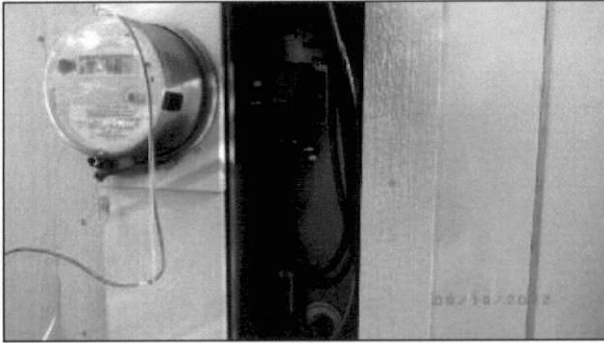
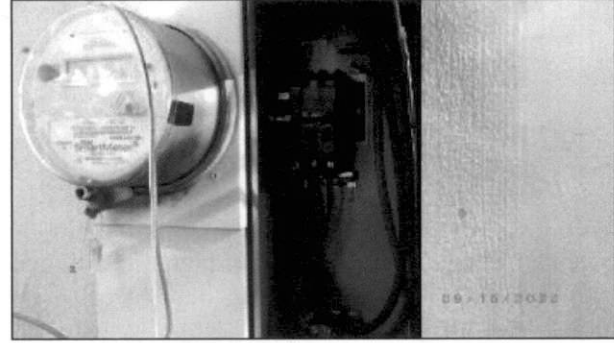
The inner protective panel is missing on the main panel. This is a potential safety hazard as persons could touch the energized interior of the service box. We recommend having a qualified electrician install the missing inner panel on this device.

Sylvania GTE panels

missing inner cover

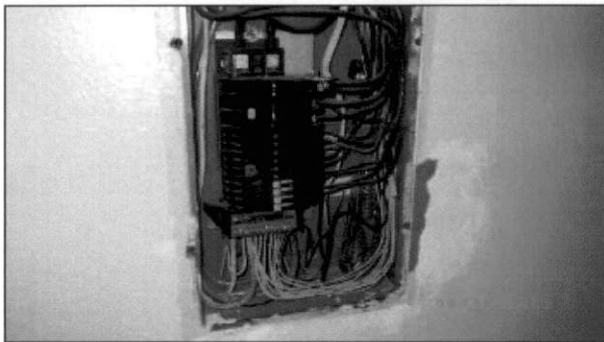
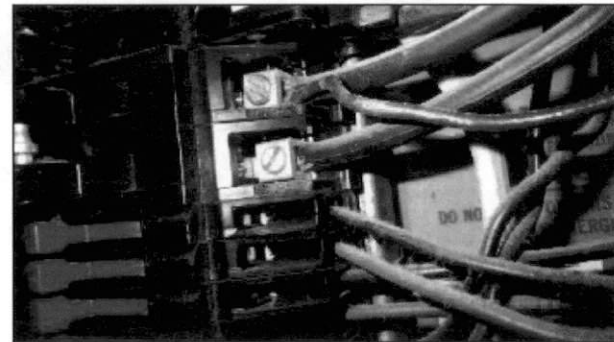
There is a least one double-lugged breaker inside the electrical sub panel. Double lugging is where more than one branch circuit is connected to a single circuit breaker. The breakers in this panel are not designed to accommodate more than one circuit. There is presently only one brand of breaker that is. We recommend correction by a qualified electrician.

Sylvania GTE panel

double tap

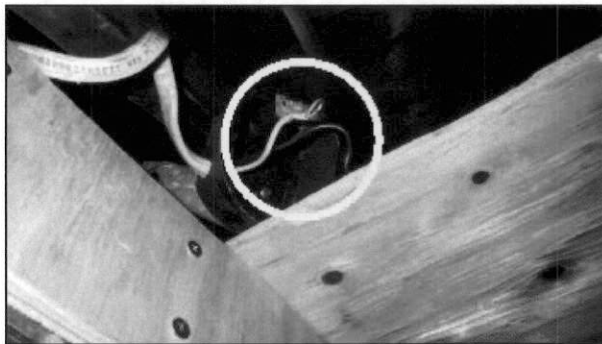
There is at least one wire in the garage that is energized and not capped or properly terminated in a junction box. This is a significant fire and safety hazard now, we recommend immediate further evaluation and repair by a qualified electrician. ✱

live uncapped wires

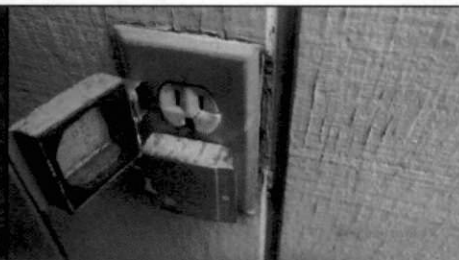
damaged outlet

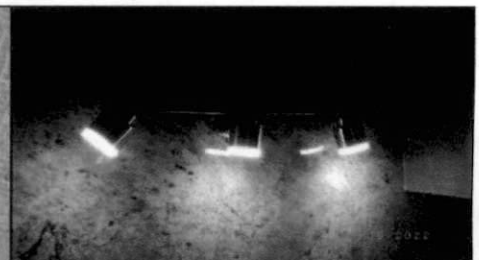
The light fixture in the kitchen above the sink is loose, loose light fixtures can be a hazard due to their weight. We recommend having a qualified handy person or electrician properly tighten or remount this fixture.

loose fixture

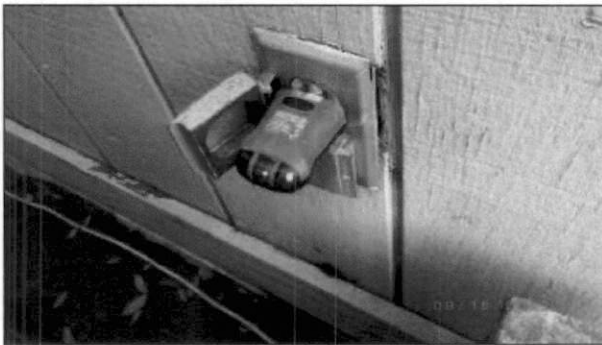
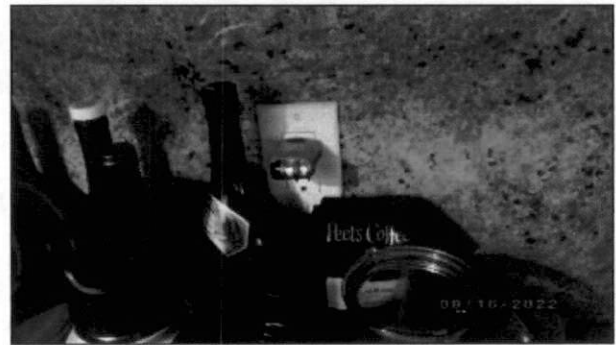
Ground fault circuit interrupter (GFCI) protected outlets are missing at the exterior, upstairs bathrooms and kitchen. This is a potential safety hazard. Because electrical work was likely done recently and/or this is a modern home - outlets near plumbing fixtures and or near damp or potentially wet locations are required to be protected. We recommend further evaluation and repairs by a qualified electrician.

missing GFCI protection

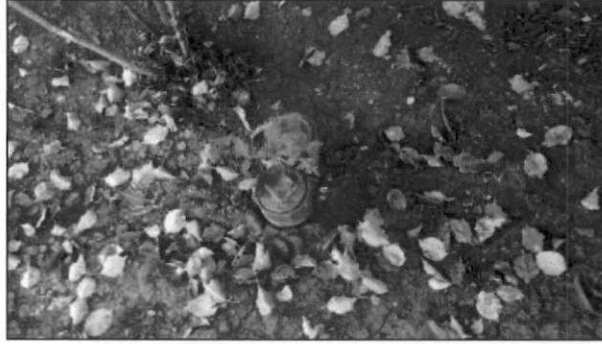
There are large trees on this lot and the home has an older waste line system. According to others there has been previous issues with clogs in the main sewer line. There were no obvious blockages at the time of this inspection. We recommend asking the owner the extent of the issues and what if any repairs were performed. Our standard recommendation for older homes or homes with large trees on the lot is to consider having the waste lines checked with a video camera for breakage, roots, or deterioration. Note: There are several plumbing companies who specialize in waste line video inspections.

sewer clean out

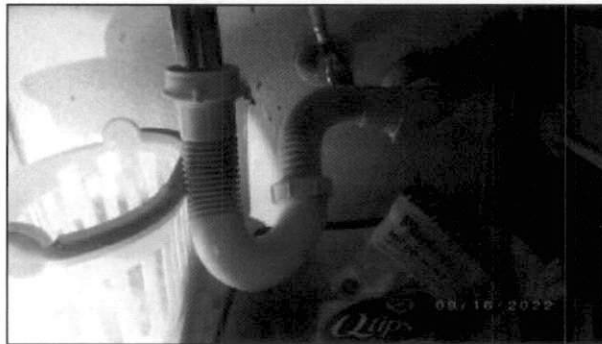
At least one sink in this home uses a flexible accordion type waste below a sink. This type of drain line is often an indication that non plumbers have done work to this sink. Normally professionals use solid sections of either plastic or metal waste lines. The accordion type units tend to clog quickly and do not have a long service life. For more information we recommend further evaluation by a qualified plumber.

flex pipe used

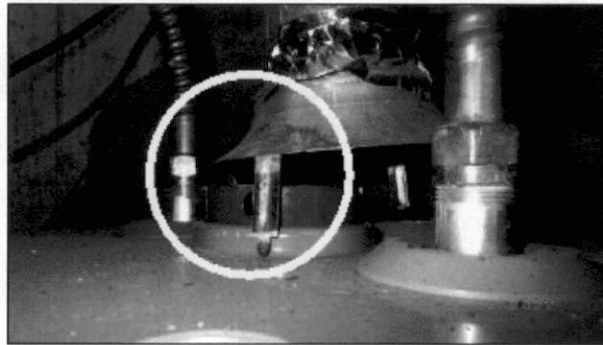
At least one water heater flue is disconnected in the exterior closet\shed. This condition is allowing hot and deadly gases to enter the structure - an immediate fire and health hazard. Deadly carbon monoxide gases can enter the home. We recommend having a qualified plumber immediately perform further evaluation and repairs.

disconnected flue

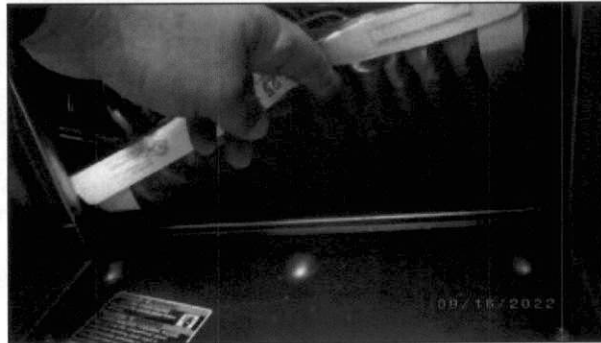
The filter for the air handling system is the wrong size. Unfiltered air can improperly bypass the filter. We recommend carefully measuring the filter flange and purchasing the correct size.

dirty and wrong size

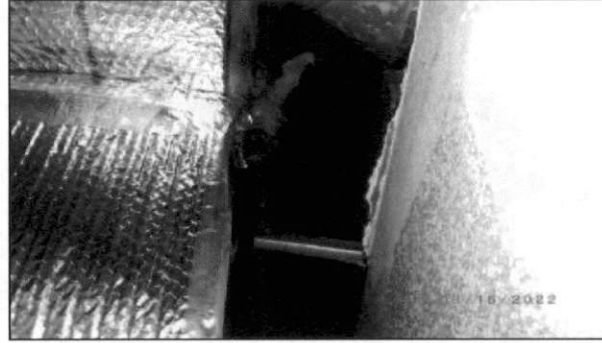
The furnace is located at an interior closet and does not have the required fire protection. Current standards require adjacent areas of the furnace closet to have conforming fire resistant sheet rock in the case of a fire so it does not spread to the rest of the home as quickly. We recommend the missing fire wall be repaired for additional fire safety. Due to the age of the home this might not have been a requirement when the home was built.

missing fire wall

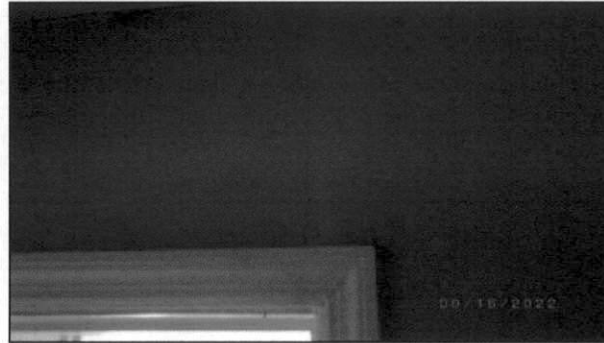
There are cracks in the interior wall/ceiling surfaces that we believe are the result of structural movement caused by settling. The cracks are unsightly and should be repaired. This inspector does not anticipate any rapid changes barring sudden impacts (construction, earthquakes, etc.). Please read the structural section of this report carefully for more information about settlement. \*

typical settlement cracks

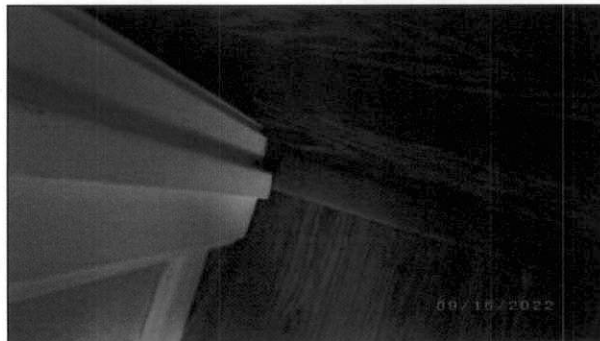
cosmetic blemishes

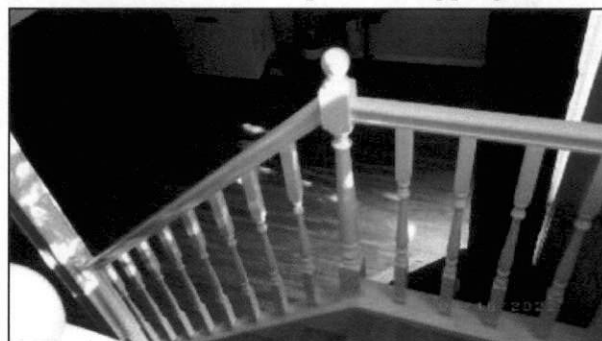
openings too big

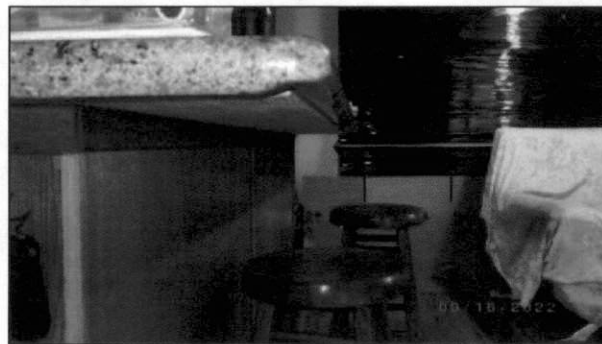
The stone counter top in the kitchen does not appear to have adequate support where it cantilevers out beyond the base cabinet. There was no damage visible at the time of this inspection. This material although very strong can crack when forced to bend. Simply leaning heavily on it, placing heavy objects, sudden blows, or sitting on this can crack it. We recommend having a qualified contractor install proper supports below this counter top. Note: Simply installing properly secured purpose built brackets can add significant rigidity.

not supported

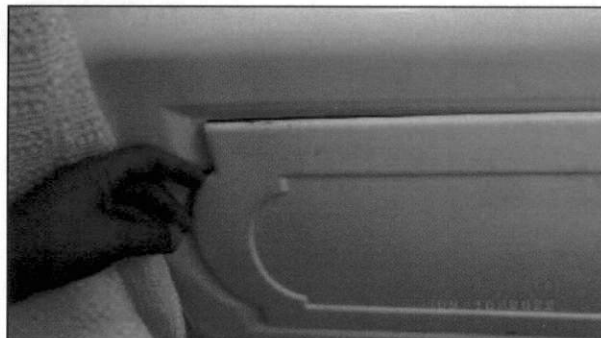
no access

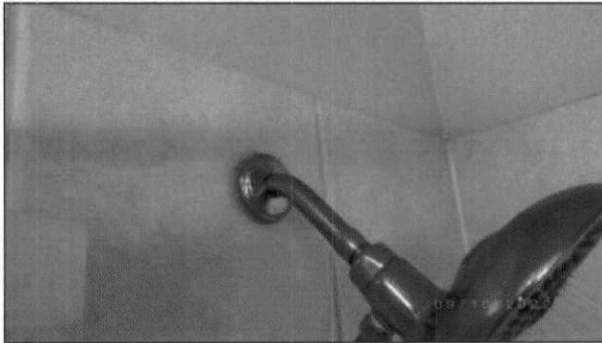
loose assembly

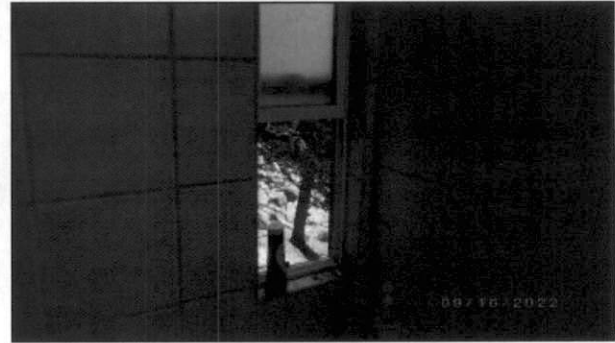
There is likely non safety glass near or in the shower area of the primary bathroom. This is a significant safety hazard as persons can easily break this window causing large shards of glass to fall - extremely hazardous to bare flesh. Improperly sealed window frames or sills can allow water to enter the framing causing substantial moisture/fungus damage. We recommend removing this window making it higher or installing tempered glass. Note: This condition is also conducive to creating moisture and insect related damage as the sill is continuously wet.

non tempered window

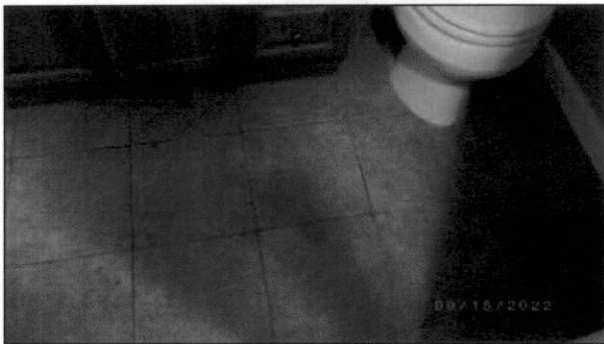
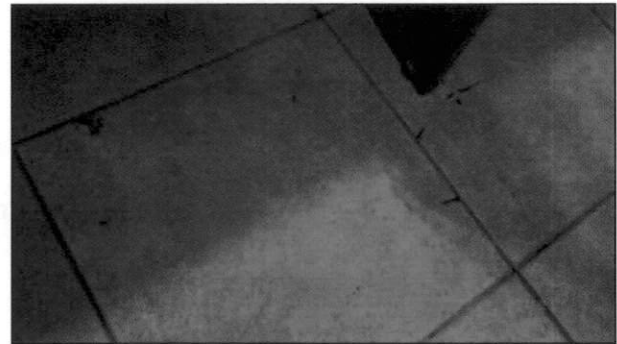
Some tiles on the floor are cracked in the primary bathroom. The exact cause of the cracking is unknown but likely due to factors including but not limited to: foundation settlement, seismic activity, framing movement, improper installation, heavy object dropped, or damage below floor. We recommend further evaluation and repairs by a qualified tile contractor.

cracked tiles

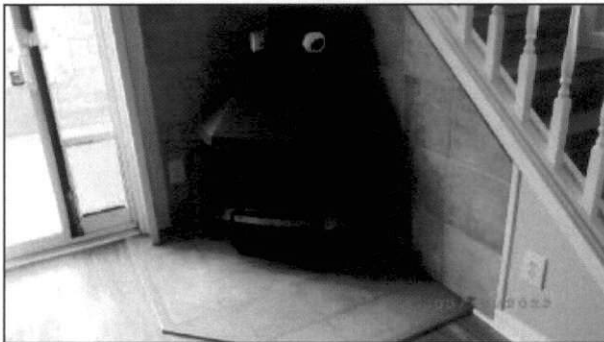
missing screen

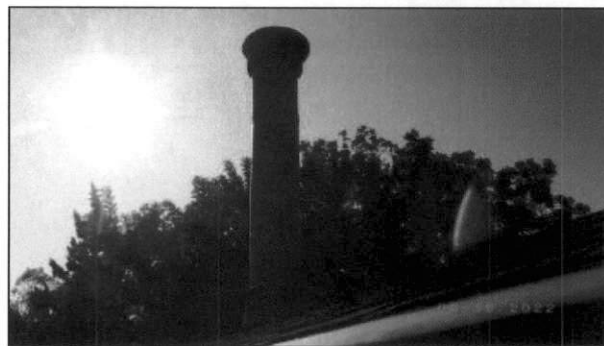
Adequate inspection of the crown and flue of the chimney could not be conducted because of the presence of a spark arrestor, the stack was simply too high or existing weather or chimney conditions made conducting such an inspection dangerous. This chimney is therefore excluded from the scope of this inspection. The National Fire Prevention Association (NFPA) recommends that a Level II inspection, with fiber-optic video camera, be conducted prior to buying/selling a home. It is recommended that the client(s) have this done prior to closing by a sweep certified by the Chimney Safety Institute of America (CSIA) or equivalent organization.

no view of flue interior

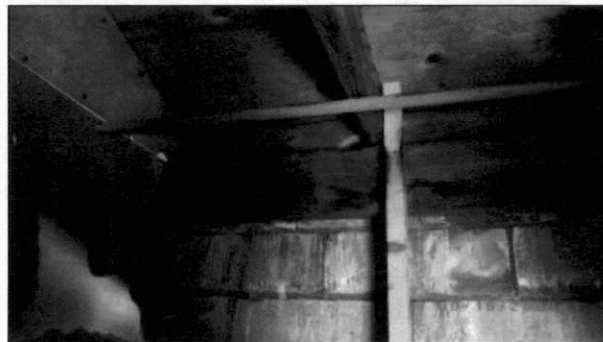
The framing in the garage is water stained at several places. The areas were dry at the time of this inspection. The source of the moisture may have been repaired or is intermittent. We recommend having this area monitored. Note: Only water testing can determine if there are active roof leaks.

dry stains

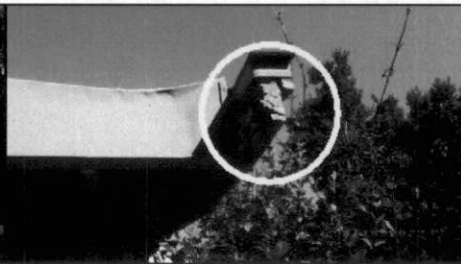
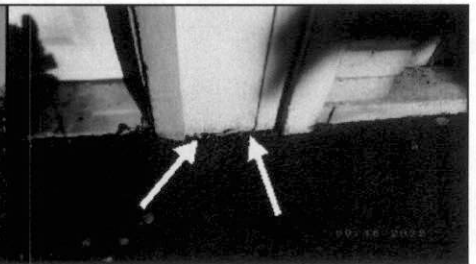
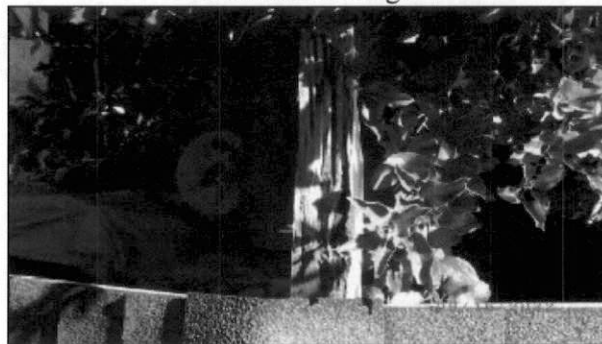
There is scattered moisture/fungus damage at the exterior of this garage at several places. We recommend further evaluation and repairs by a Class 3 Structural Pest Control Operator.

moisture damage

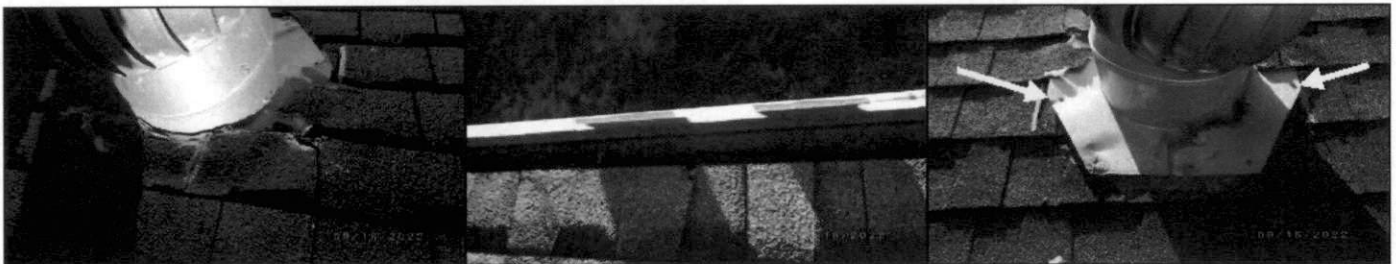
We found that the roof cover has sustained physical damage. If not corrected this issue could eventually result in significant structural damage to other parts of the structure through rainwater infiltration. Immediate correction by a qualified roofer is recommended.

physical damage

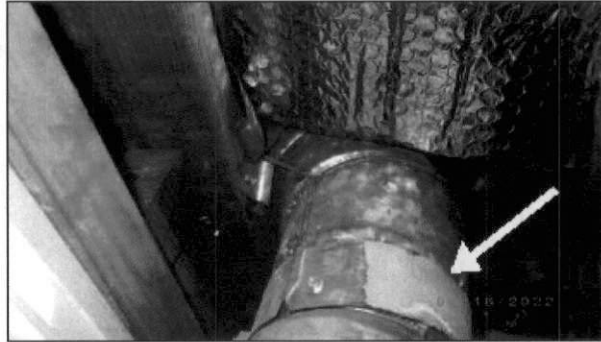
Most people exposed to small amounts of asbestos, as we all are in our daily lives, do not develop these health problems. However, if disturbed, asbestos material may release asbestos fibers, which can be inhaled into the lungs. The fibers can remain there for a long time, increasing the risk of disease. Asbestos material that would crumble easily if handled or that has been sawed, scraped, or sanded into a powder is more likely to create a health hazard.”

possible asbestos material
