**PAUL E. JONES**
NAPI CERT. # 30667P.O. BOX 981071
W. SACRAMENTO, CA 95798
(916) 752-0275
e-mail: pjones21@comcast.net**INSPECTION DATE:** December 12, 2024**REPORT NUMBER:** A12721**CLIENT:** Jenine Fortney & Scott Ohlhausen**PROPERTY INSPECTED:** 350 Walnut Ave
Vacaville, CA 95688

The property inspected is a 4 bedroom, 2 bath single family home. The weather at the commencement of the inspection was raining with a temperature reading of approximately 56 degrees Fahrenheit.

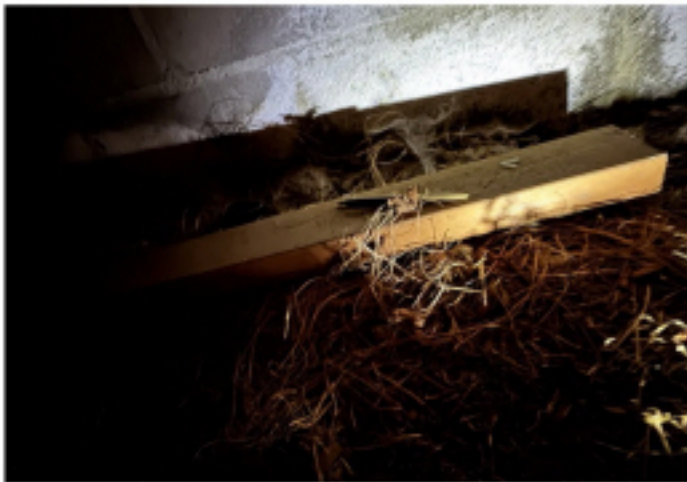
PHOTO #1

1. Wood debris conducive to attracting wood destroying insects was found on the soil floor of the sub area. Please refer to the structural pest report for additional comments and recommendations, if any. (See Photo #1)

WOOD AND PLASTIC
DEBRIS FOUND IN THE SOIL
FLOOR OF THE SUB AREA

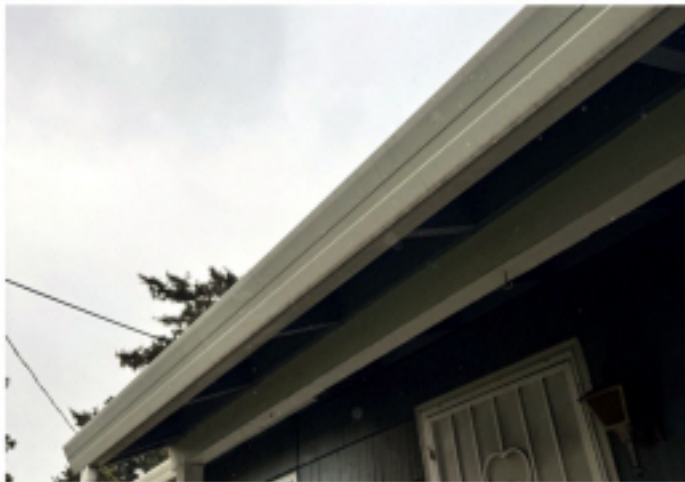
PHOTO #2

1. The gutter at the front entry roof cover has pulled away from the fascia and is loose. Suggest the gutter be repaired by a qualified licensed contractor. (See Photo #2)
2. The gutter at the North wall of the house leaks at the seam. Suggest the seam be sealed with an exterior grade caulking material by a qualified licensed contractor. (See Photo #3)

THE GUTTER AT THE FRONT ENTRY IS LOOSE

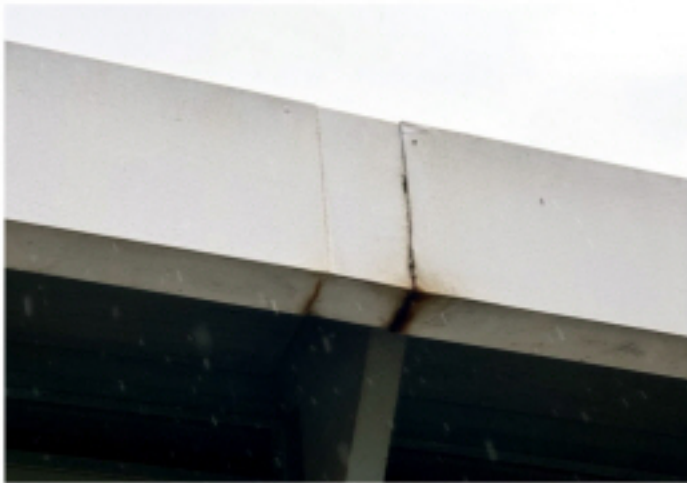
PHOTO #3

THE GUTTER AT THE NORTH WALL OF THE HOUSE LEAKS AT THE SEAM

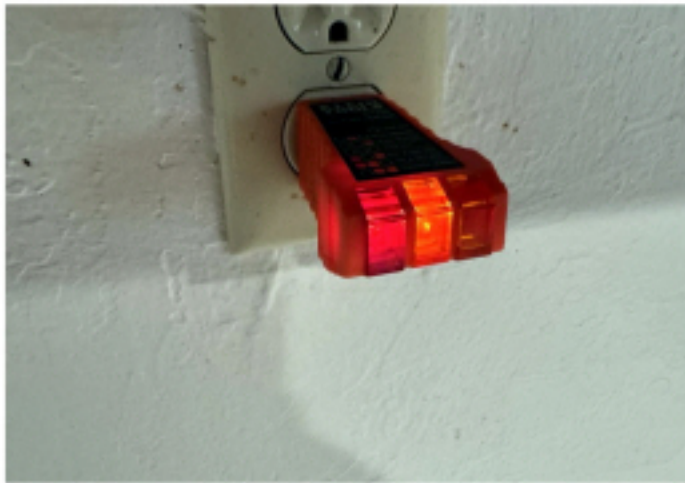
PHOTO #4

1. The electrical outlet near the kitchen sink is improperly wired (hot/neutral wires are reversed). Suggest the electrical outlet be rewired by a licensed electrician. (Safety Concern, See Photo #4)

THE ELECTRICAL OUTLET
NEAR THE SINK IS
IMPROPERLY WIRED
(HOT/NEUTRAL REVERSED)

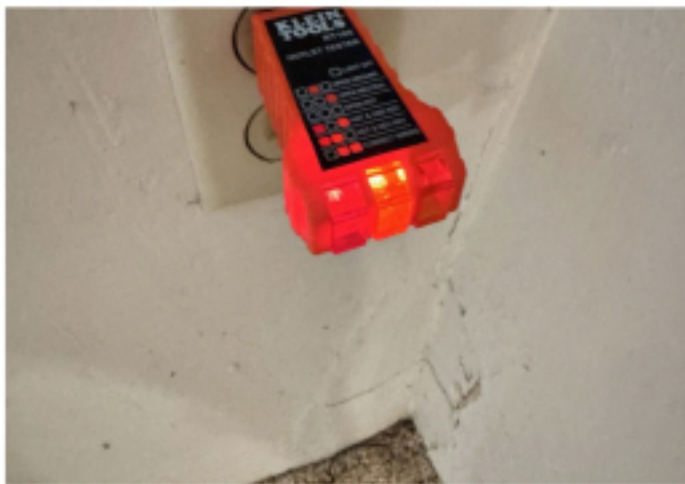
PHOTO #6

1. The electrical outlet at the South wall is improperly wired (hot/neutral wires are reversed). Suggest the electrical outlet be rewired by a licensed electrician. (Safety Concern, See Photo #6)

THE ELECTRICAL OUTLET
AT THE SOUTH WALL IS
IMPROPERLY WIRED
(HOT/NEUTRAL REVERSED)

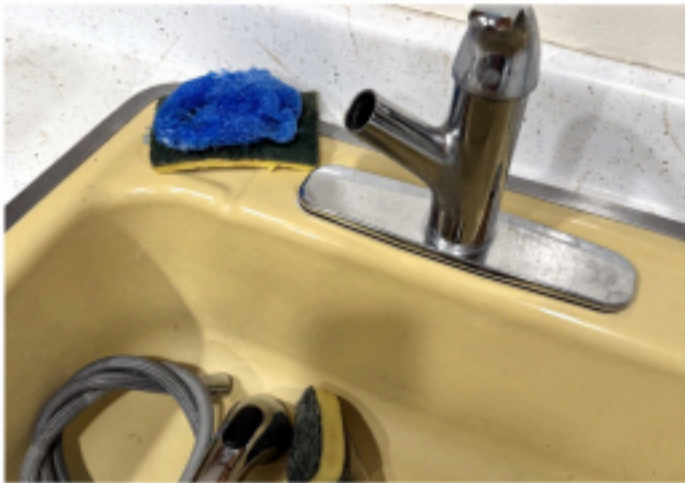
PHOTO #9

1. The sink faucet is partially disassembled and inoperable. Suggest the sink faucet be replaced by a licensed plumber. (See Photo #9)

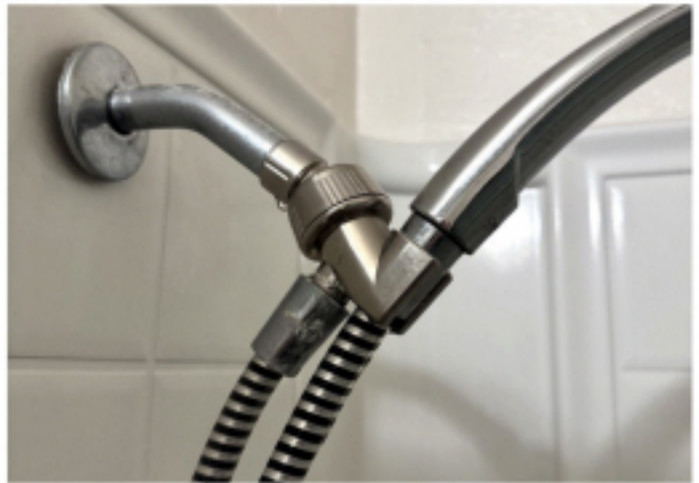
PHOTO #10

1. The showerhead leaks at the swivel assembly. Suggest the showerhead be replaced by a licensed plumber. (See Photo #10)

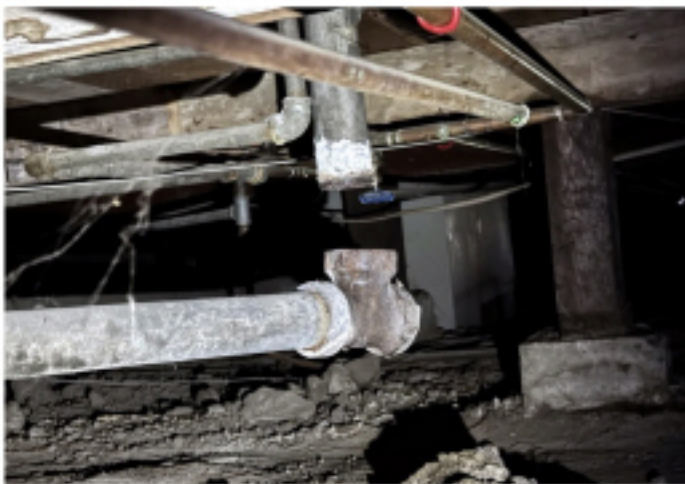
PHOTO #11

1. The fitting to one waste line in the sub area below the North Bathroom is separated at the fitting and leaks. Suggest the waste line be repaired by a licensed plumber. (See Photo #11)

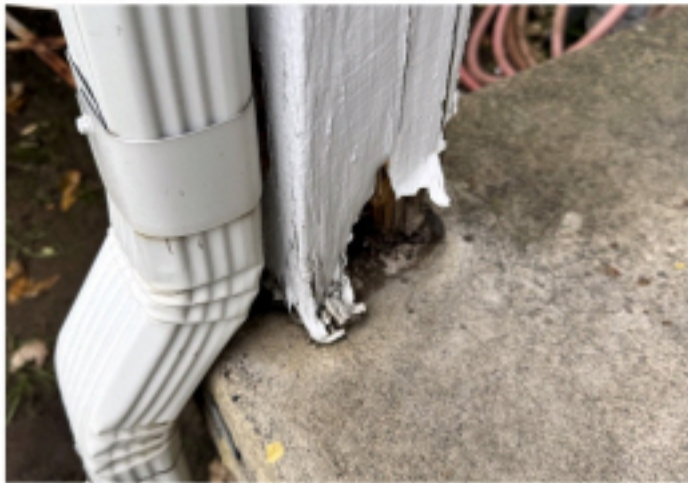
PHOTO #16

2. The base of one front entry roof cover support post appears moisture damaged. Please refer to the structural pest report for additional comments and recommendations, if any. (See Photo #16)

ONE FRONT ENTRY ROOF
COVER SUPPORT POST
APPEARS MOISTURE DAMAGED

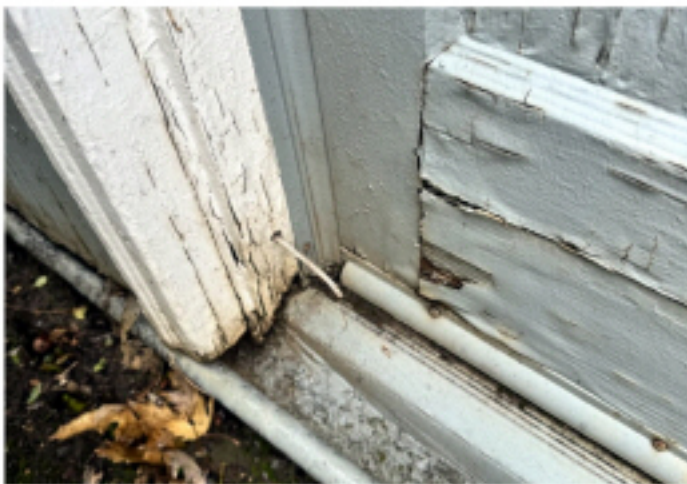
PHOTO #17

3. The Dining Room exterior door and door casing appear moisture damaged. Please refer to the structural pest report for additional comments and recommendations, if any. (See Photo #17)

THE DINING ROOM EXTERIOR
DOOR AND DOOR CASING APPEAR
MOISTURE DAMAGED

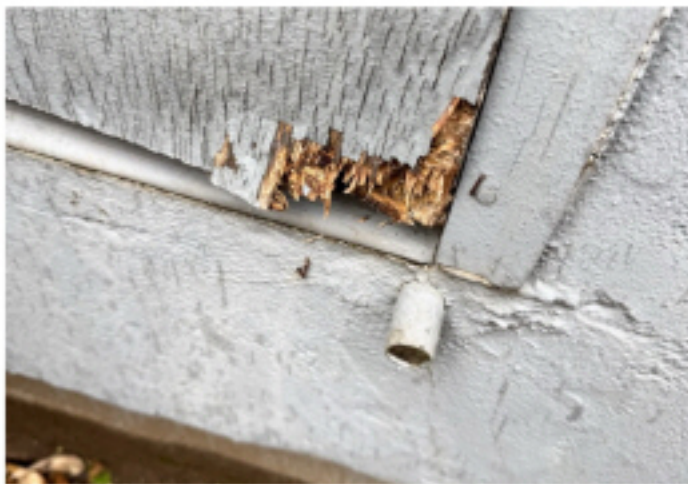
PHOTO #18

4. The water heater closet door appears moisture damaged. Please refer to the structural pest report for additional comments and recommendations, if any. (See Photo #18)

THE WATER HEATER CLOSET DOOR APPEARS
MOISTURE DAMAGED

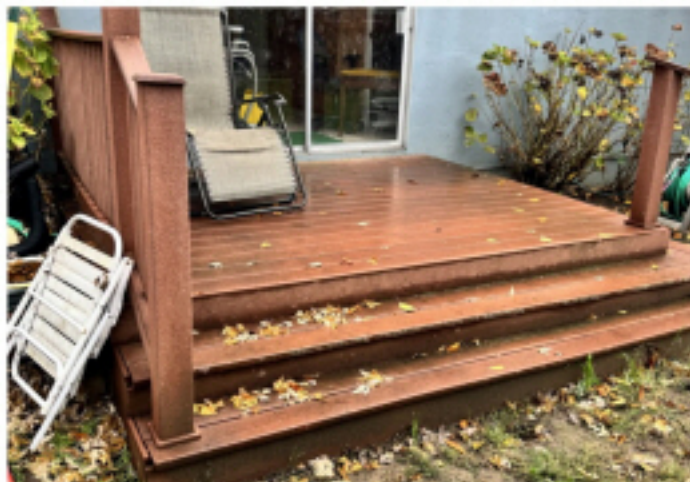
PHOTO #19

5. The inspection of the deck was limited due to no access to under the deck was found. Please refer to the structural pest report for additional comments and recommendations, if any. (See Photo #19)
