WOOD DESTROYING PESTS AND ORGANISMS INSPECTION REPORT

Building No. 350	Street Walnut Avenue	City Vacaville	Zip 95688	Date of Inspection November 25, 2024	Number of Pages 5
Sheppard Termite Services 707-208-2102 or 707-452-0422 PR#4624 SheppardTermite@sbcglobal.net				Company Report # S0080	
Ordered By: Jacki Plata		Property Owner and/or Party of Interest:		Report sent to: Same	
DocuSigned by:

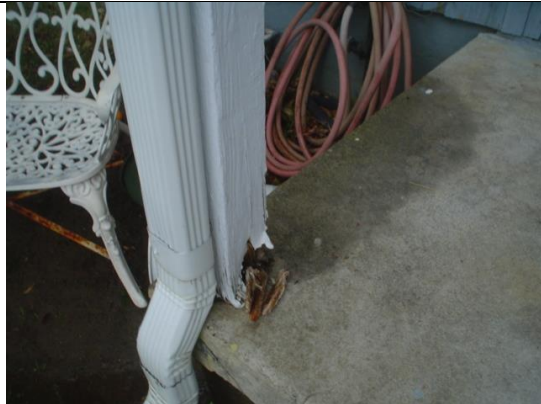
1 Finding: Fungi (wood-rot) damage found at post. Indicated on the diagram by “1”, and some areas shown in Fig.1 images on the back pages of this report.

Recommendation: Replace post.

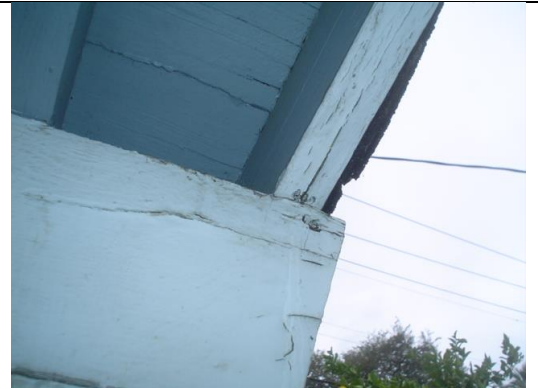
Fig.2a

2 Finding: Fungi (wood-rot) damage found in the roof eave areas. Indicated on the diagram by “2”, and some areas shown in Fig.2 images on the back pages of this report.

Recommendation: Remove roof covering as needed. Remove and replace damaged wood members as needed. Reinstall roof covering.

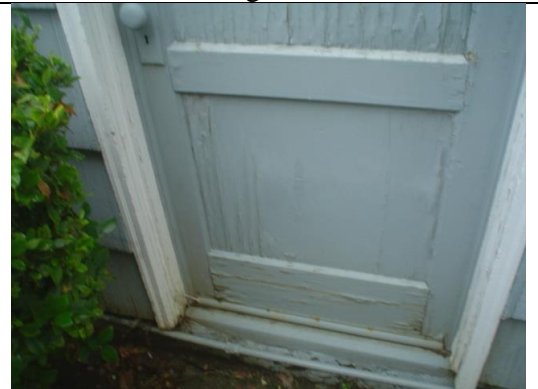
3 Finding: Fungi (wood-rot) damage found at exterior door and door casing. Indicated on the diagram by “3”, and some areas shown in Fig.3 images on the back pages of this report.

Recommendation: Install new door and door casing.

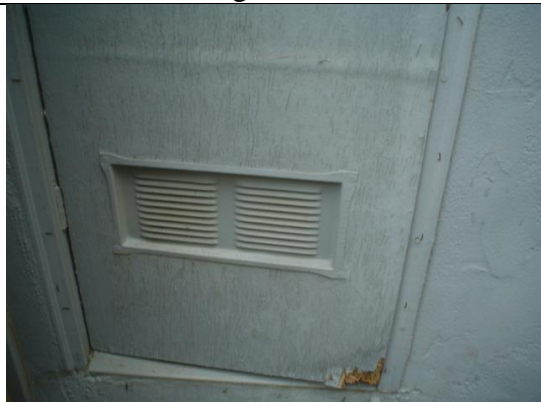
4 Finding: Fungi (wood-rot) damage found in the water heater closet door. Indicated on the diagram by “4”, and some areas shown in Fig.4 images on the back pages of this report.

Recommendation: Replace plywood door.

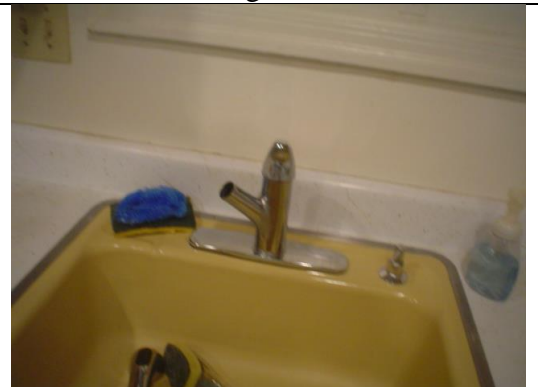
Fig.5a

5 Finding: Kitchen faucet was damaged. Moisture damage found at the inner cabinet floor. Indicated on the diagram by “5”, and some areas shown in Fig.5 images on the back pages of this report.

Recommendation: Install new faucet. Repair/replace inner cabinet floor as needed.

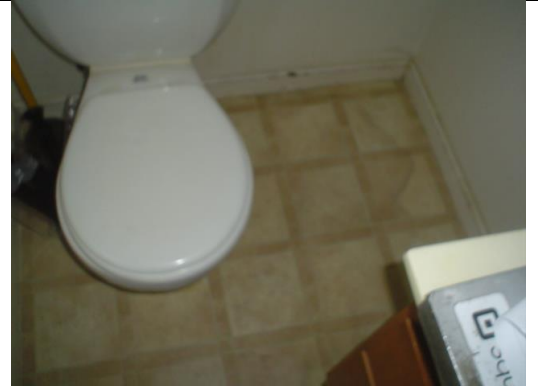
6 Finding: Evidence of moisture damage to the underlayment found at the bathroom floor of addition. Indicated on the diagram by “6”, and some areas shown in Fig.6 images on the back pages of this report.

Recommendation: Remove floor covering and damaged underlayment as needed. Install new underlayment and floor covering, reset toilet.

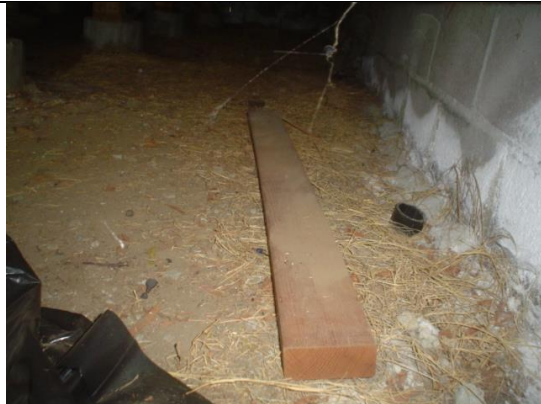
7 Finding: Cellulose debris (scrap wood, paper, etc.) found in the subarea. Indicated on the diagram by “7”, and some areas shown in Fig.7 images on the back pages of this report.

Recommendation: Remove all cellulose debris of size that can be raked.

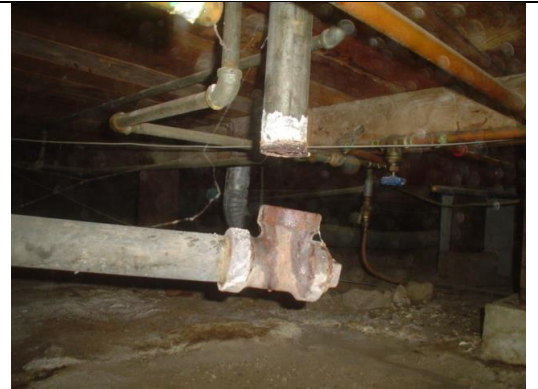
Fig.8a

8 Finding: A plumbing leak was found at galvanized waste pipe in subarea. Indicated on the diagram by “8”, and some areas shown in Fig.8 images on the back pages of this report.

Recommendation: Owner should employ others to repair plumbing as needed to eliminate leakage.
