WOOD DESTROYING PESTS AND ORGANISMS INSPECTION REPORT

Building No. 430	Street Cernon Street	City Vacaville	Zip 95688	Date of Inspection December 15, 2021	Number of Pages 4
---------------------	-------------------------	-------------------	--------------	--	----------------------

Company Report
 # R8857

General Description:
 Commercial building.

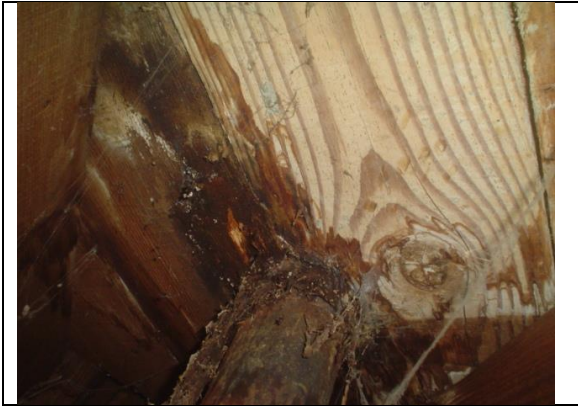
1 Finding: Women's bathroom toilet leaks at base. Minor fungi damage found at subfloor. Indicated on the diagram by "1", and some areas shown in Fig.1 images on the back pages of this report.

Recommendation: Reset toilet on new wax ring using new bolts. From subarea, cut out fungi damaged areas of subfloor as needed. Further inspect upon opening of enclosed areas.

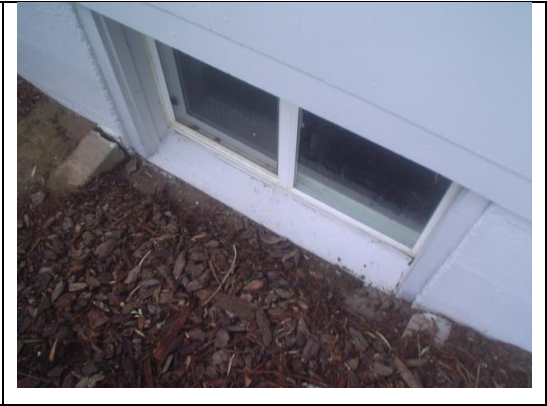
2 Finding: Earth to wood contacts found at windowsills, casings and trim. Indicated on the diagram by "2", and some areas shown in Fig.2 images on the back pages of this report.

Recommendation: Lower soil level to eliminate earth to wood contacts.
