## SWIMMING POOL INSPECTION

**454 Manzanita Avenue, Fairfield, CA 94533**  
**Inspection Performed October 19, 2023**  
**By: Angelo Tomassi – North Bay Water Services Inc.**

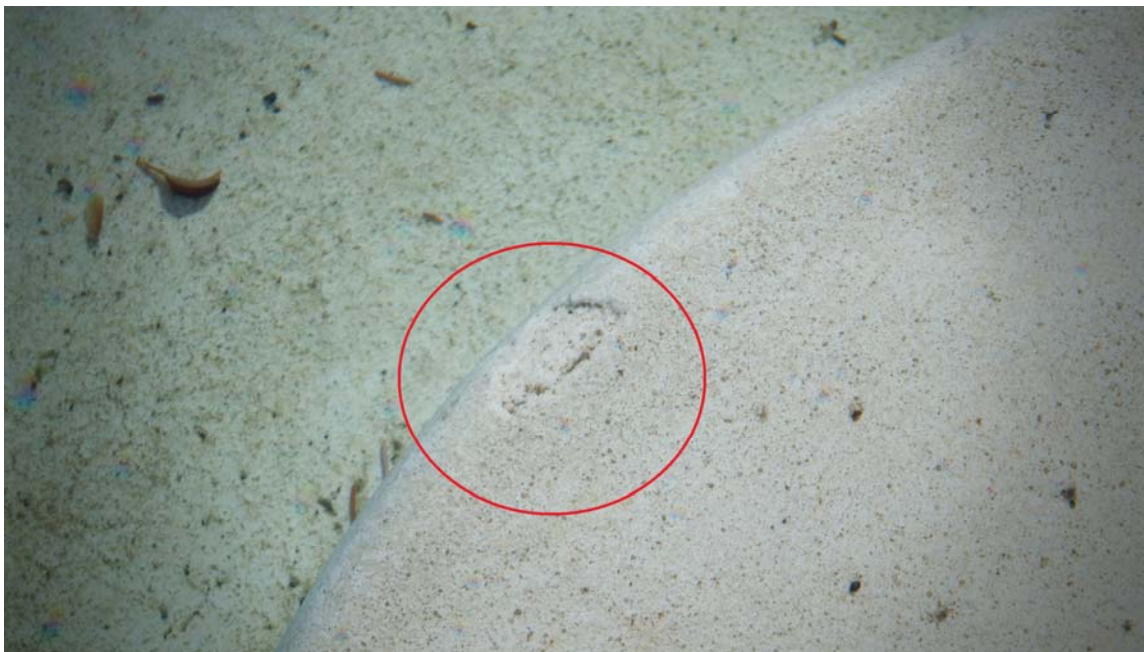
1. Pool Surface Condition: **Acceptable**
  - \* **Pool surface shows discoloration on walls and floor of the pool.**
  - \* **Chipped plaster by the steps. (Pictures 1-2)**

Picture 1 - Chipped plaster on steps.

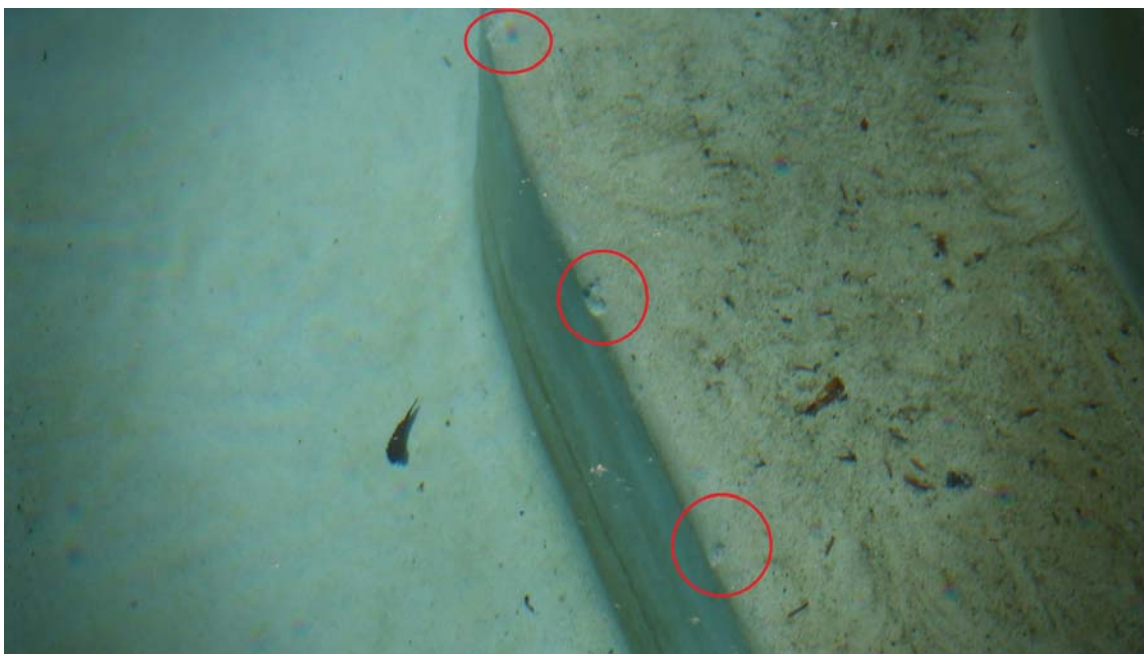
Picture 2 - Chipped plaster on steps.

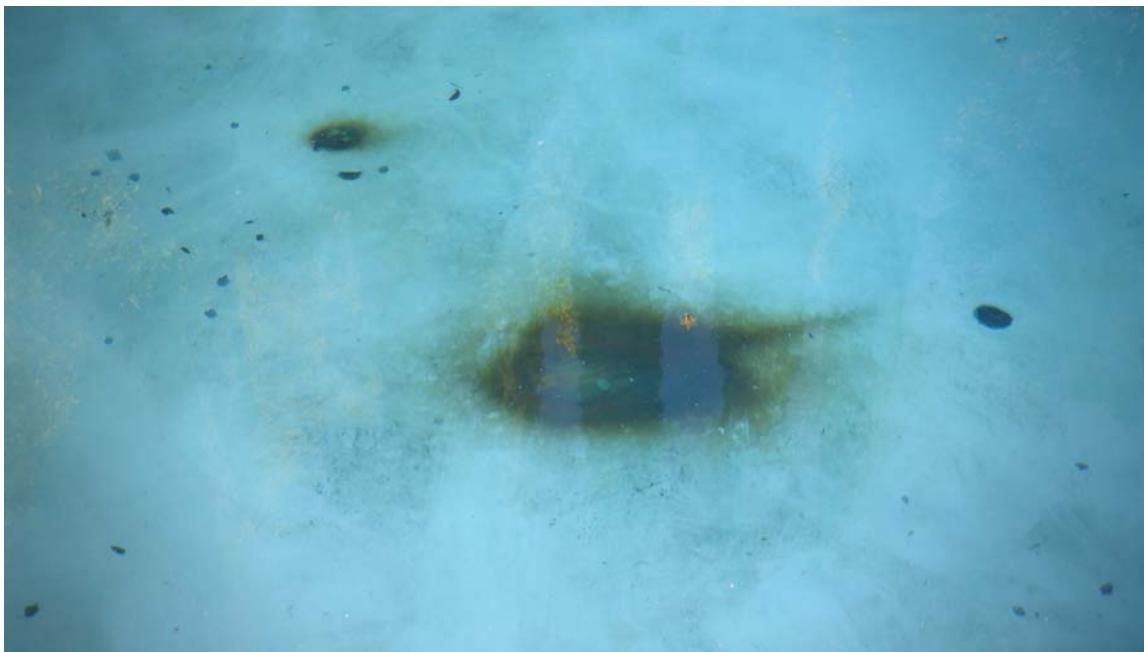
- \* **Rust stains at shallow and deep end of pool. (Pictures 3-4)**
2. Pool Tile & Deck Condition: **Acceptable**
  - \* **Concrete deck has a few cracks. (Pictures 5-6)**

Picture 3 - Rust Stains on Pool Surface.

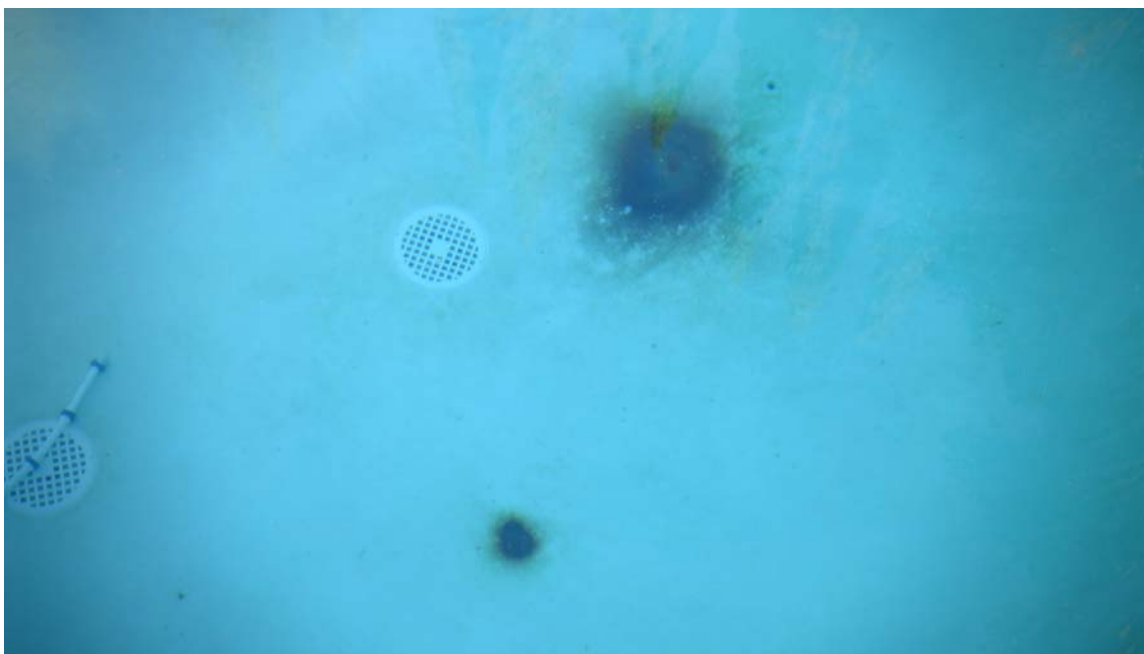
Picture 4 - Rust Stains on Pool Surface.

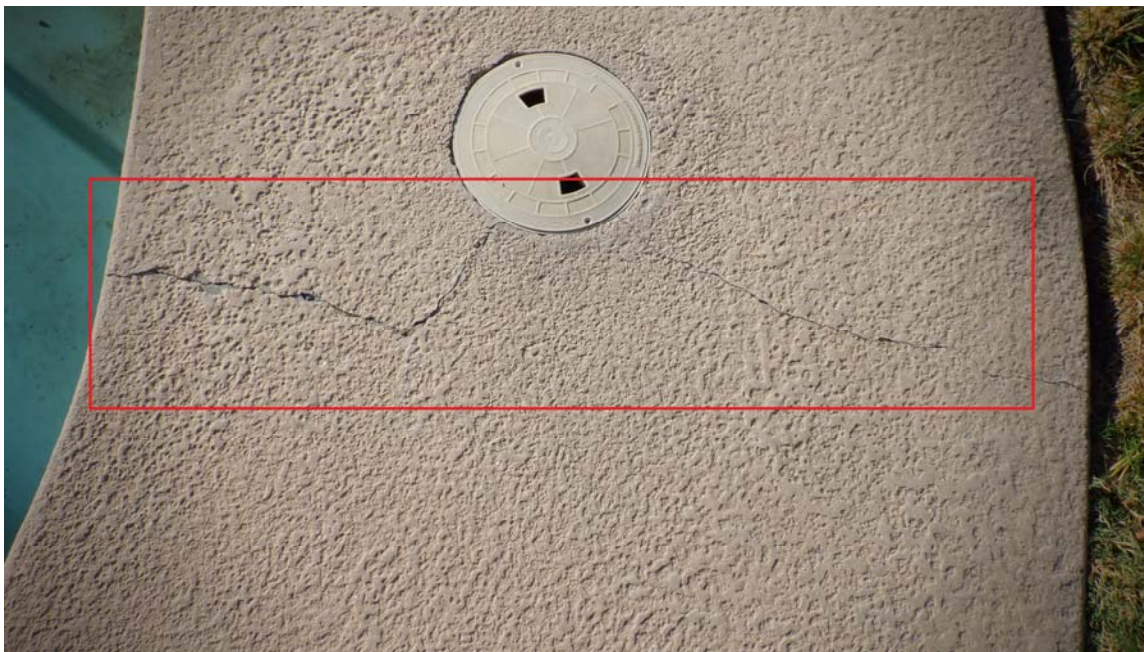
Picture 5 - Crack on concrete deck.

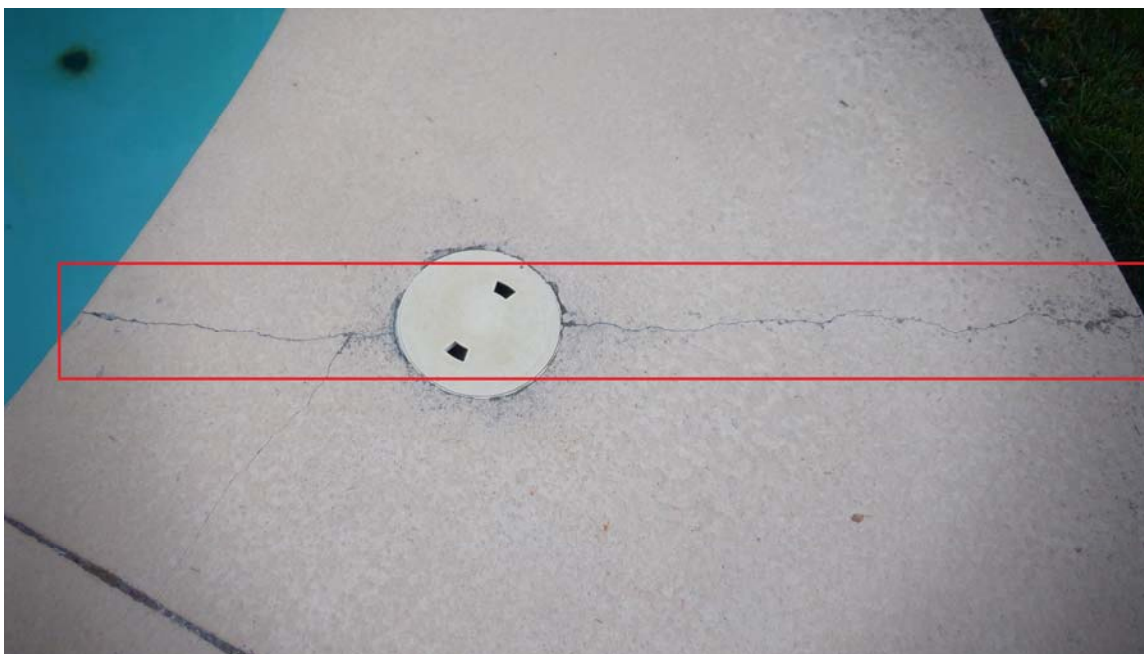
Picture 6 - Crack on concrete deck.

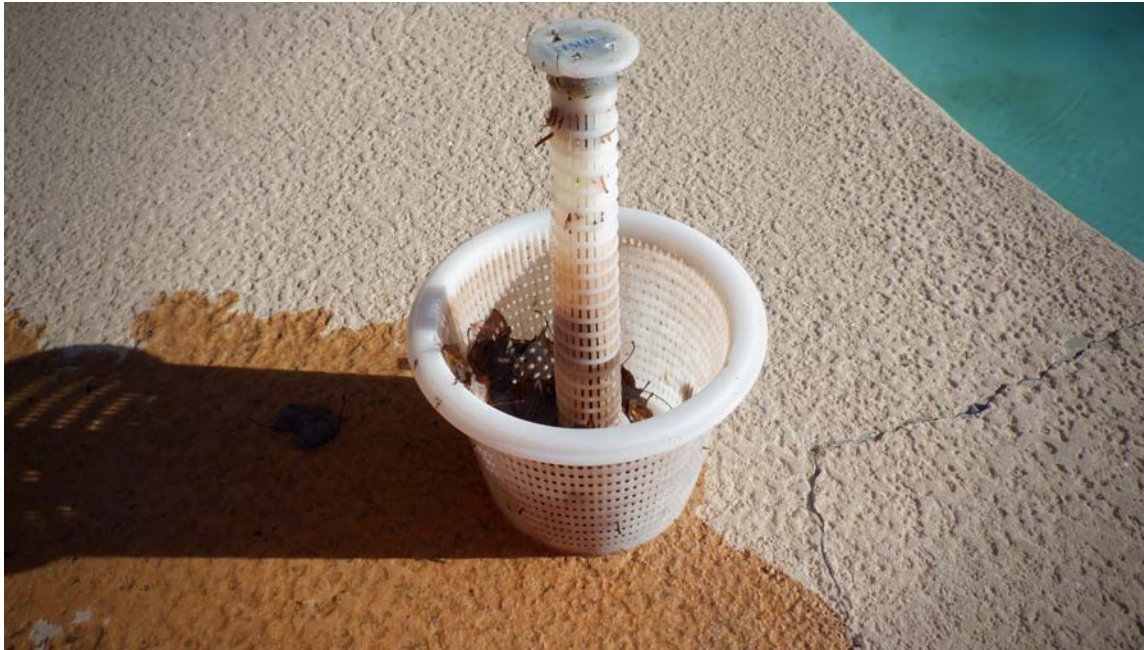
- \* **Tiles are in good condition.**
3. Skimmer & Main Drains: **Defective**
  - \* **Skimmer Baskets are in good condition. (Picture 7)**
  - \* **Main Drain Covers not VGB/Anti-Entrapment Compliant. (Picture 8)**

Picture 7 - Skimmer Basket

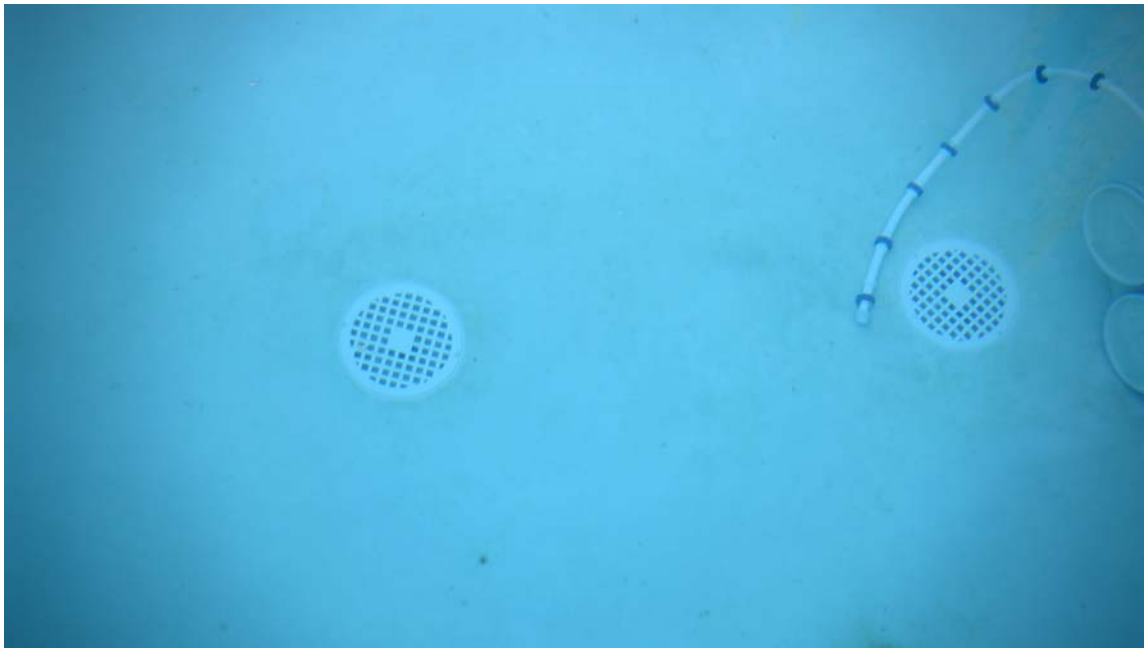
Picture 8 - Pool Main Drain Covers not VGB/Anti-Entrapment Compliant

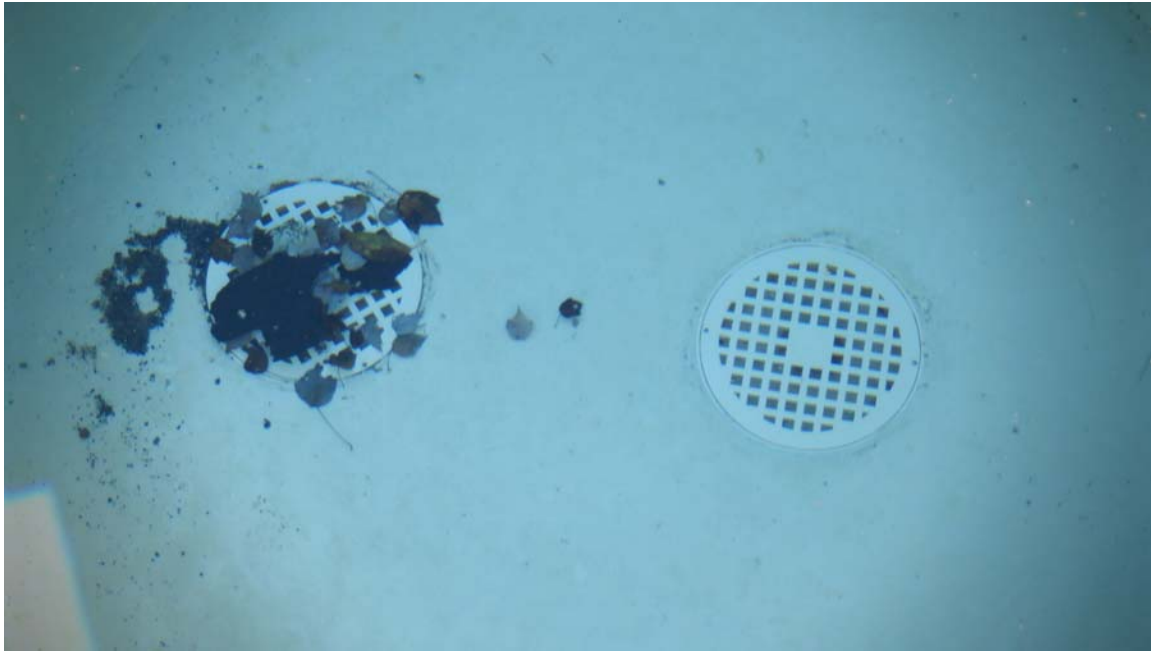
- \* **Spa Drain Covers not VGB/Anti-Entrapment Compliant. (Picture 9)**
  - \* **Float Valve missing in both skimmers. (Picture 10)**
4. Filter Condition: **Good**

Picture 9 - Spa Drain Covers not VGB/Anti-Entrapment Compliant

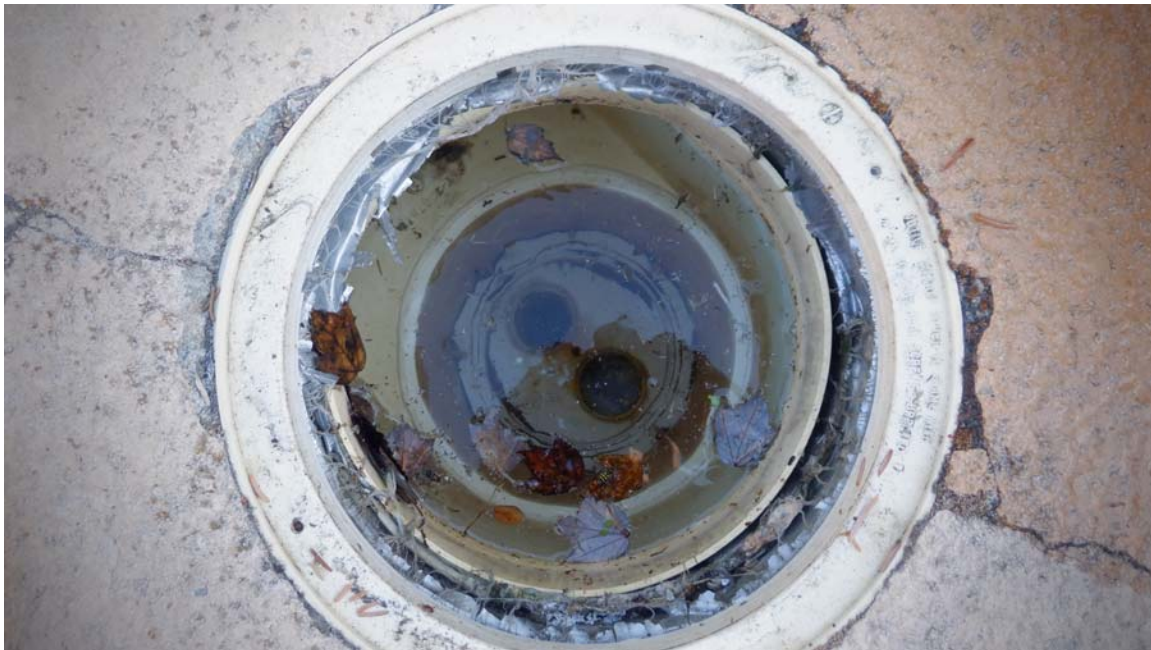
Picture 10 - Float Valve missing in skimmer.

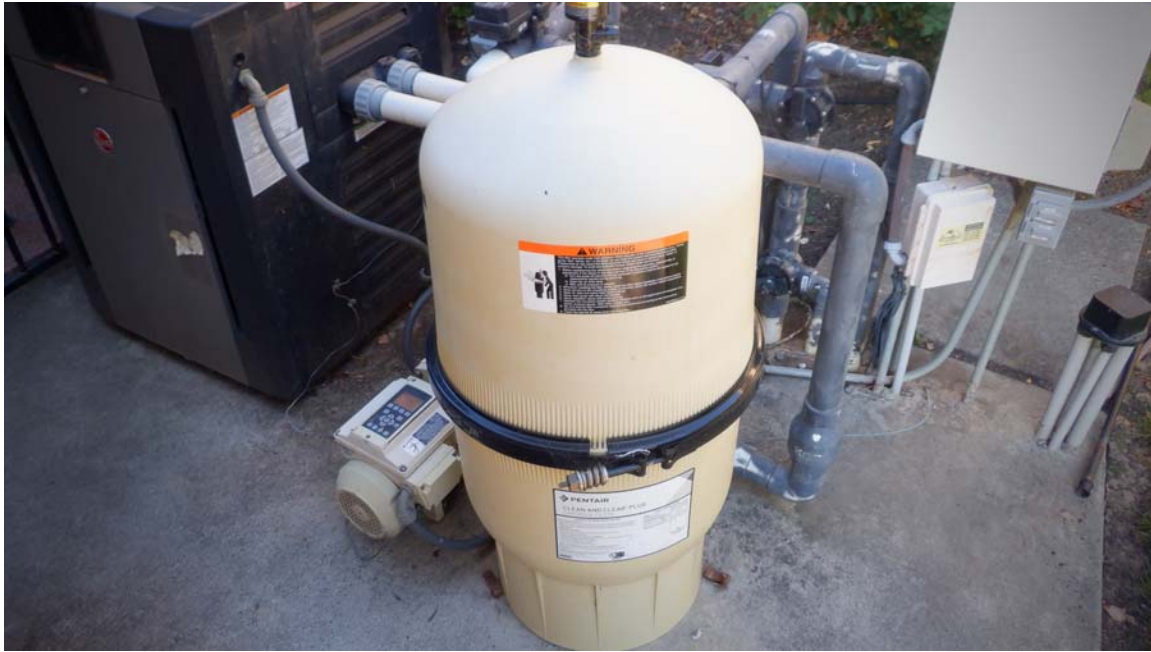
- \* **Pentair Clean & Clear Plus (CCP) 420 Cartridge Filter in good working condition (Picture 11)**
5. Filter Pump Condition: **Good**
  - \* **Pentair Intelliflo VS Pump is working properly. (Picture 12)**

Picture 11 - Pentair Clean and Clear Plus (CCP) 420 Cartridge Filter

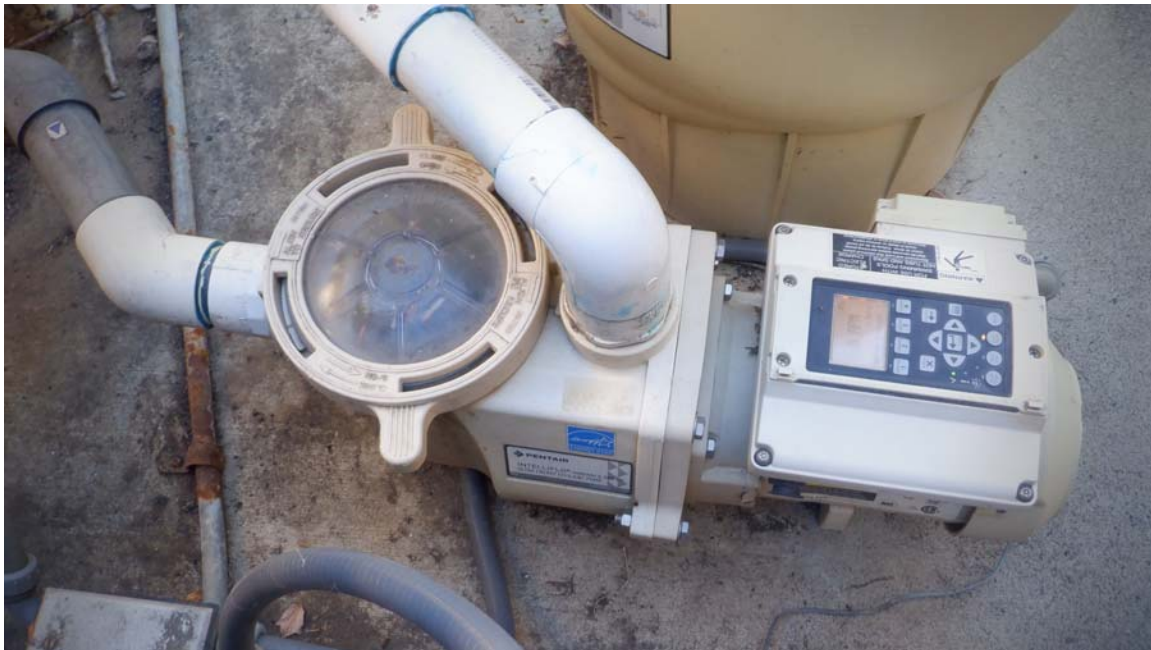
Picture 12 - Pentair Intelliflo VS (variable speed) Pump.

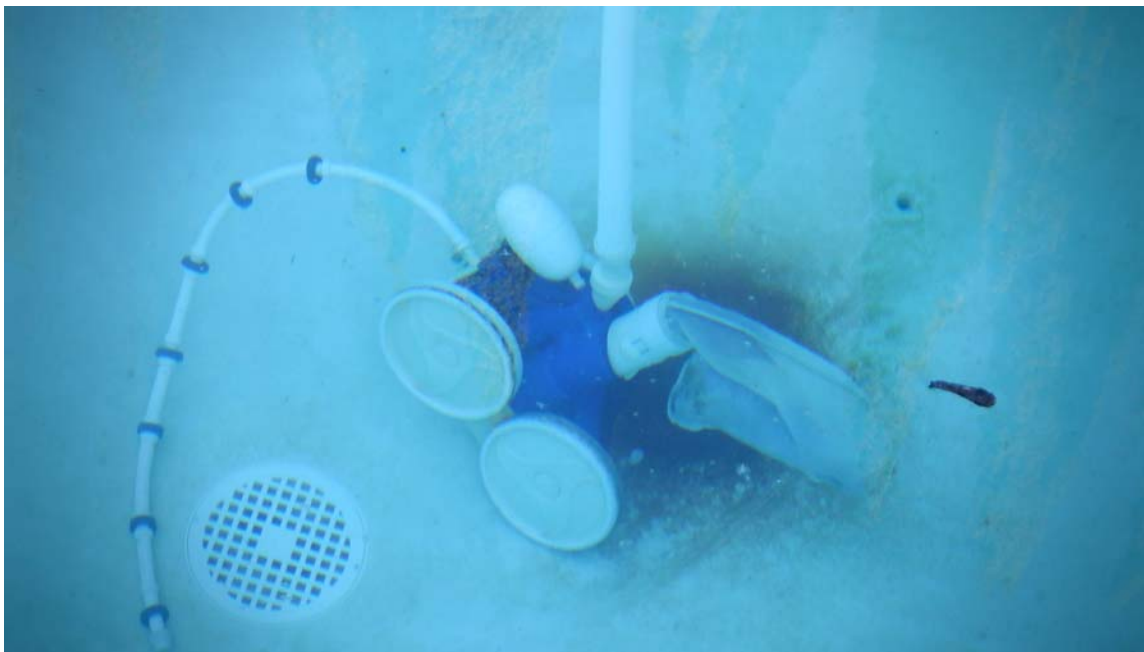
6. Pool Cleaner Condition: **Defective**
  - \* **Polaris 360 Pressure Side Pool Cleaner has a broken belt. (Picture 13)**
7. Plumbing & Valve Condition: **Good**

Picture 13 - Polaris 360 Pressure Side Pool Cleaner.

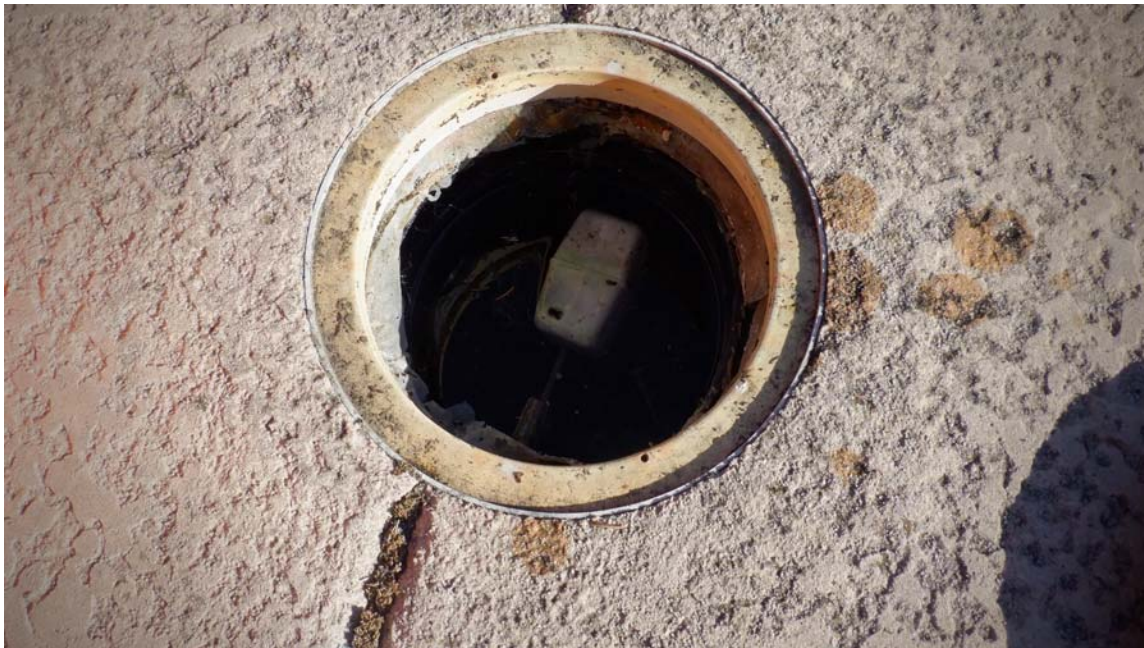
- \* **Plumbing, valves, and valve actuators are in good working condition.**
  - \* **Pool Water Auto-fill is working properly. (Picture 14)**
  - \* **Pool Water Valve (Picture 15)**

Picture 14 - Pool Water Auto-fill

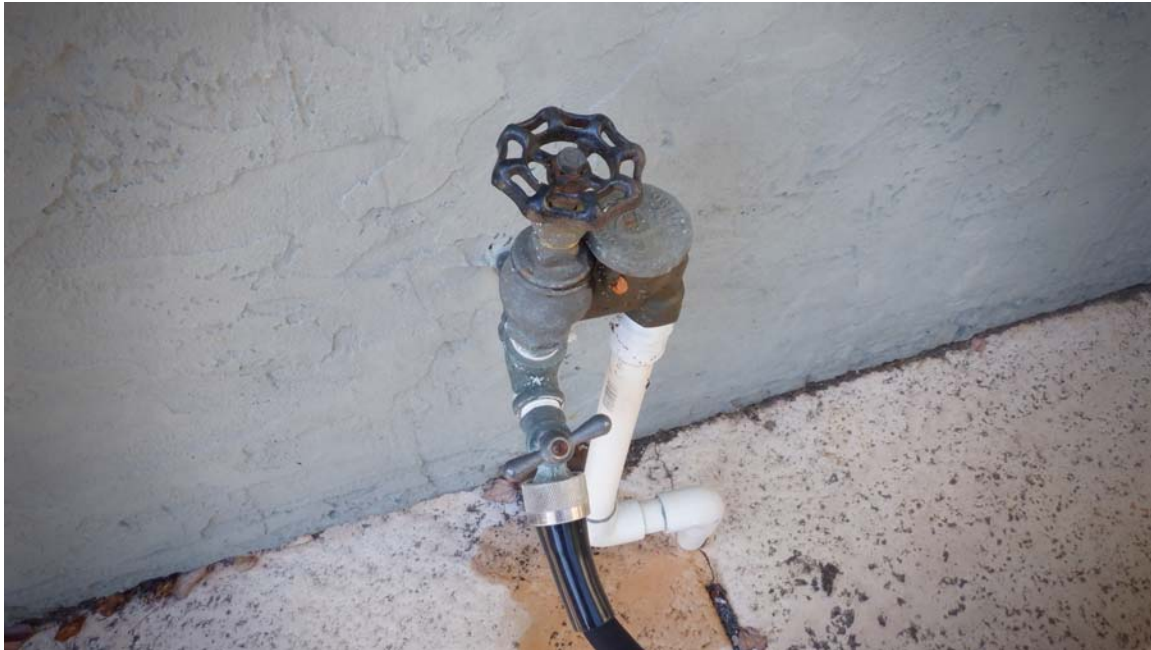
Picture 15 - Pool Water Valve

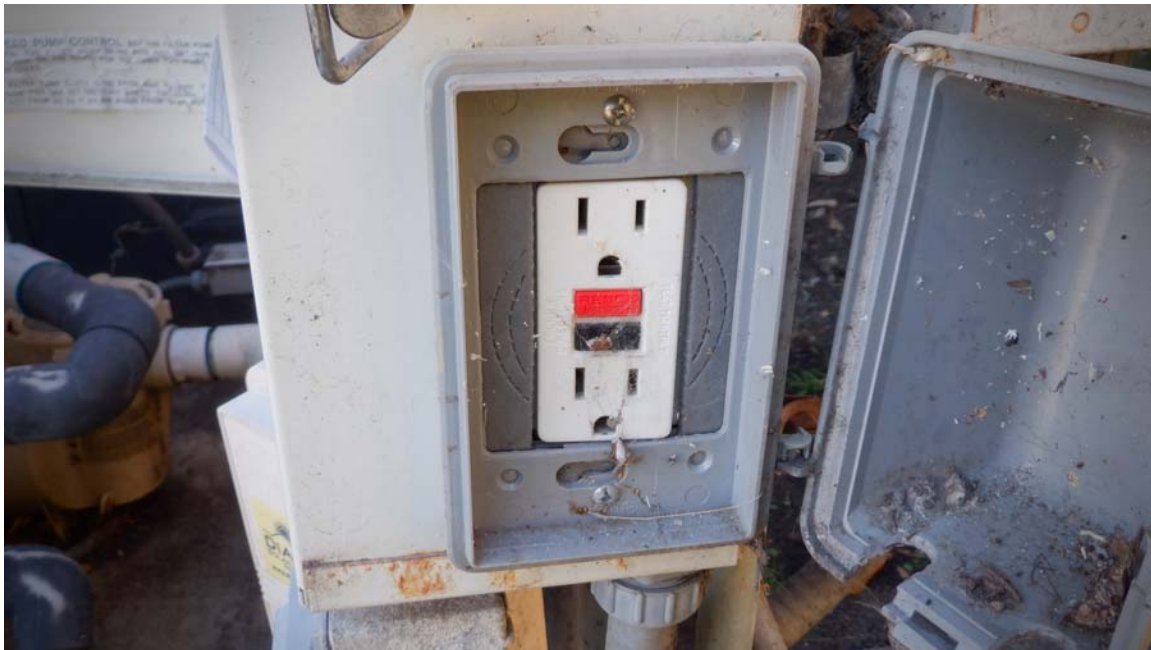
8. Electrical Condition: **Good**
  - \* **All electrical connections look good.**
  - \* **GFCI protected receptacle for Pool & Spa lights is working properly. (Picture 16)**

Picture 16 - GFCI Protected Receptacle

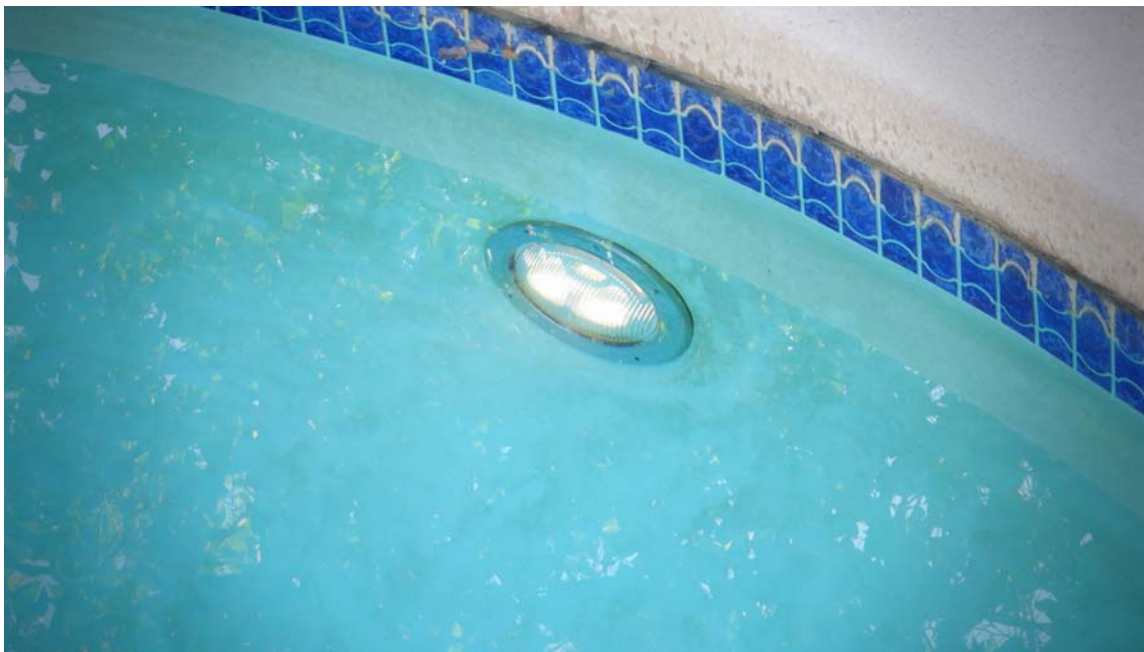
- \* **Pool Light is working properly. (Picture 17)**
  - \* **Spa Light is working properly. (Picture 18)**
  - \* **Switches to operate Pool and Spa lights. (Picture 19)**

Picture 17 - Pool Light

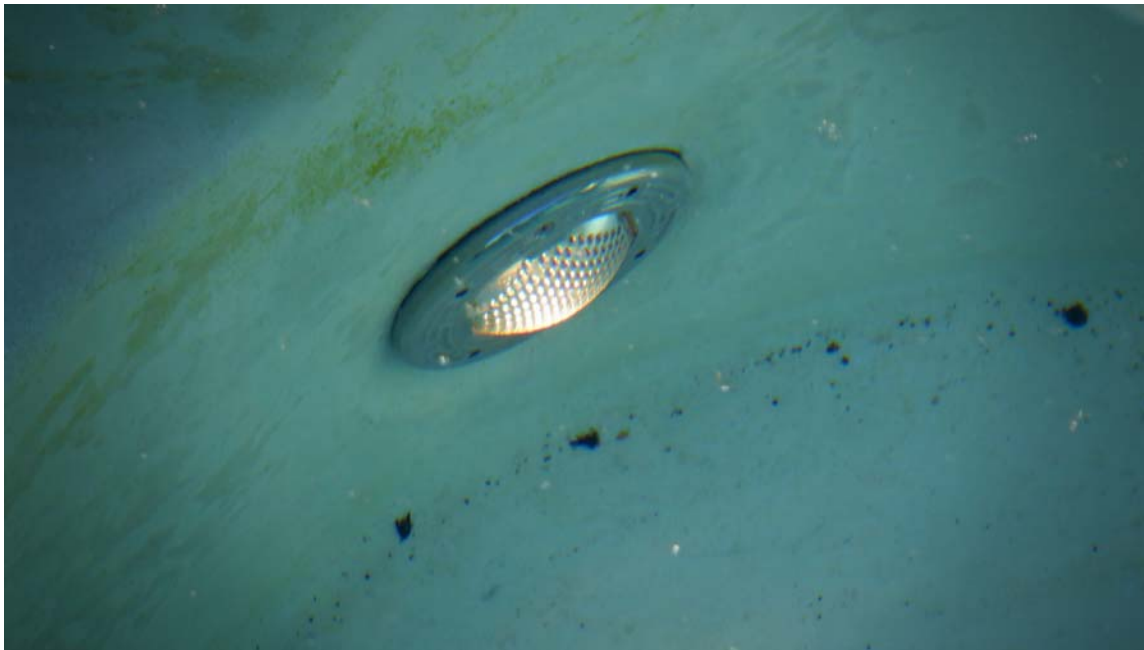
Picture 18 - Spa Light

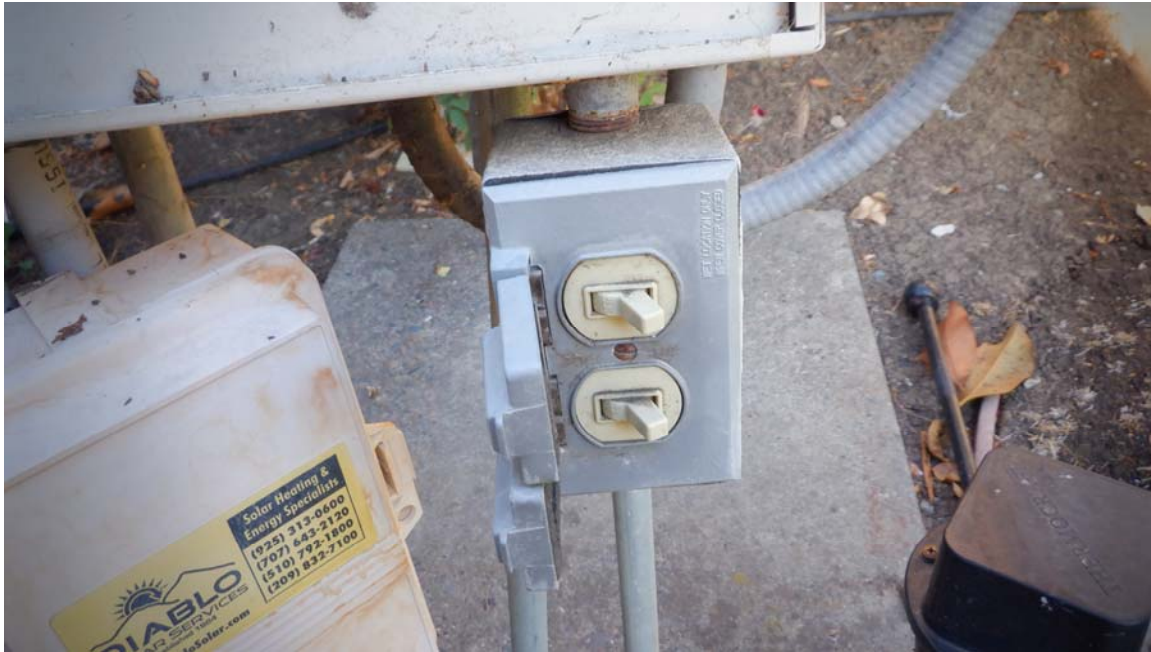
Picture 19 - Pool & Spa light switches

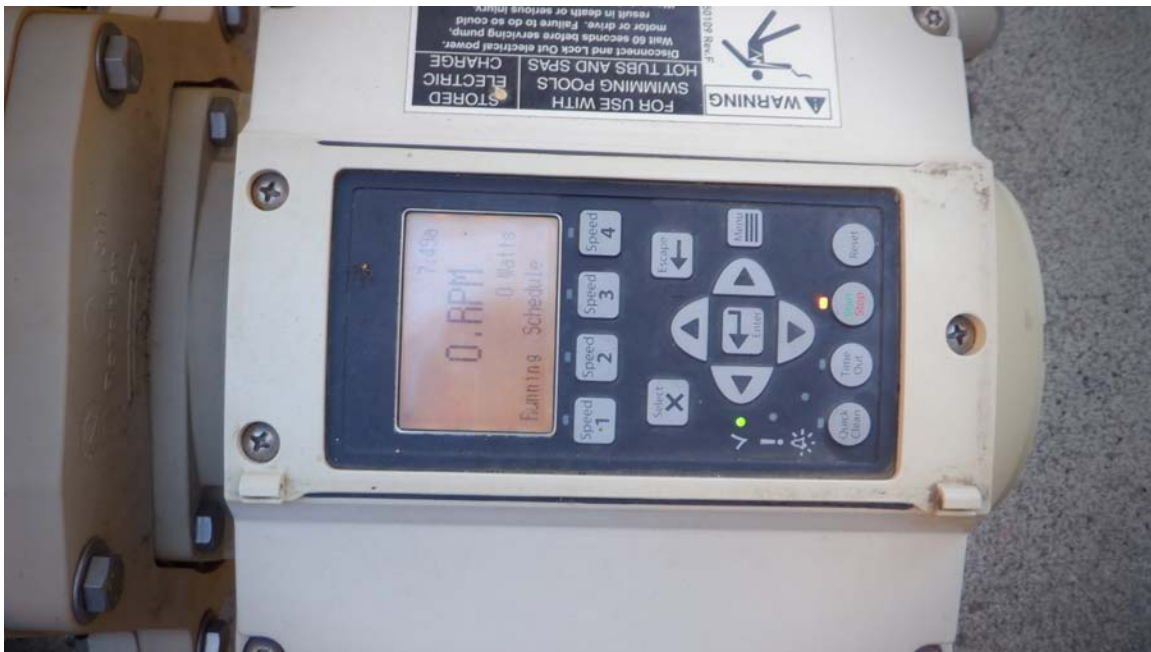
9. Control System Condition: **Good**
  - \* **Controller on the filter pump is working properly. (Picture 20)**

Picture 20 - Controller on pump for filter system

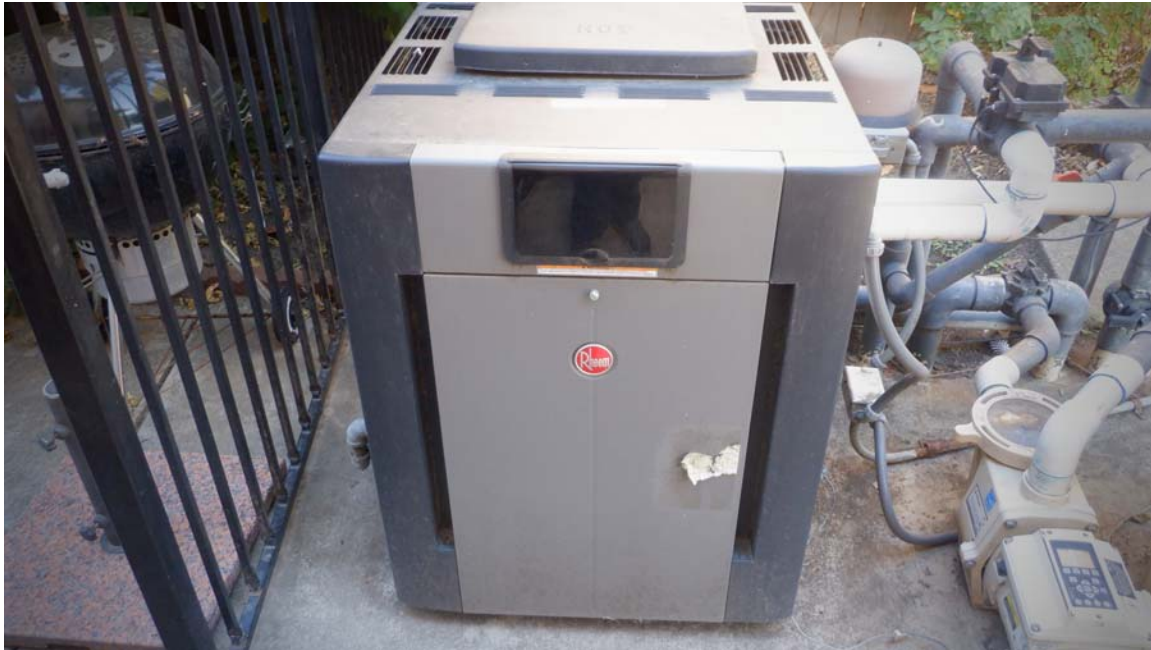
11. Heater: **Defective**
  - \* **Rheem model P-M406A-EN-C not working when tested. (Picture 21)**
  - \* **Display showing a “sensor failure” message. (Picture 22)**

Picture 21 - Rheem Gas Heater

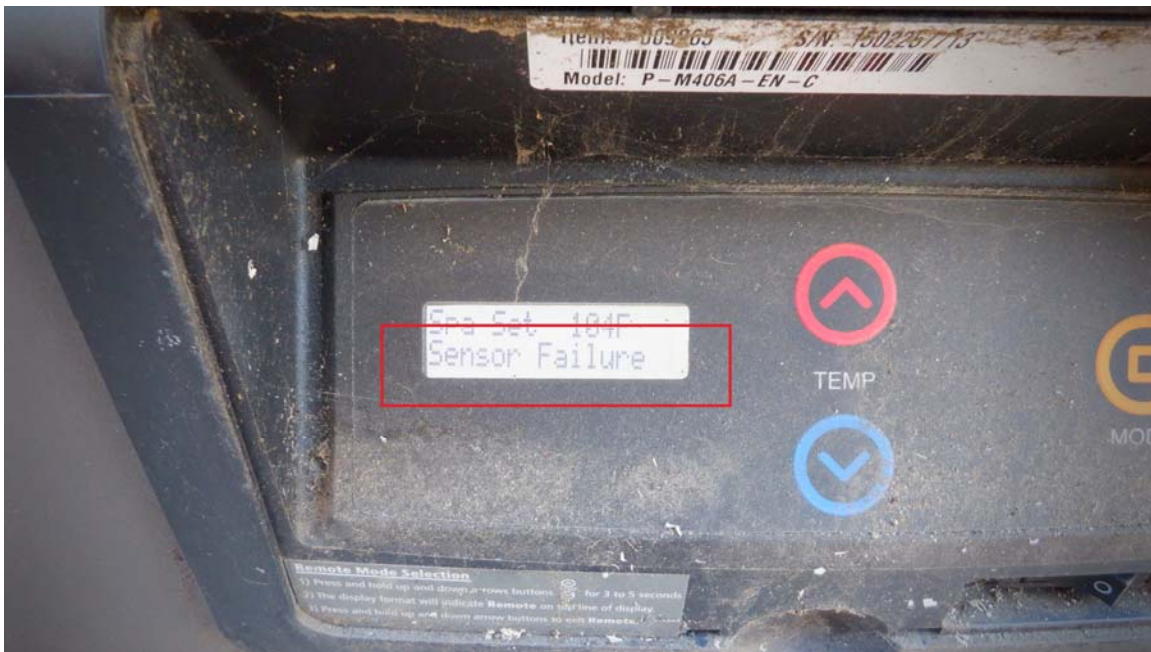
Picture 22 - Heater display reads "Sensor Failure"

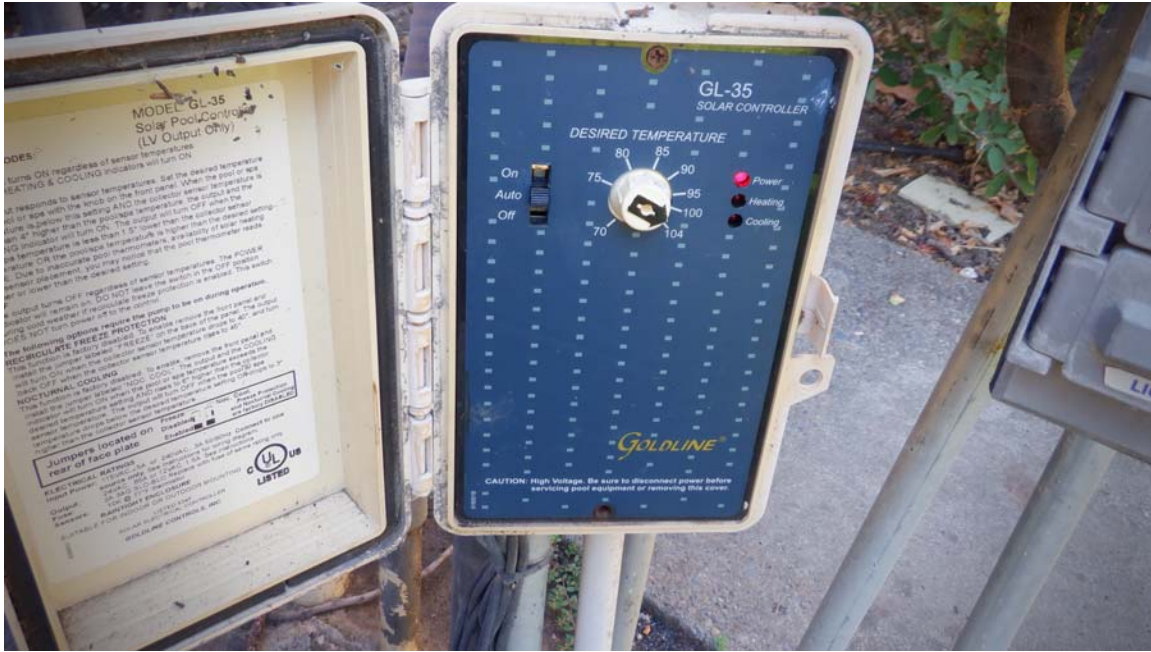
12. Solar: **Good**
  - \* **Goldline GL-35 Solar Controller working properly. (Picture 23)**
  - \* **Actuator on Solar Valve is working properly. (Picture 24)**

Picture 23 - Goldline GL-35 Solar Controller

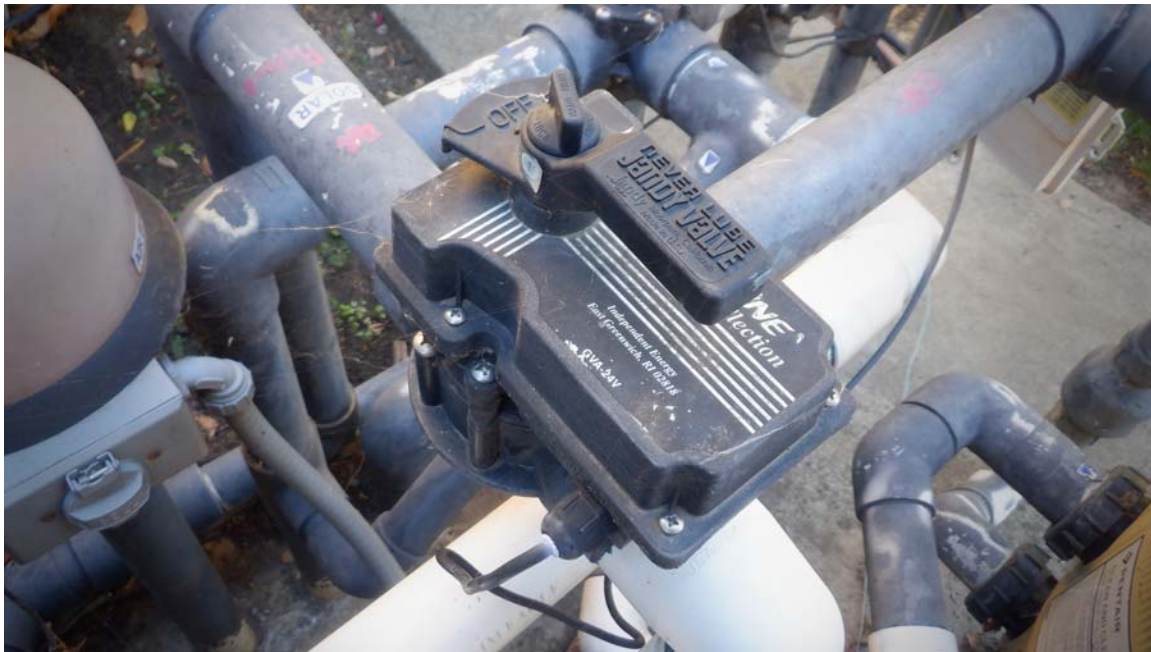
Picture 24 - Valve Actuator for Solar Operation.

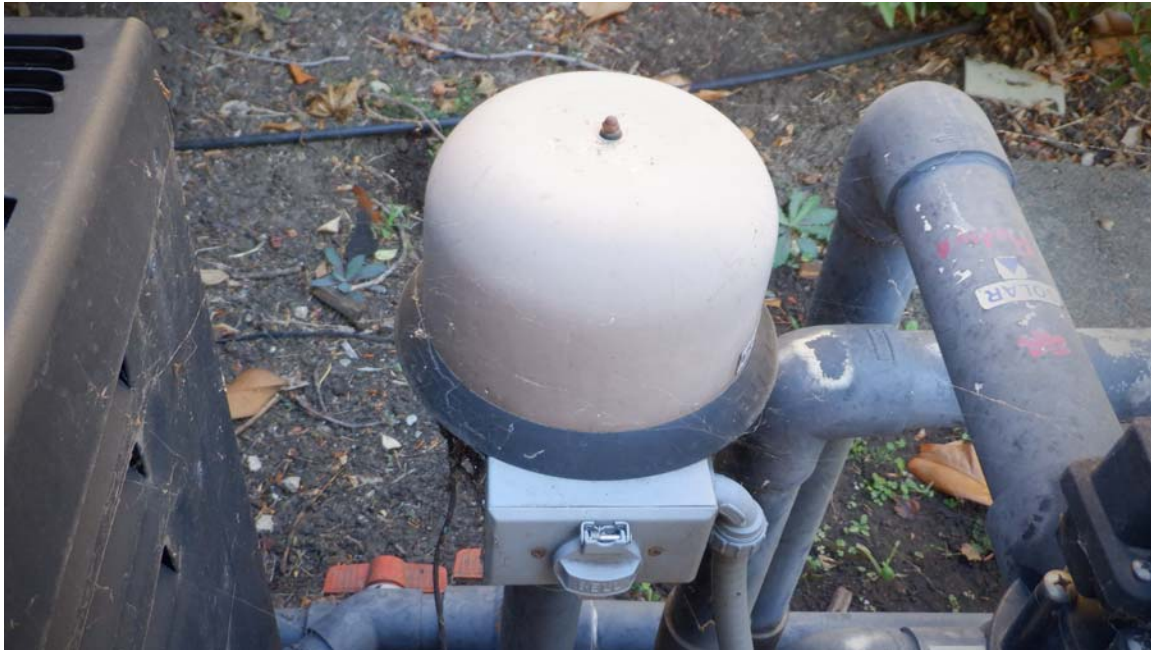
13. Blower: **Good**
  - \* **Air Blower for the spa is working properly. (Picture 25)**

Picture 25 - Air Blower for Spa Jets.

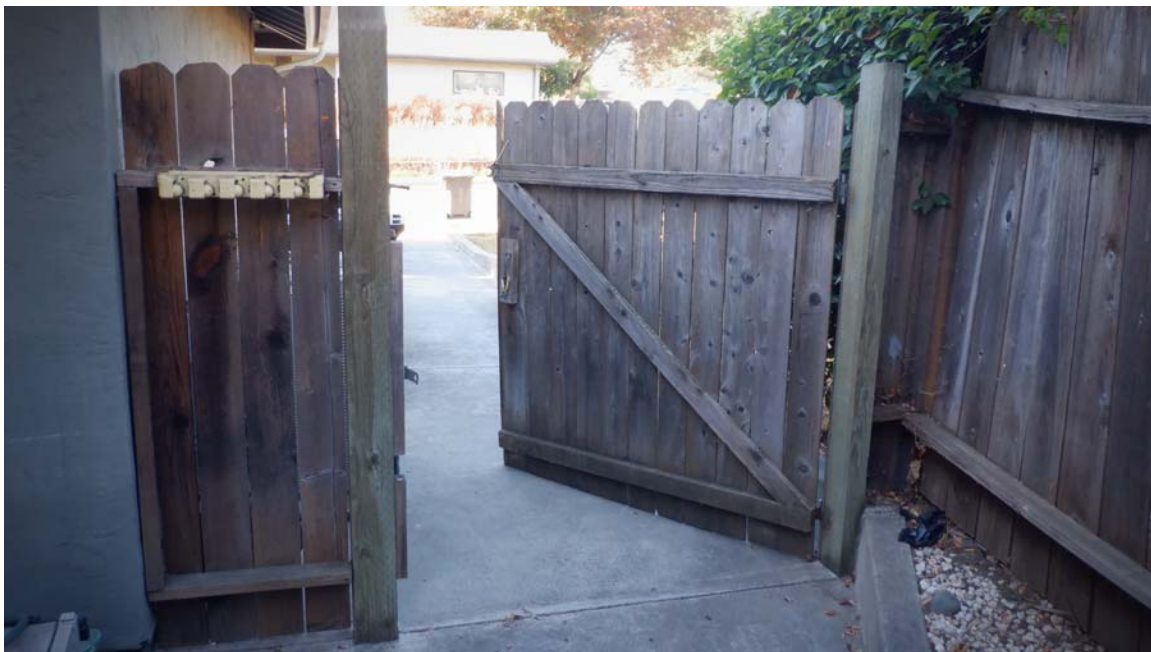
14. Gate Condition: **Defective**
  - \* **Backyard access gate is not Self-Closing and Self-Latching. (Picture 26)**

Picture 26 - Backyard access gate is not Self-Closing/Self-Latching.

**State & City Codes require that a Pool be fenced with Self-Closing and Self-Latching Gates**
