WOOD DESTROYING PESTS AND ORGANISMS INSPECTION REPORT

Building No 535	Street Cement Hill Road	City Fairfield	Zip 94533	Date of Inspection 06/27/2024	Number of Pages 12
--------------------	----------------------------	-------------------	--------------	----------------------------------	-----------------------

<p>General Description: THIS PROPERTY CONSISTS OF A TWO STORY RESIDENCE WITH WOOD AND STUCCO SIDING</p>	<p>Inspection Tag Posted: GARAGE</p>
	<p>Other Tags Posted: NONE</p>

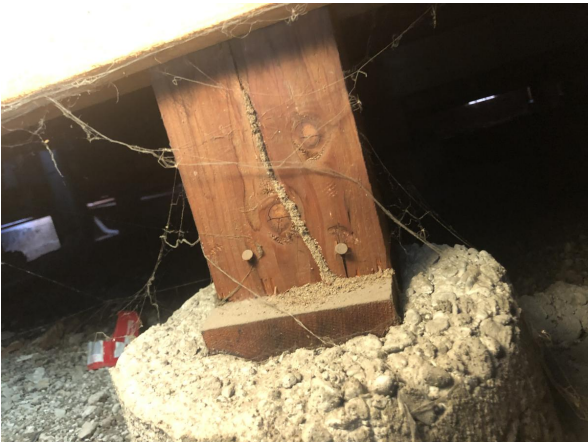
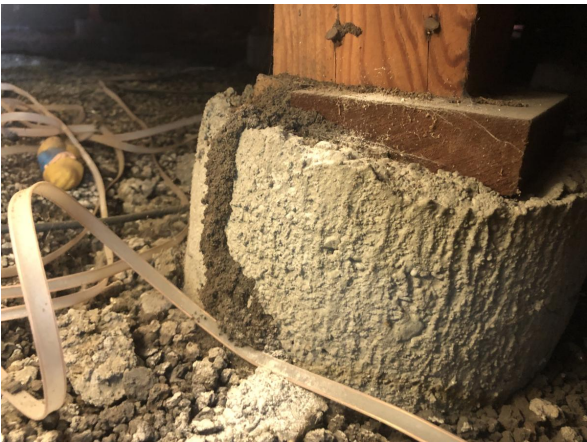
1A:

1A. FINDING: EVIDENCE OF SUBTERRANEAN TERMITE ACTIVITY IS VISIBLE AT THE SUBAREA FRAMING .

RECOMMENDATION: CHEMICALLY TREAT THE SUBAREA SOIL ADJACENT TO THE PIER PADS WITH TERMIDOR (ACTIVE INGREDIENT, FIPRONIL) FOR THE CONTROL OF SUBTERRANEAN TERMITES. ALSO TRENCH AND/OR ROD TREAT THE SOIL ADJACENT TO THE EXTERIOR FOUNDATION WALLS WITH THE SAME MATERIAL. DRILL A SERIES OF HOLES AS INDICATED BY "X" ON THE DIAGRAM THROUGH ANY ATTACHED CONCRETE SLABS ADJACENT TO THE EXTERIOR FOUNDATION WALLS (APPROX. 18" ON CENTER) AND PRESSURE INJECT TERMIDOR INTO THE SOIL BELOW. PATCH ALL HOLES WITH MORTAR. REMOVE ALL ACCESSIBLE TERMITE EVIDENCE.

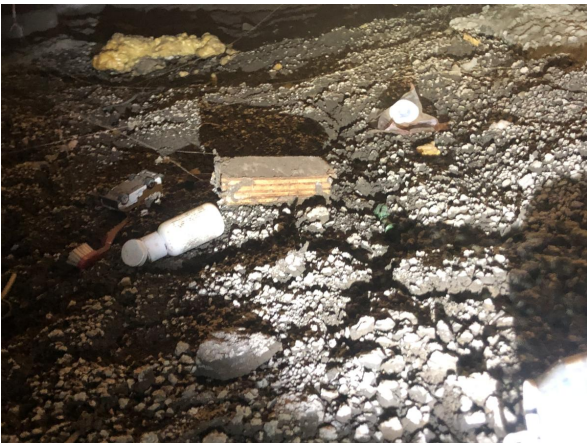
1B:

1B. FINDING: EVIDENCE OF SUBTERRANEAN TERMITE ACTIVITY IS VISIBLE IN THE CELLULOSE DEBRIS AT THE SUBAREA.

RECOMMENDATION: REMOVE AND DISPOSE OF ALL LOOSE WOOD SCRAPS AND OTHER CELLULOSE DEBRIS OF RAKEABLE SIZE OR LARGER.

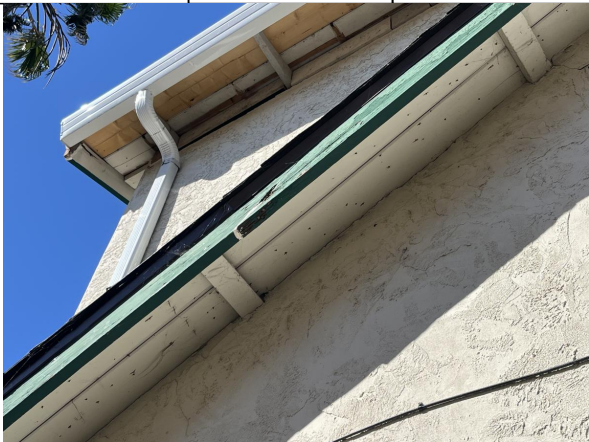
3A:

3A. FINDING: THERE IS WOOD DECAY FUNGI (DRY ROT) DAMAGE AT THE BARGE RAFTER .

RECOMMENDATION: TRIM OUT THE INFECTED MATERIALS AND APPLY TIMBOR (ACTIVE INGREDIENT: DISODIUM OCTABORATE TETRAHYDRATE) TO THE ADJACENT INFECTED AREAS AS NECESSARY FOR THE CONTROL OF WOOD DECAY FUNGI (DRY ROT). FILL THE VOIDS USING AN APPROPRIATE FILLER.

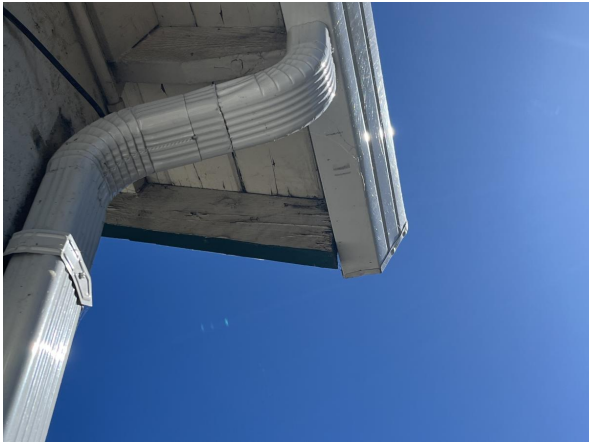
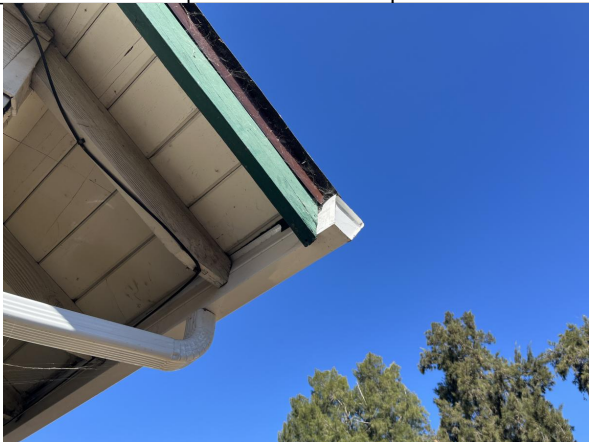
3B:

THERE IS WOOD DECAY FUNGI (DRY ROT) DAMAGE AT THE BARGE RAFTER .

REMOVE ALL DAMAGED WOOD AND REPLACE WITH NEW MATERIAL. APPLY TIMBOR (ACTIVE INGREDIENT, DISODIUM OCTABORATE TETRAHYDRATE) TO THE ADJACENT INFECTED AREAS AS NECESSARY FOR THE CONTROL OF WOOD DECAY FUNGI (DRY ROT).

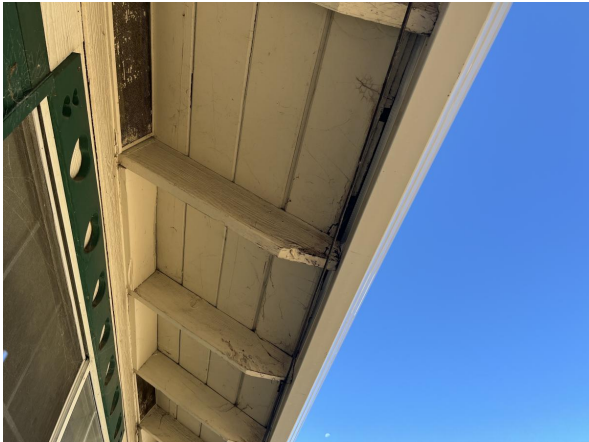
3C:

3C. FINDING:	THERE IS EVIDENCE OF WOOD DECAY FUNGI (DRY ROT) DAMAGE AT THE SHEATHING AND RAFTER OF THE ROOF OVERHANG.
RECOMMENDATION:	REMOVE THE ROOF COVERING TO EXPOSE THE DAMAGED AREAS IF NECESSARY. REMOVE ALL STRUCTURALLY DAMAGED WOOD MEMBERS AND REPLACE WITH NEW MATERIAL. APPLY TIMBOR (ACTIVE INGREDIENT, DISODIUM OCTABORATE TETRAHYDRATE) ADJACENT TO THE INFECTED AREAS FOR THE CONTROL OF WOOD DECAY FUNGI AS NECESSARY. INSTALL ROOF COVERING TO THE EXPOSED AREAS ONLY. GUARANTEE APPLIES TO ROOF COVERING IN REPAIRED AREAS ONLY.
NOTES:	DURING THE COURSE OF REPAIRS, IF ADDITIONAL LAYERS OF ROOFING AND/OR ROOF SHEATHING ARE DISCOVERED AT THE EXPOSED AREA, THE HOMEOWNER WILL BE CONTACTED AND A SUPPLEMENTAL REPORT ISSUED REFLECTING ADDITIONAL FINDINGS/COSTS.

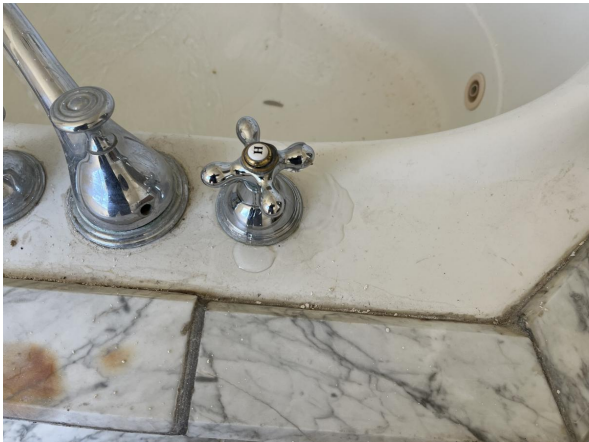
4B:

4B. FINDING: THERE IS A PLUMBING LEAK AT THE HOT WATER HANDLE OF THE TUB IN THE MASTER BATHROOM .

RECOMMENDATION: THE OWNER SHOULD CONTACT A LICENSED PLUMBER TO MAKE THE NECESSARY REPAIRS.

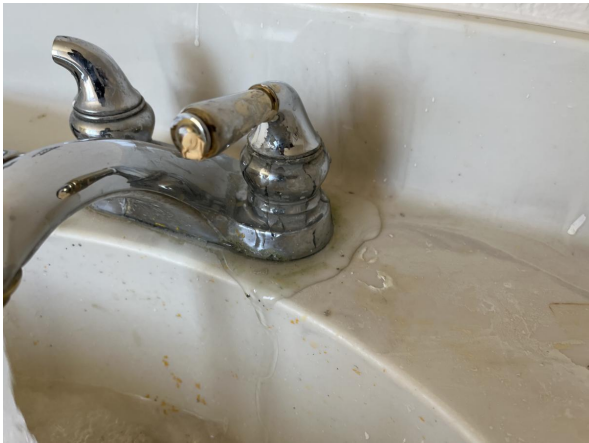
4C:

4C. FINDING: THERE IS A PLUMBING LEAK AT THE RIGHT HANDLE OF THE LEFT VANITY IN THE MASTER BATHROOM .

RECOMMENDATION: THE OWNER SHOULD CONTACT A LICENSED PLUMBER TO MAKE THE NECESSARY REPAIRS.

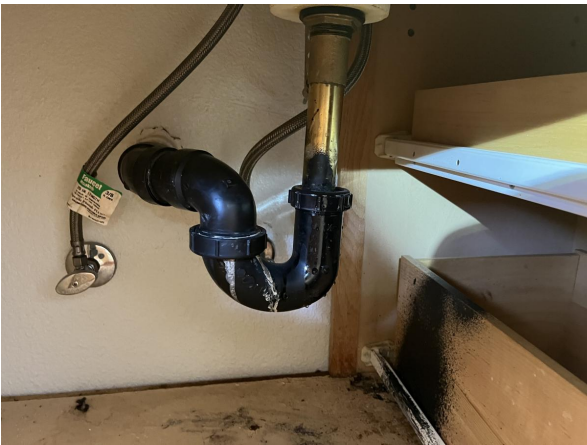
4D:

4D. FINDING: THERE IS A PLUMBING LEAK AT THE RIGHT VANITY SINK DRAIN IN THE MASTER BATHROOM .

RECOMMENDATION: THE OWNER SHOULD CONTACT A LICENSED PLUMBER TO MAKE THE NECESSARY REPAIRS.

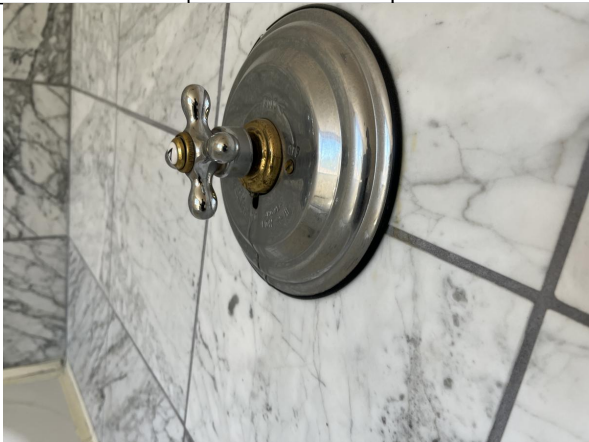
4F:

4F. FINDING: THERE IS A PLUMBING LEAK AT THE MASTER BATHROOM SHOWER HANDLE .

RECOMMENDATION: THE OWNER SHOULD CONTACT A LICENSED PLUMBER TO MAKE THE NECESSARY REPAIRS.
