WOOD DESTROYING PESTS AND ORGANISMS INSPECTION REPORT

Building No. 896	Street Granada Lane	City Vacaville	Zip 95688	Date of Inspection November 2, 2022	Number of Pages 7
---------------------	------------------------	-------------------	--------------	--	----------------------

Company Report
 # R9341

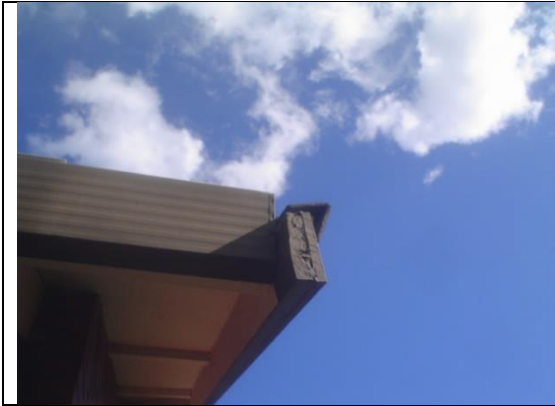
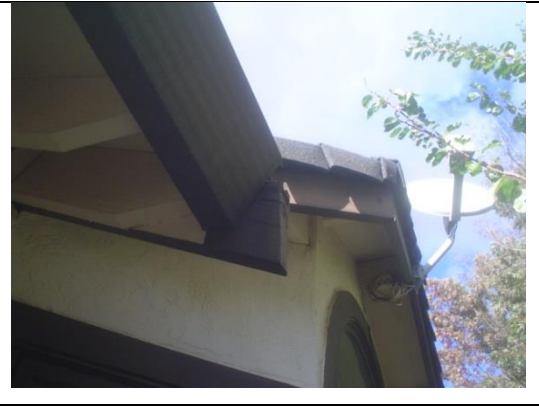
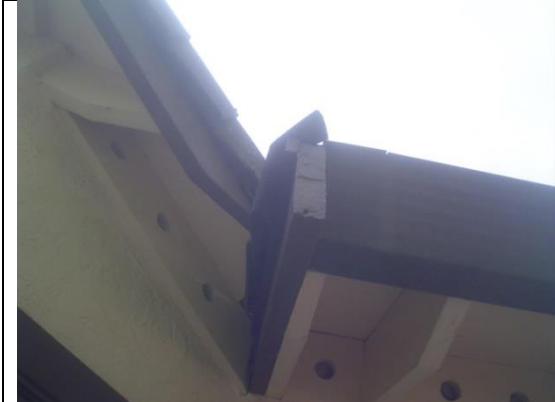
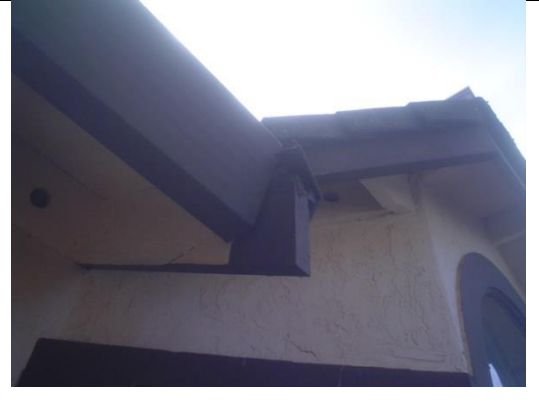
1 Finding: Fungi (wood-rot) damage found in the fascia rafter areas. Indicated on the diagram by “1”, and some areas shown in Fig.1 images on the back pages of this report.

Recommendation: Repair/replace fungi damaged wood members as needed.

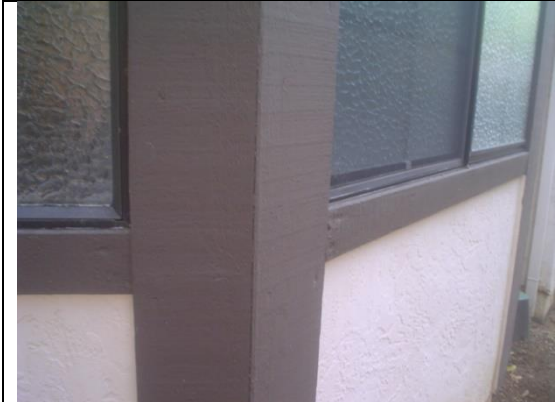
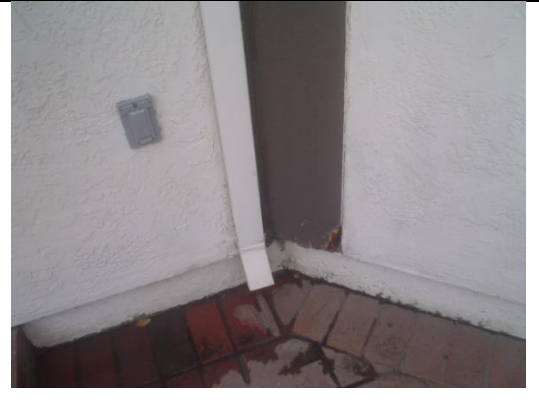
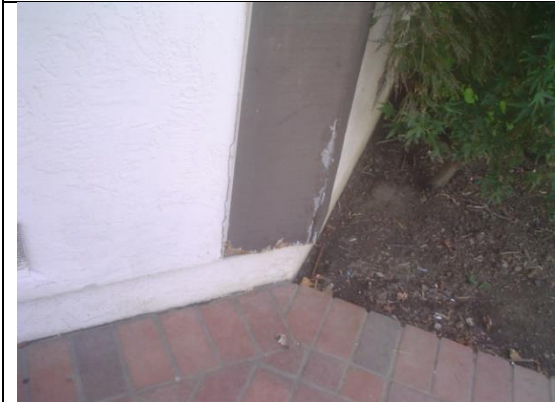
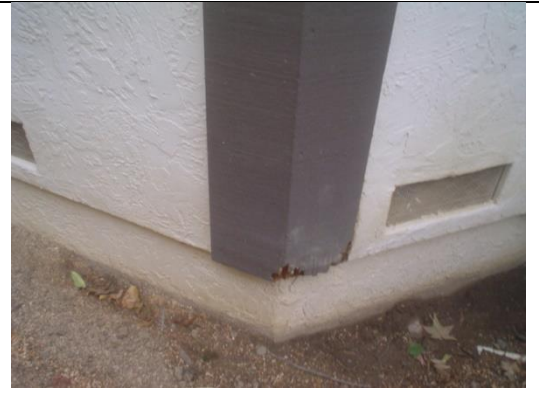
2 Finding: Fungi (wood-rot) damage found in the exterior trim. Indicated on the diagram by “2”, and some areas shown in Fig.2 images on the back pages of this report.

Recommendation: Replace damaged areas of trim as needed.

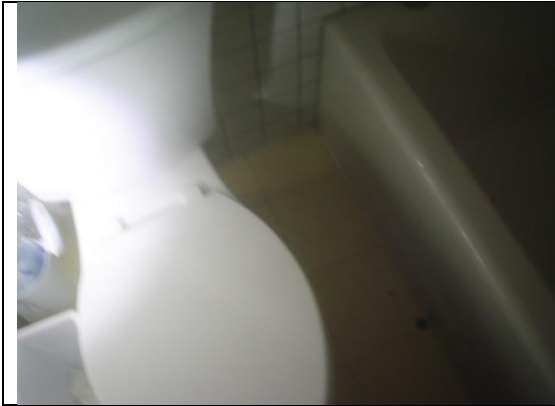
Fig.3

3 Finding: Evidence of moisture damage to the underlayment found at the downstairs hall bathroom floor. Indicated on the diagram by “3”, and some areas shown in Fig. images on the back pages of this report.

Recommendation: Remove floor covering and damaged underlayment as needed. Further inspect upon opening of enclosed areas. Install new underlayment and floor covering, reset toilet.

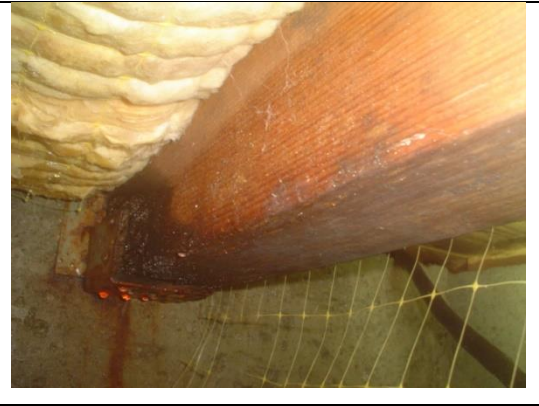
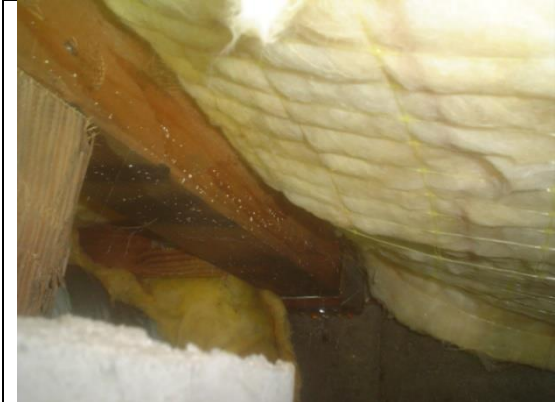
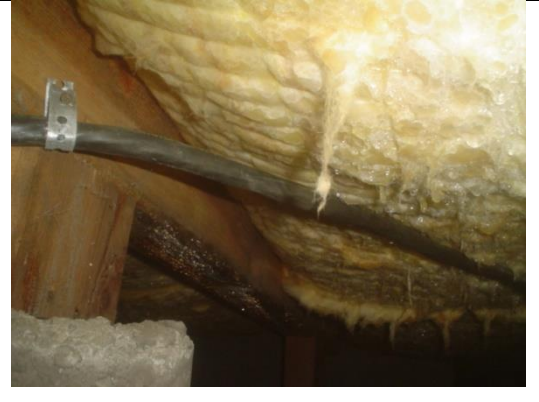
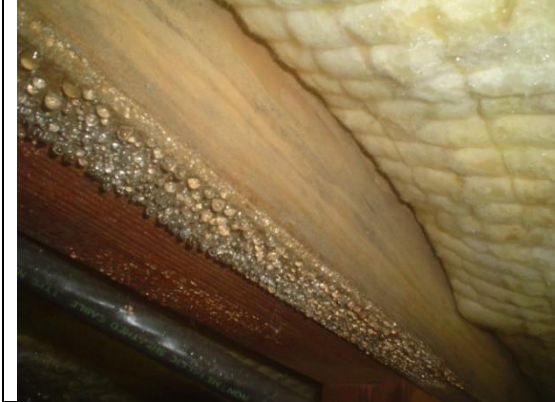
4 Finding: Fungi (wood-rot) damage found at floor joist. This timbers and insulation throughout this area of the subarea are excessively moist. Insulation is saturated in areas. These conditions appear to be due to inadequate ventilation. Indicated on the diagram by “4”, and some areas shown in Fig.4 images on the back pages of this report.

Recommendation: Owner should employ others to remove all insulation from these areas. Remove and replace fungi damaged material as needed. Install additional vent openings and/or forced ventilation system as needed to eliminate excessive moisture.

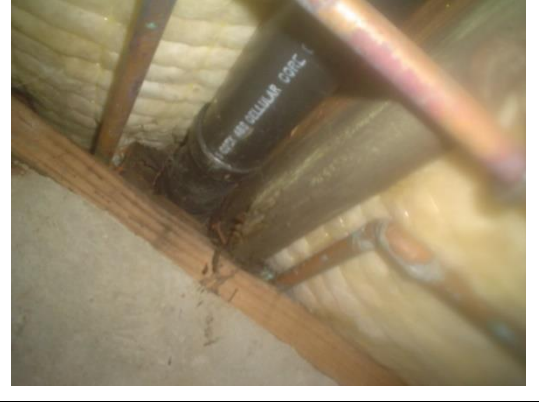
5 Finding: Fungi (wood-rot) damage found in the rim joist and floor joist under bathroom sink area. Indicated on the diagram by “5”, and some areas shown in Fig.5 images on the back pages of this report. ‘

Recommendation: Owner should employ others to remove and replace fungi damaged material as needed. It appears that the bathroom sink cabinet would need to be removed to access areas.

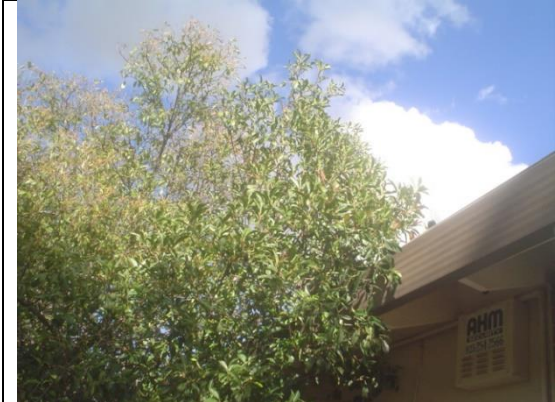
6 Finding: Tree branches are in contact with the structure. Indicated on the diagram by “6”, and some areas shown in Fig.6 images on the back pages of this report.

Recommendation: Owner should cut back tree branches as needed to eliminate contact with the structure.

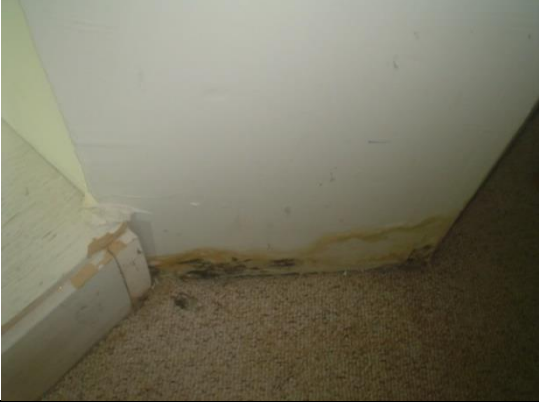
8 Finding: Discolored wallboard found at an upstairs closet wall. Indicated on the diagram by “8”, and some areas shown in Fig.8 images on the back pages of this report.

Recommendation: Remove discolored wallboard as needed to allow for further inspection. Further inspect. Replace removed wallboard upon completion.
