Property Inspection Report

Oscar & Rina Posadas
160 Shepard St.,
Hercules, Ca
c/o
Jackie Plata
Plata Realty Group

FILE # **FF082021-1**

DATE OF INSPECTION: **8/20/2021**

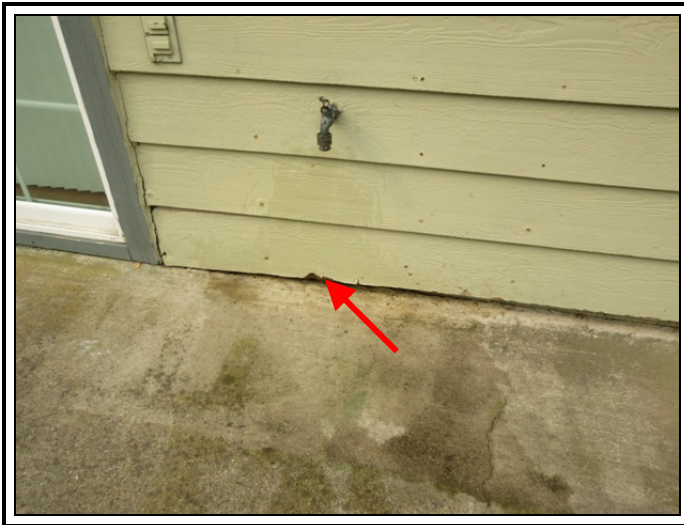
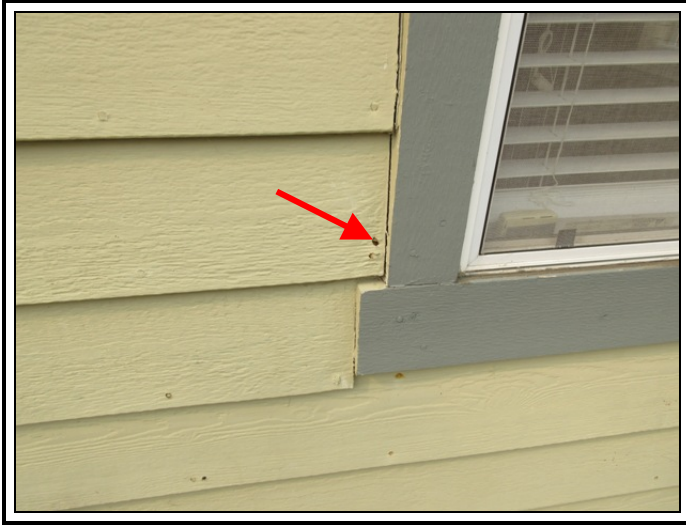
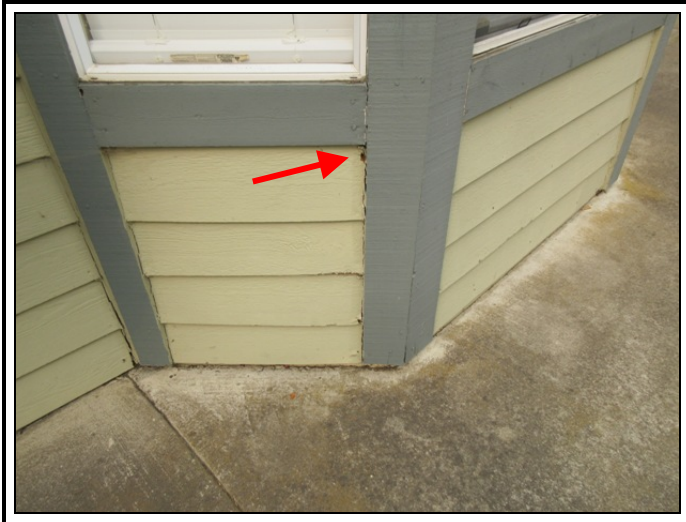
Deterioration of the wood siding is present at the rear area of the home. Refer to your pest report for comments in this area.

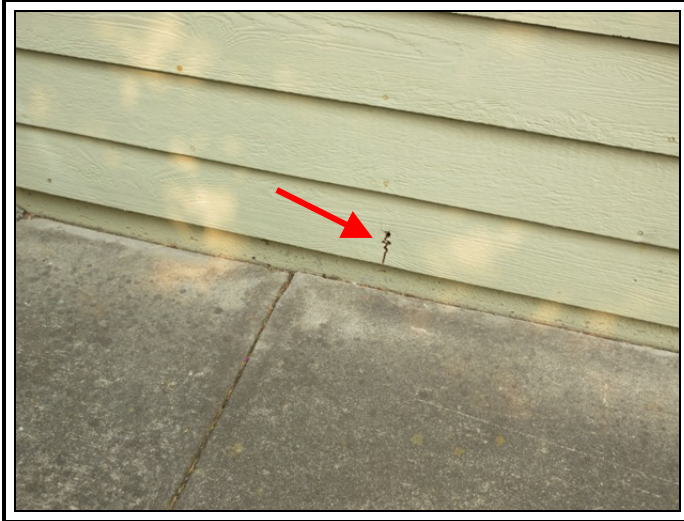
Deterioration of the wood siding is present at the right side area of the home. Refer to your pest report for comments in this area.

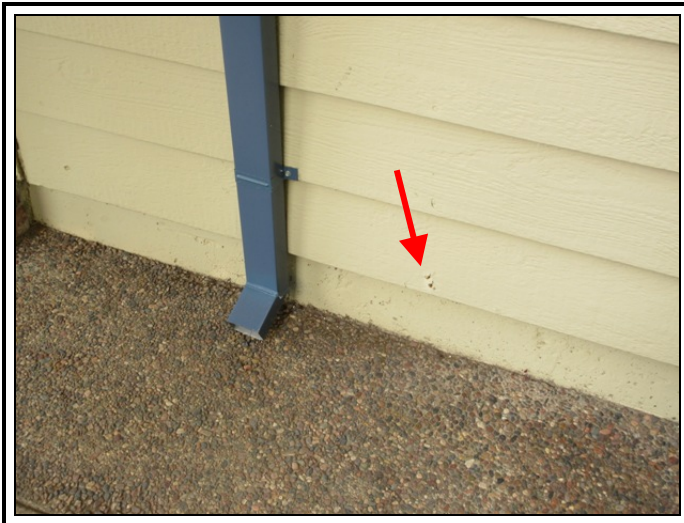
Deterioration of the wood siding is present at the front area of the home. Refer to your pest report for comments in this area.

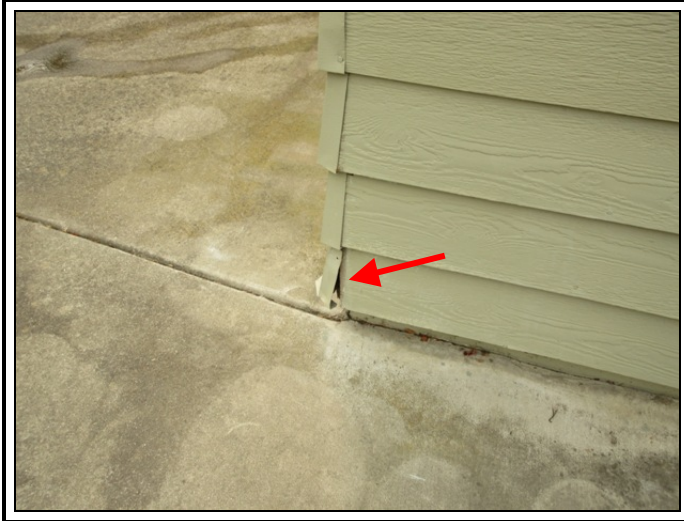
Damage of the siding corner trim piece is present at the rear of the home. Repair as needed.

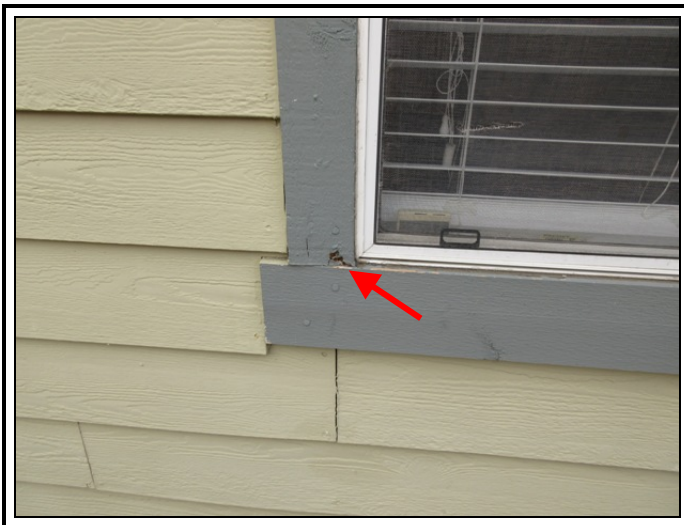
Deterioration of the wood trim is present at the left side area of the home. Refer to your pest report for comments in this area.

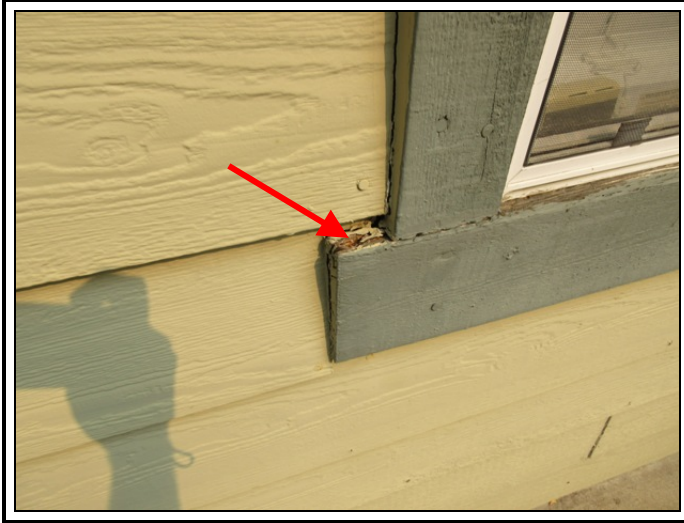
Deterioration of the wood trim is present at the right side area of the home. Refer to your pest report for comments in this area.

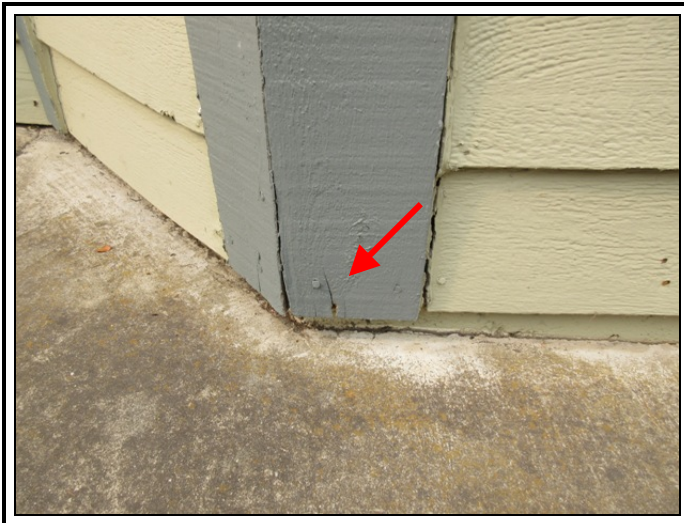
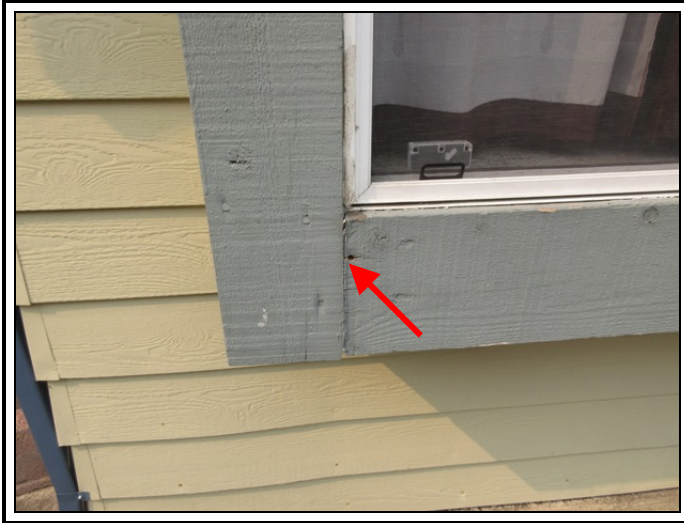
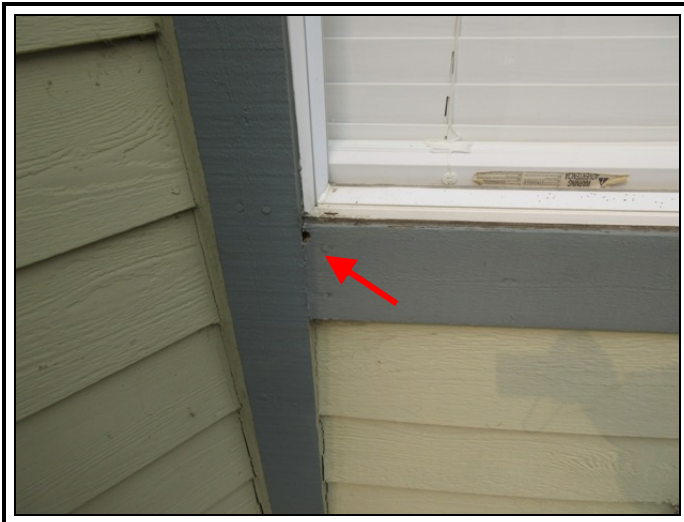
Deterioration of the wood trim is present at the rear area of the home. Refer to your pest report for comments in this area.

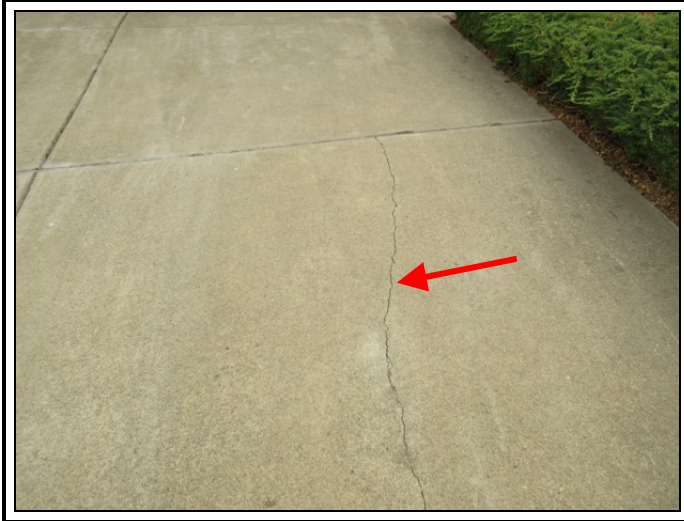
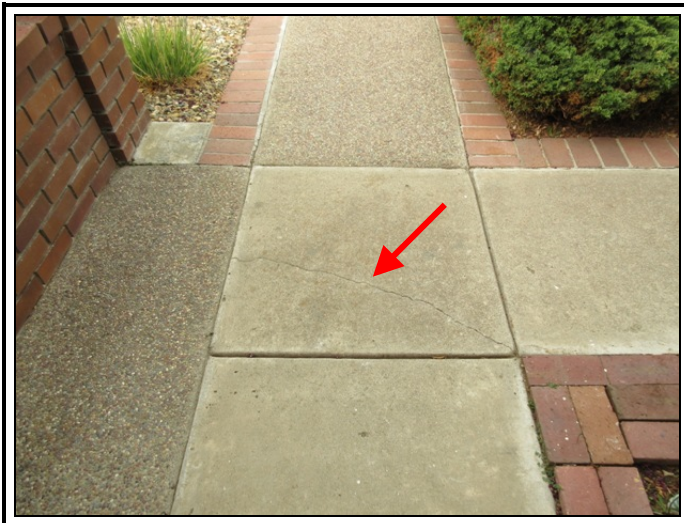
Driveway / Walkway - Cracking has occurred in the driveway and walkways. Cracking should be filled / sealed to prevent the collection of moisture below the surface.

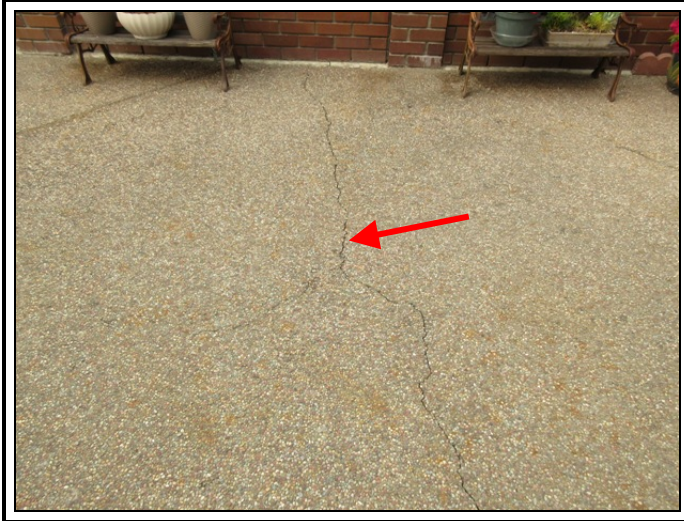
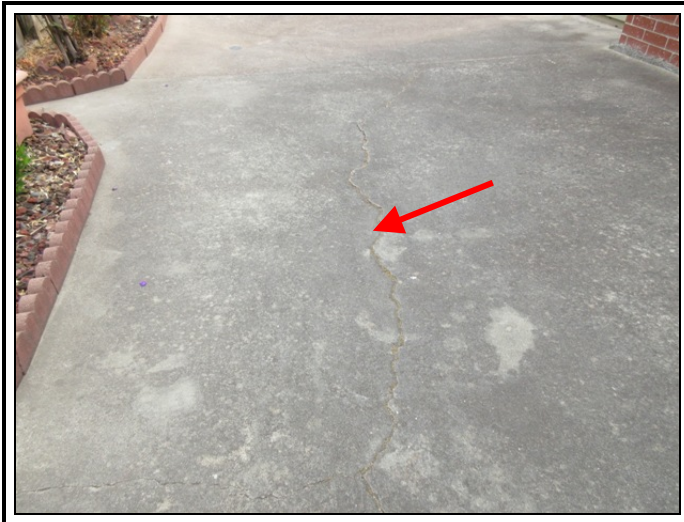
Patio / Porch - The concrete surfaces of the front and rear patios have cracked. Cracks of this type should be filled / sealed to prevent the collection of moisture below the concrete surface.

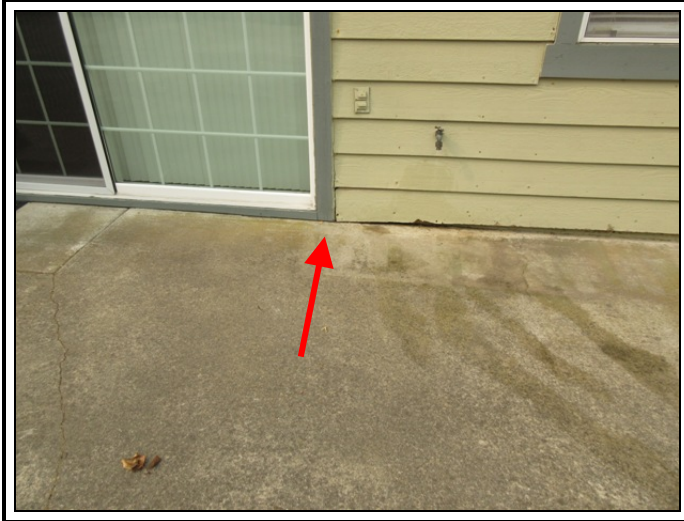
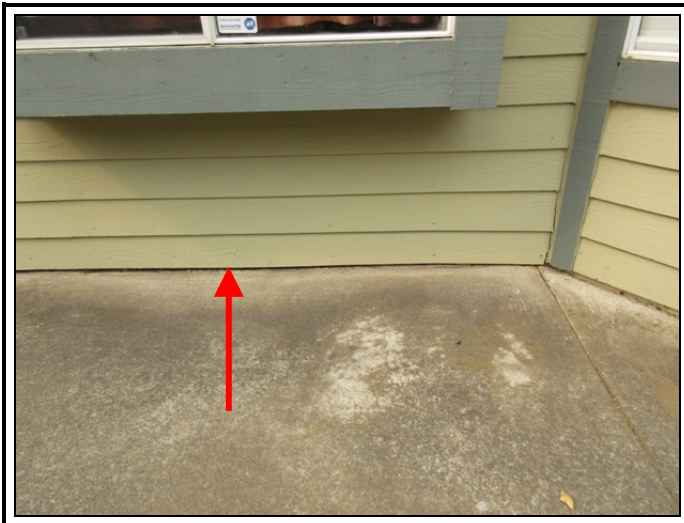
The rear patio was poured up to the weep screed. Generally a 2" clearance is maintained between the weep screed and the concrete.

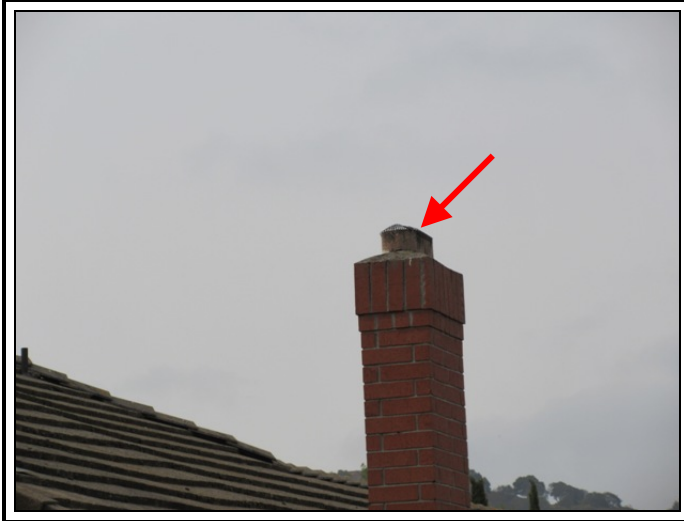
The installation of a certified spark arrestor with a rain cap assembly is recommended.

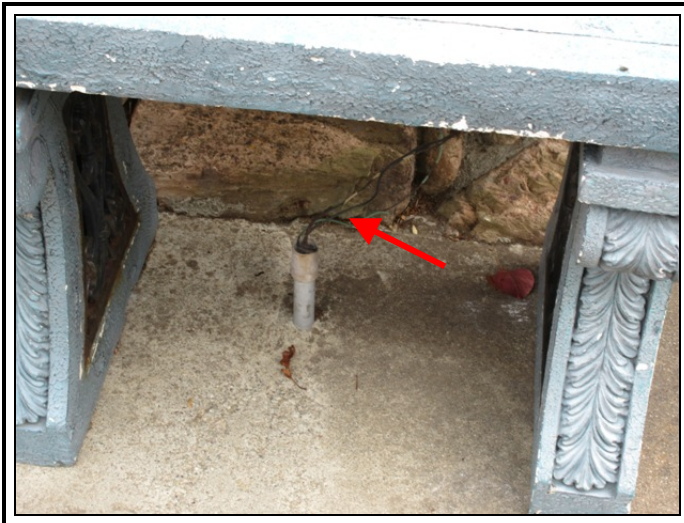
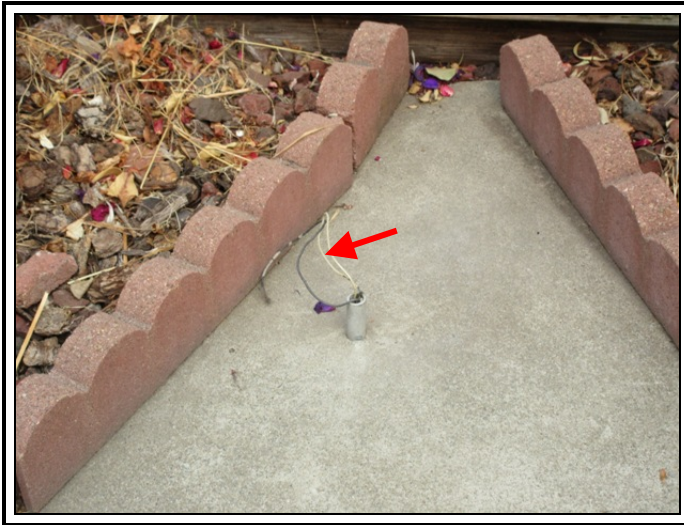
Unsafe Wiring – The electrical wiring located in the rear of the home is not properly terminated. Proper termination within a covered junction box is needed for safety.

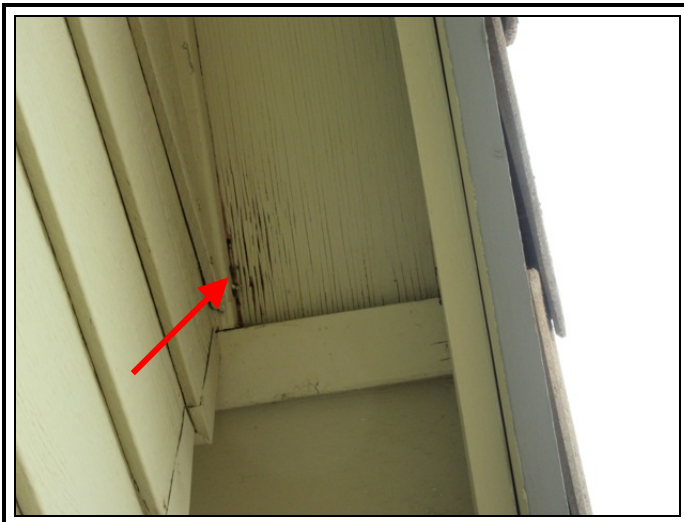
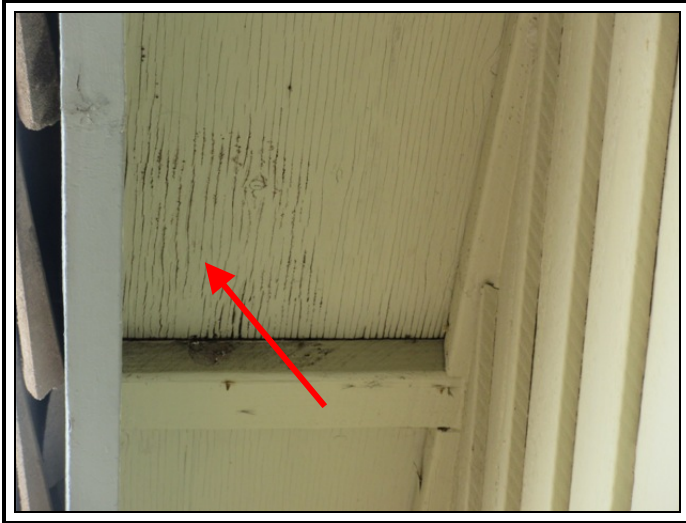
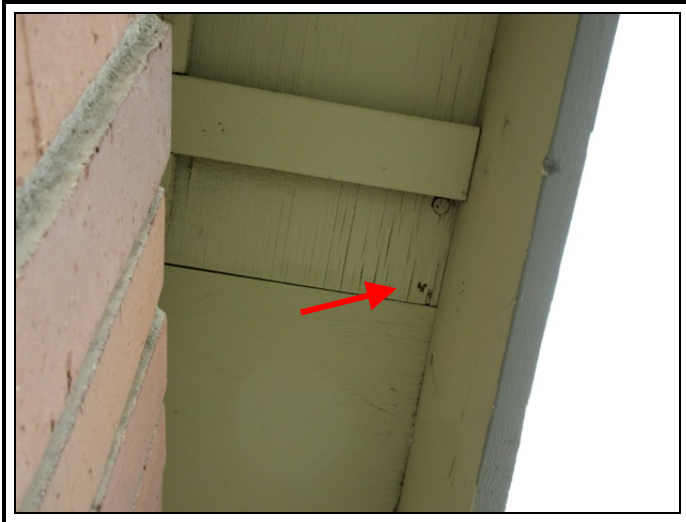
Deterioration was noted in the roof sheeting at the front of the home. Refer to your pest report for comments in this area.

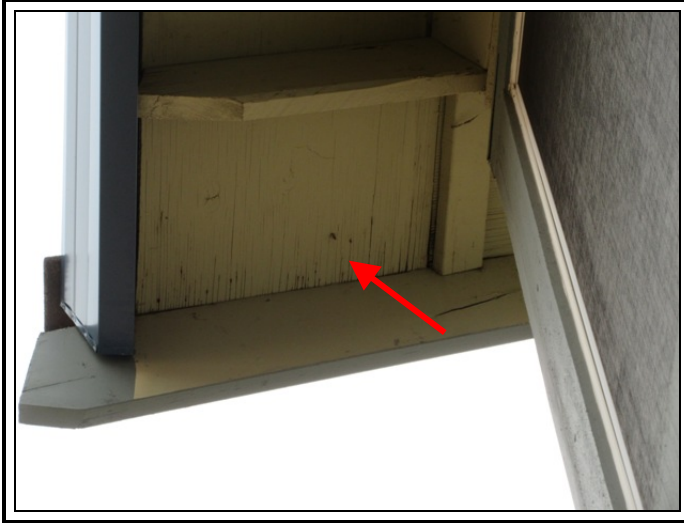
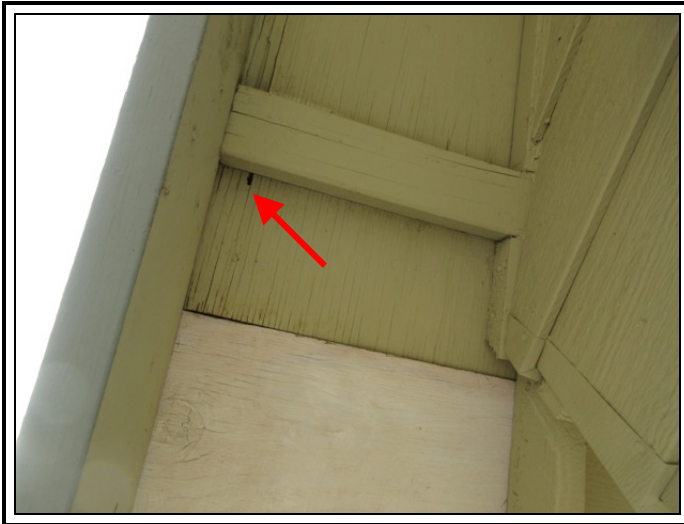
Deterioration was noted in the roof sheathing at the rear of the home. Refer to your pest report for comments in this area.

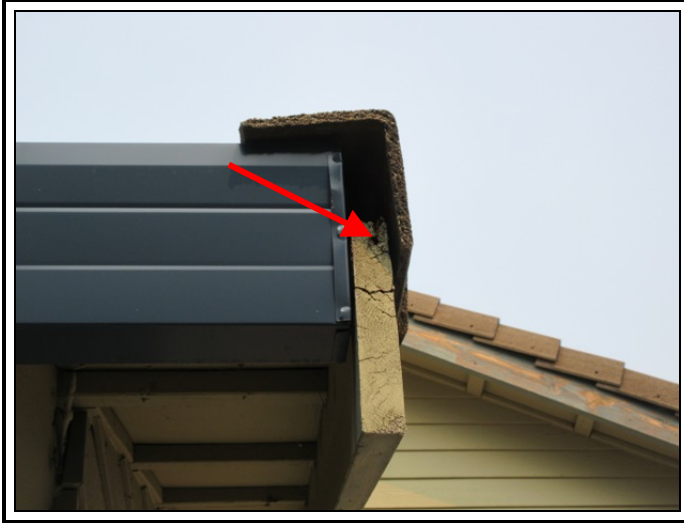
Deterioration was noted in the barge rafter at the right side of the home. Refer to your pest report for comments in this area.

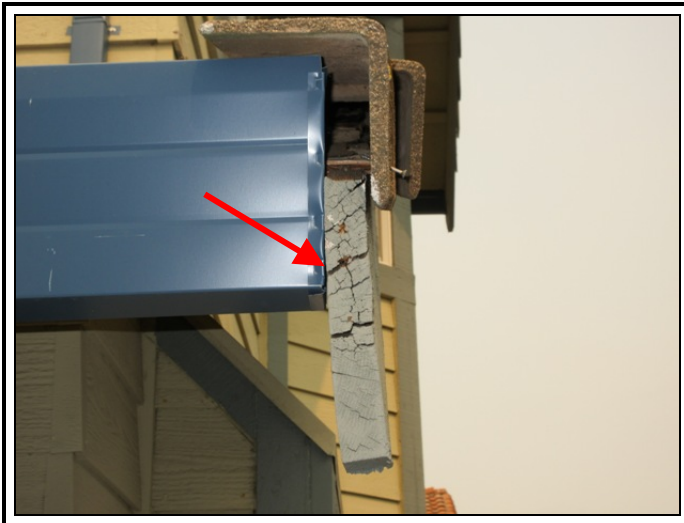
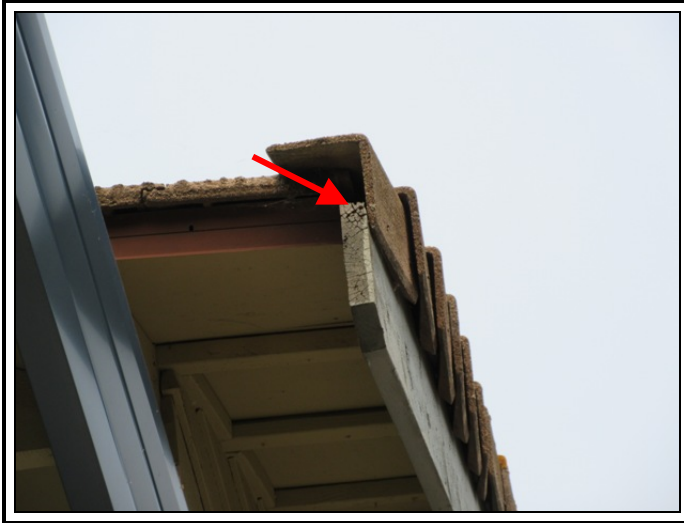
Deterioration was noted in the barge rafter at the rear of the home. Refer to your pest report for comments in this area.

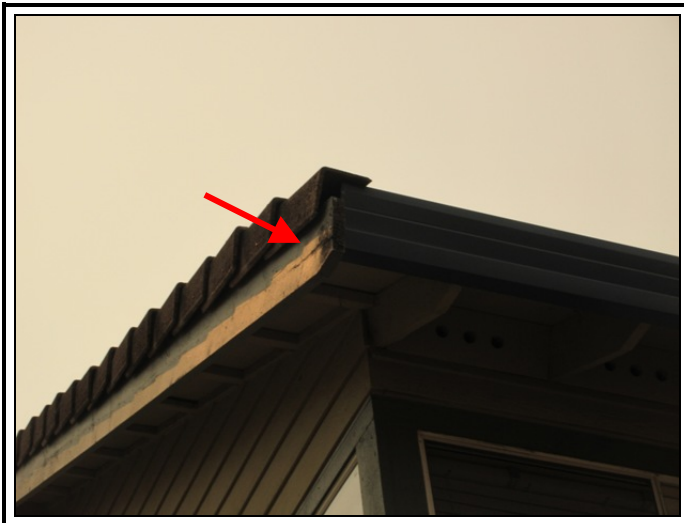
Deterioration was noted in the barge rafter at the left side of the home. Refer to your pest report for comments in this area.

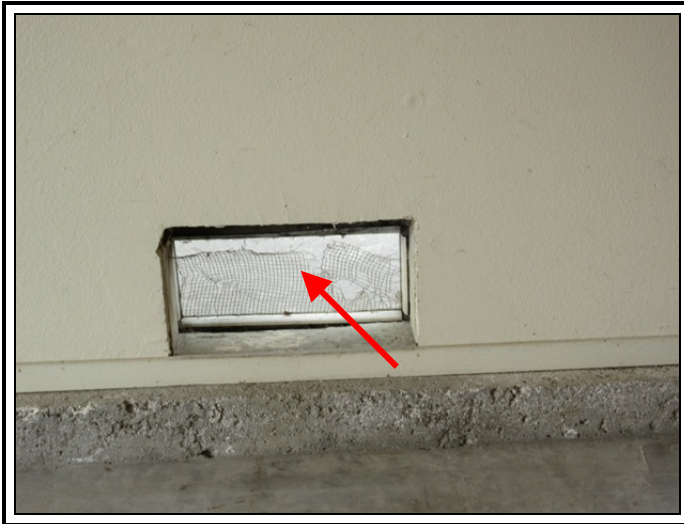
Vent screen(s) are in need of repair or replacement.

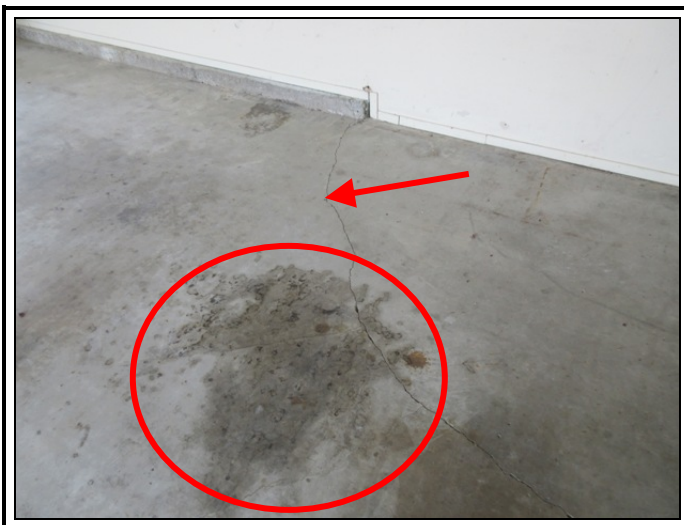
The concrete floor area is oil stained. This condition can pose a tripping or falling hazard. Removal of a stain of this type should be done by a professional.

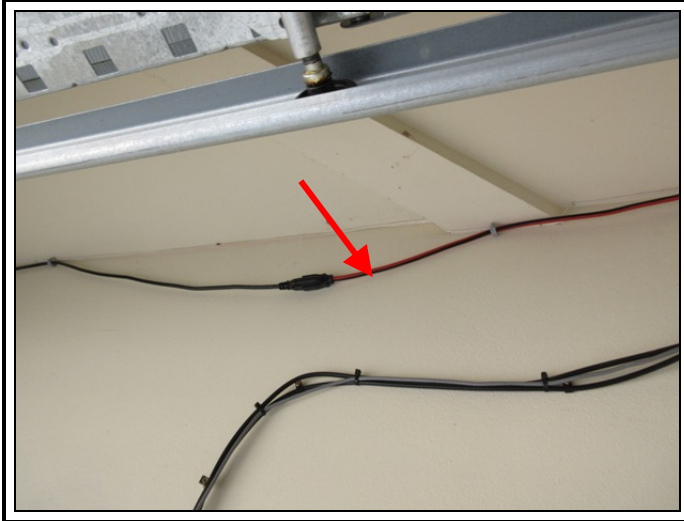
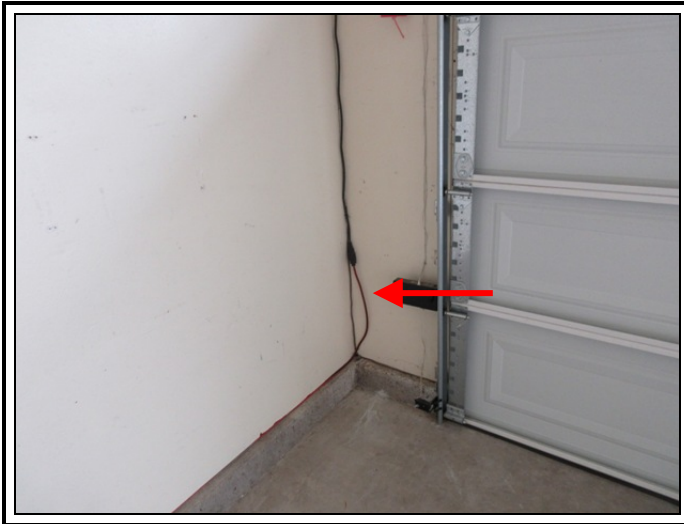
Power to the garage door openers is supplied via extension cords. This type of wiring was not designed for permanent use. The installation of a dedicated outlet at the unit is recommended.

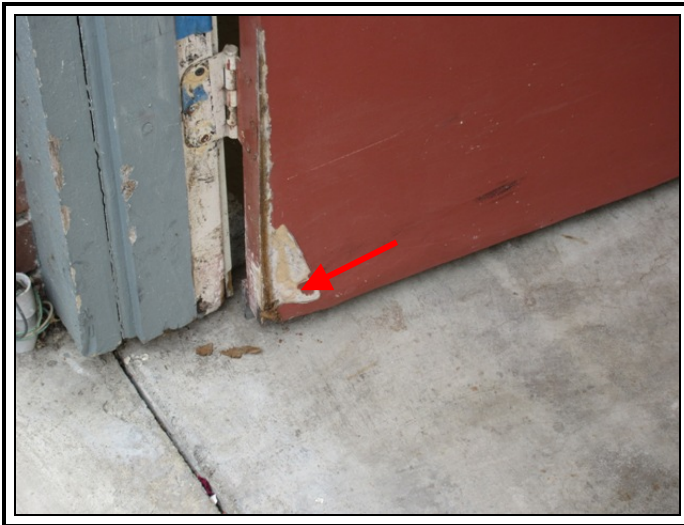
Pedestrian / Man Door – The pedestrian or man door is deteriorated. Replacement is recommended. Refer to your pest report for comments in this area.

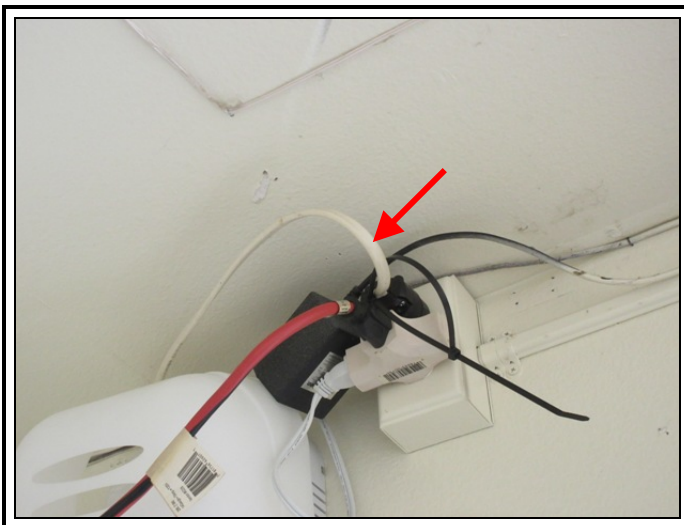
Unsafe Wiring – The romex electrical wiring located at the ceiling has had a plug installed and used as an extension or appliance cord. This type of wiring is not designed for this use. Proper hard wiring or removal is needed for safety. A qualified electrician should make the needed corrections.

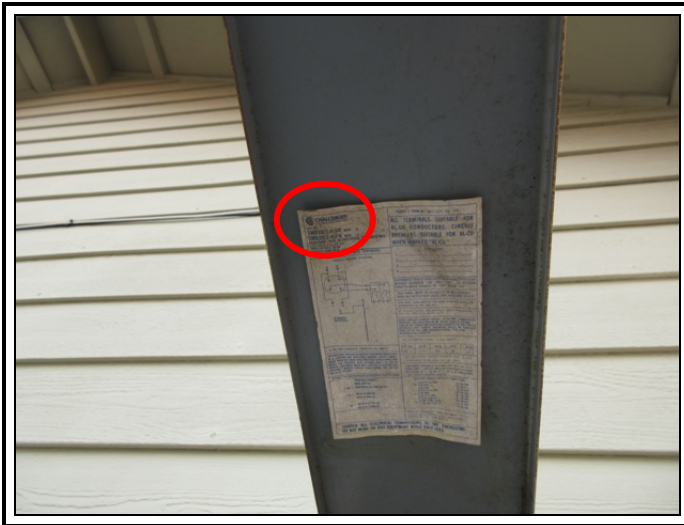
The electrical main panel is one of the older Zinsco panels. These panels were very popular during the late 60's through the late 70's. Breakers in these panels have come under question regarding their ability to trip under a normal over load condition. It is also know that these panels can contain buss bars that corrode and can cause over heating of the circuit breakers. Zinsco / Challenger panels are not internally evaluated. An electrician should be obtained.

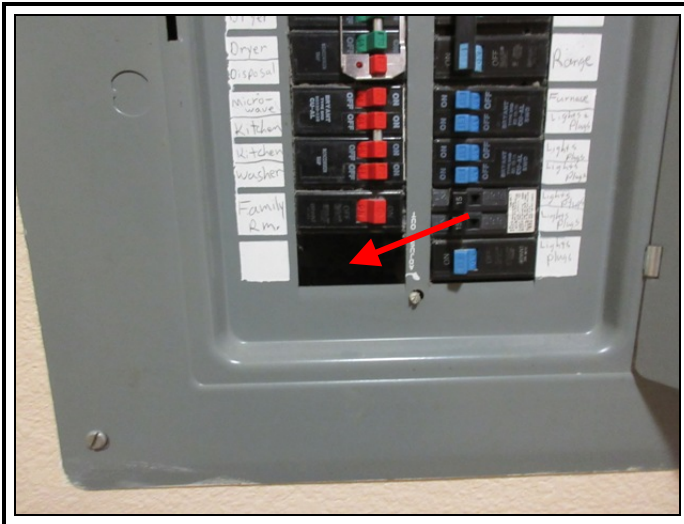
The electrical sub panel is in need of repair. Breakers and or blank plates have been removed exposing the buss bar and or live wires within this sub panel. A qualified electrician should make this correction as a safety measure.

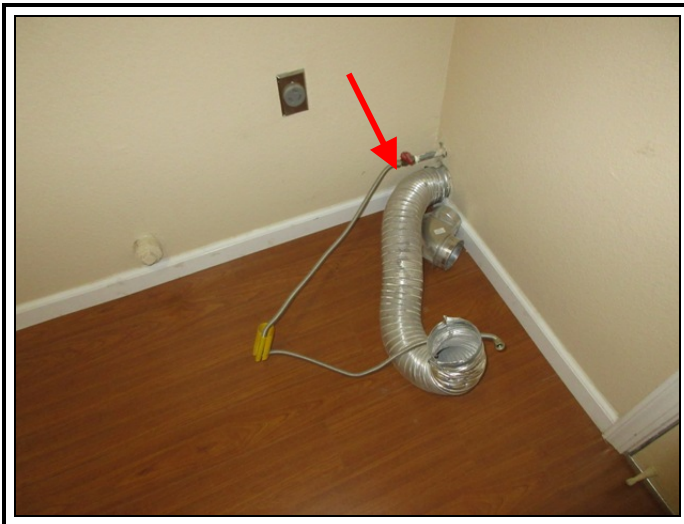
Proper capping of the open gas line is needed for safety.

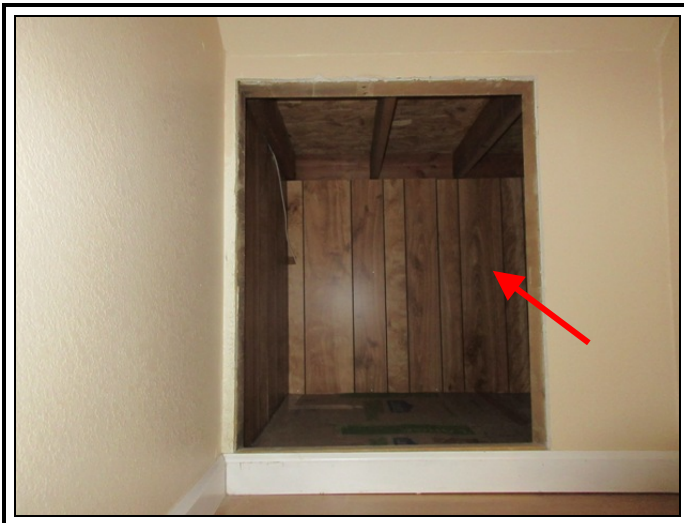
Walls – A hole in the wall was noted at the rear of the closet accessing the area beneath the stairs. This void is in need of repair for fire safety.

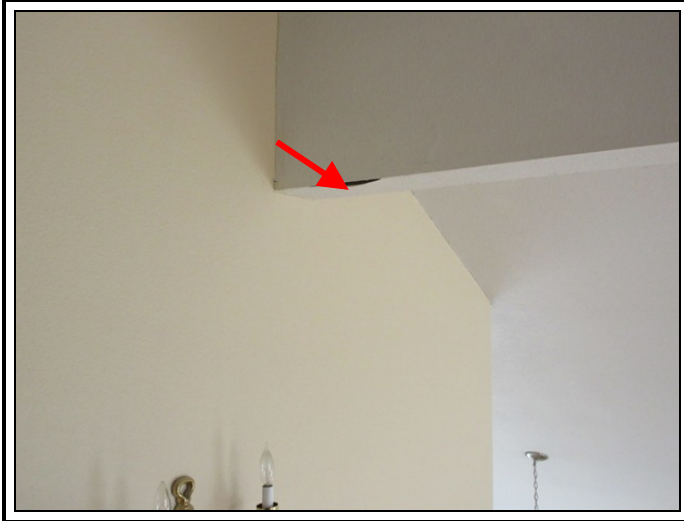
Ceiling – Cracking was noted in this area of the home. Cracking should be properly repaired as needed.

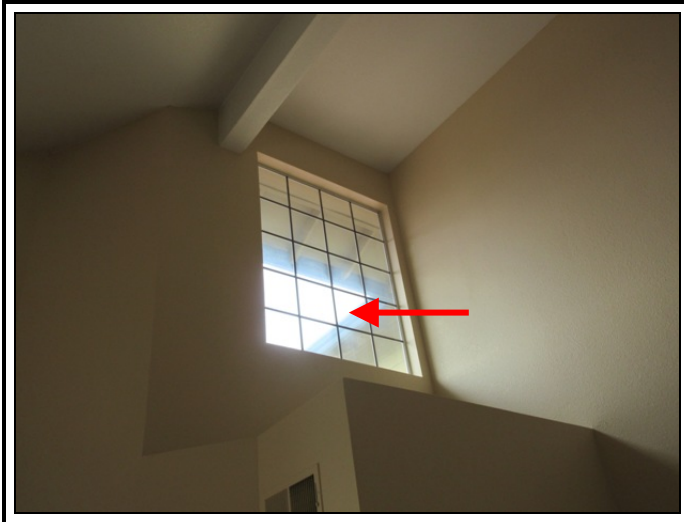
Windows – The seal that divides the two panes of glass has failed allowing moisture to collect between the two panes. Replacement is likely, as repairs of this type are generally not successful.

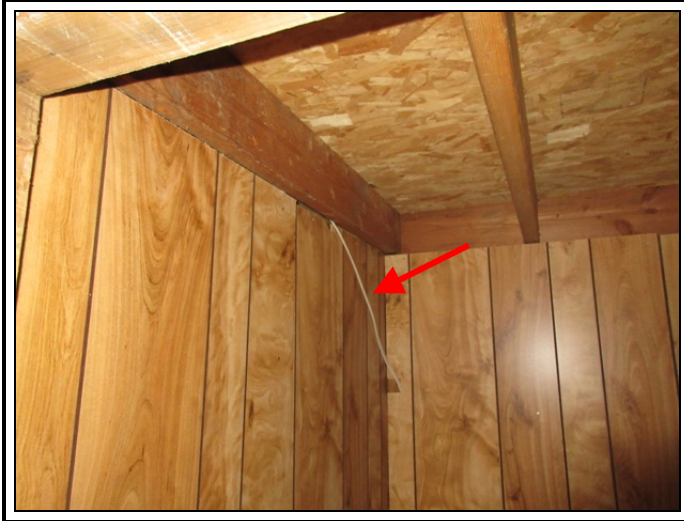
Closet - Unsafe Wiring – Exposed romex type wiring is visible within the closet. Wiring in this location must be protected or enclosed in a conduit type material for electrical safety.

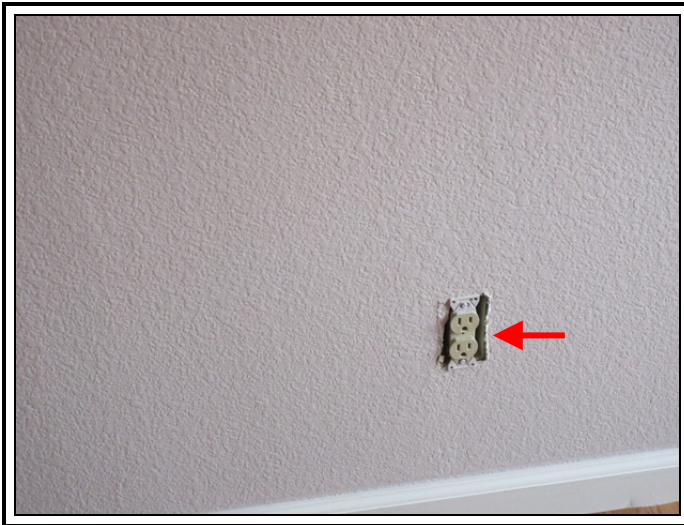
Outlets – Replacement of the broken outlet cover(s) is needed for safety.

Replacement of the missing outlet cover(s) is needed for safety.

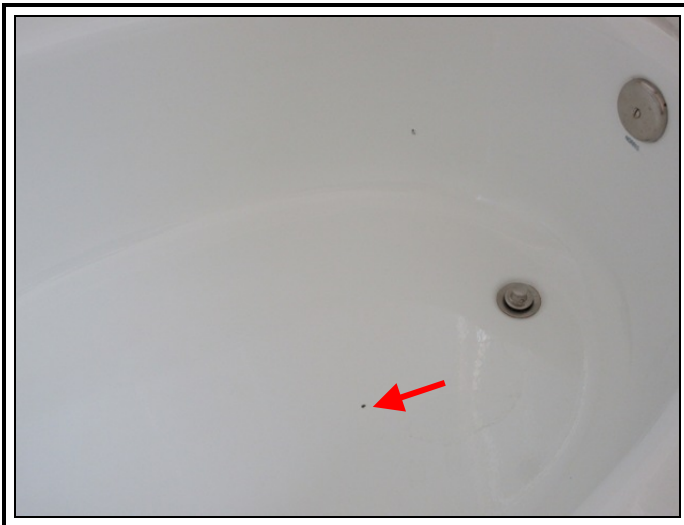
Tub - Chips in the finish material of the tub were visible.

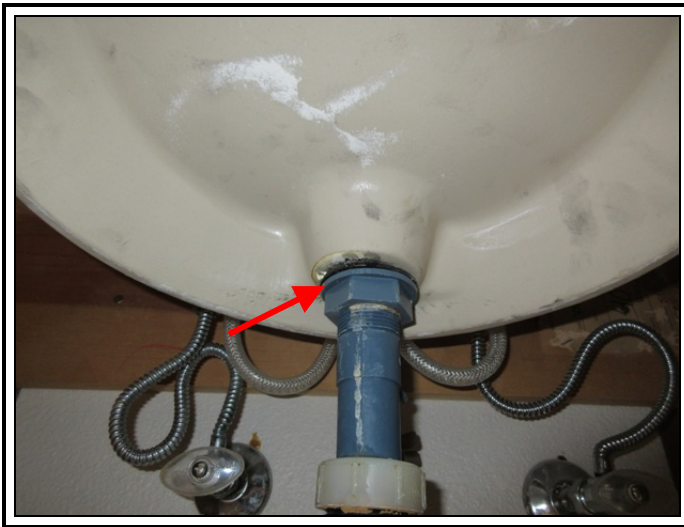
The drainage piping below the left side sink was leaking. Repair is needed.

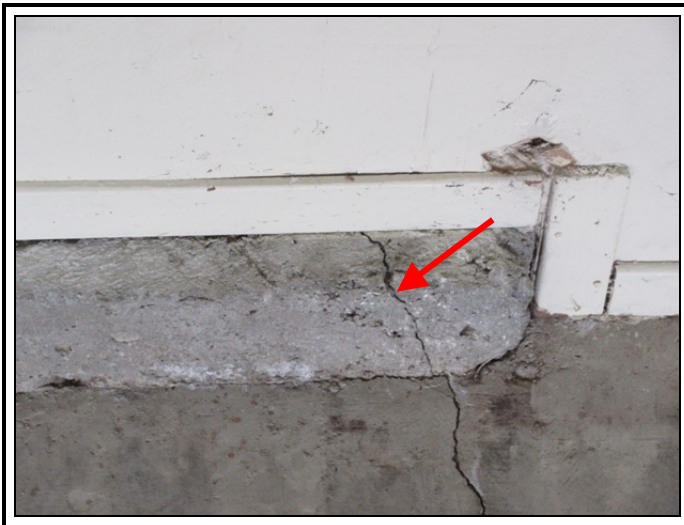
Cracking was noted in the foundation at the garage area. Cracking noted in a slab can or may become larger and should be monitored. Soil conditions, drainage and settling all play a part in foundation conditions.
