Accurate

HOME INSPECTIONS

Property Inspection Report

Walt & Lisa Eckhoff
943 Stillspring Ct.,
Vacaville, Ca
c/o
Jackie Plata
Plata Realty Group

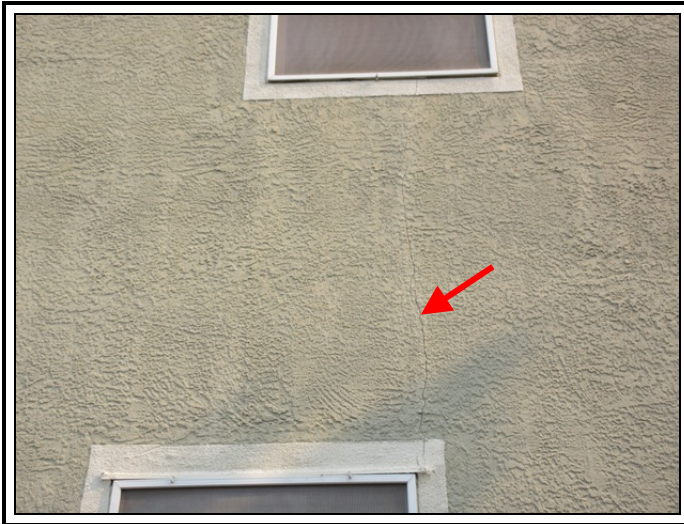
The cracking located in the left side area is in need of sealing.

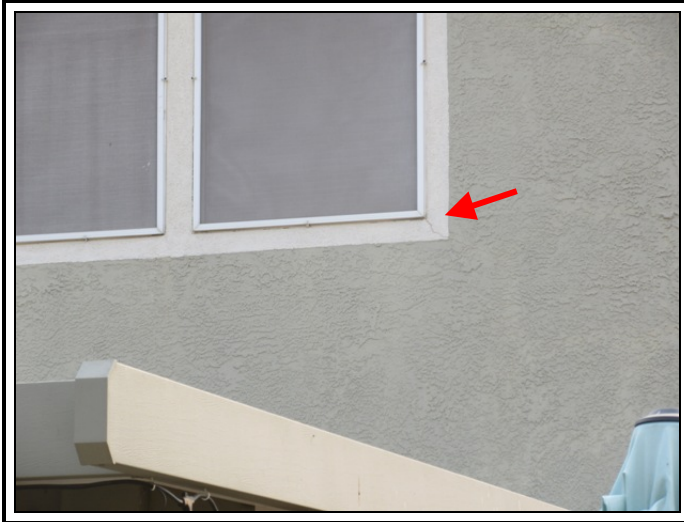
The cracking located in the rear area is in need of sealing.

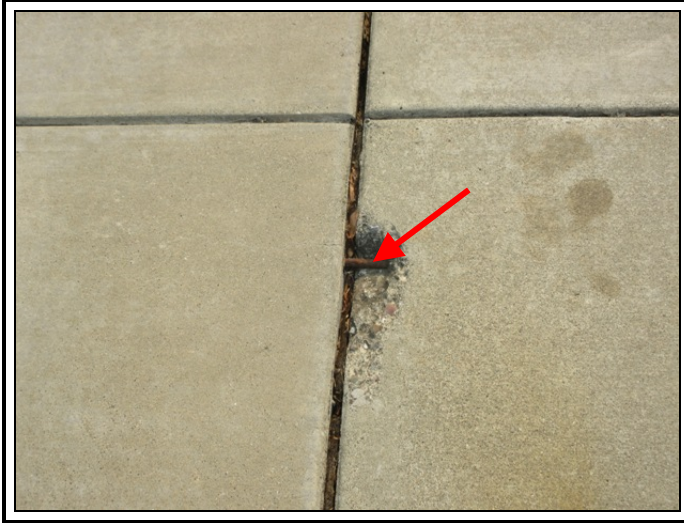
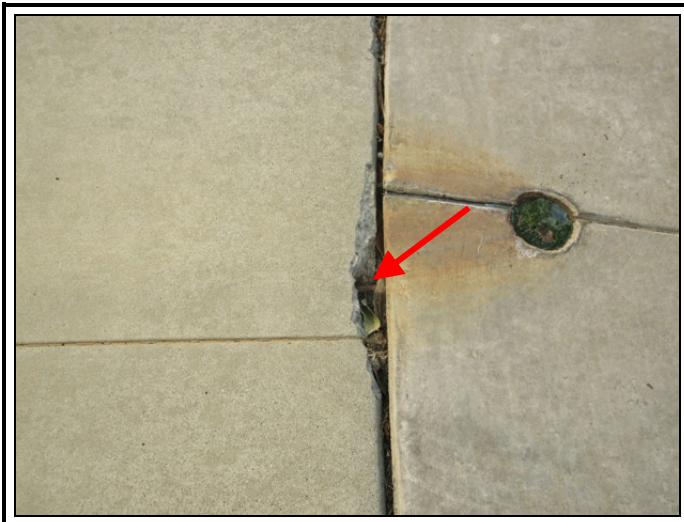
Driveway / Walkway - The driveway has cracked and chipped leaving large voids. These voids should be repaired, filled / sealed to prevent water from collecting below the concrete surface. This area should also be monitored for further movement.

Exposed re-bar was visible at the driveway. This condition can cause rust and expansion to the rebar, causing further concrete damage. Re-bar should be treated and repaired. Contact a licensed contractor for corrections in this area.

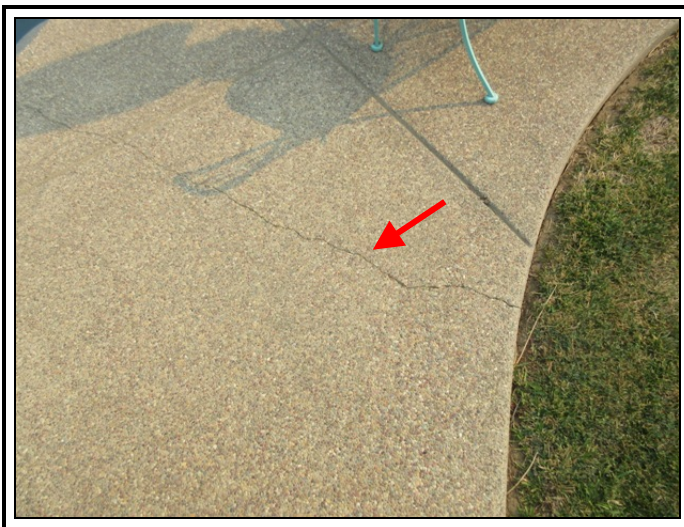
Patio / Decks / Porch - The concrete surface of the patio has cracked. Cracks of this type should be filled / sealed to prevent the collection of moisture below the concrete surface.

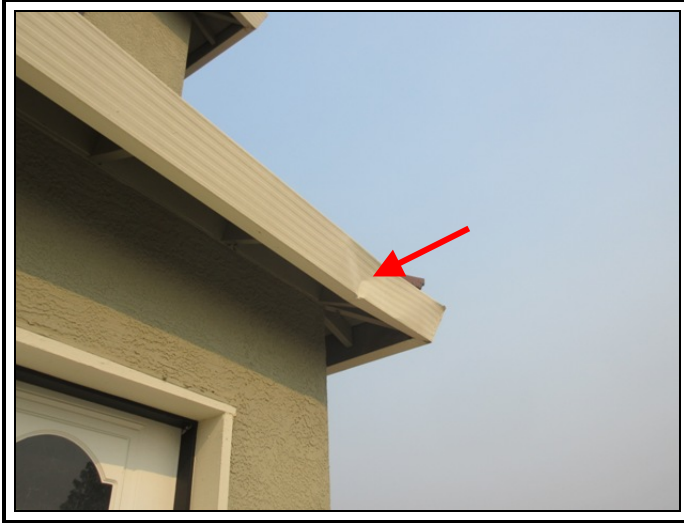
The gutter over the front is in need of repair or replacement. Contact a qualified sheet metal contractor for needed corrections.

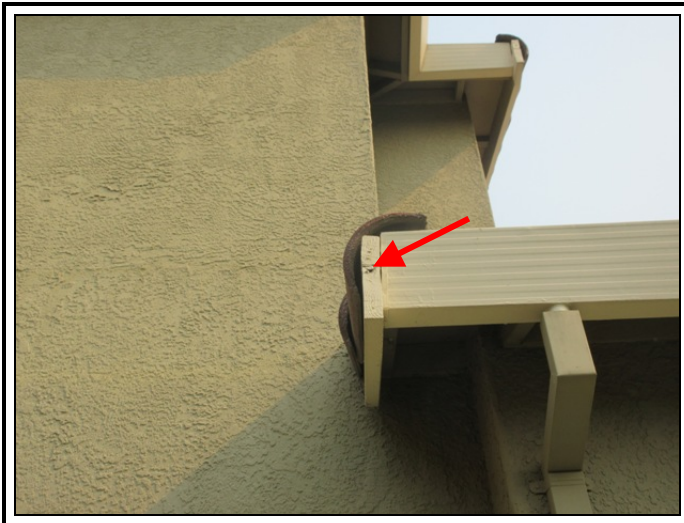
Over Hang / Eaves / Fascia - Deterioration was noted in the barge rafter at the front of the home. Refer to your pest report for comments in this area.

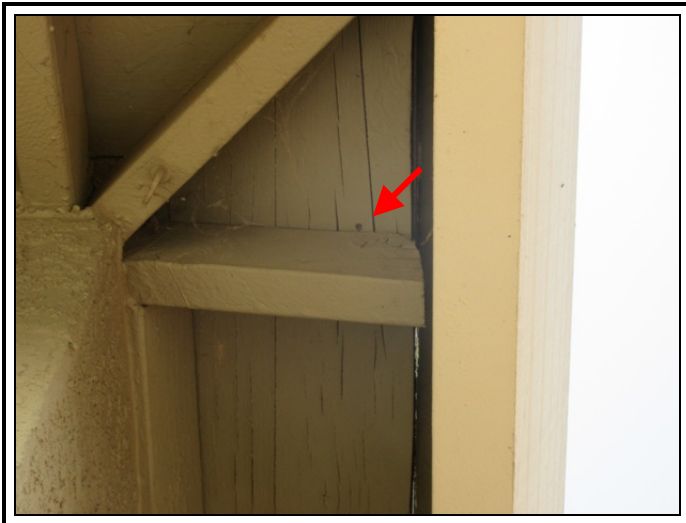
Deterioration was noted in the roof sheathing at the front of the home. Refer to your pest report for comments in this area.

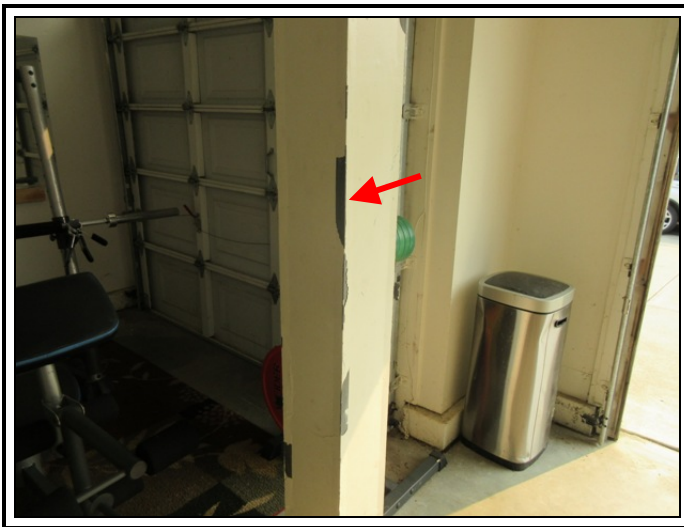
Walls – Physical damage to the post was noted. Repair as needed.

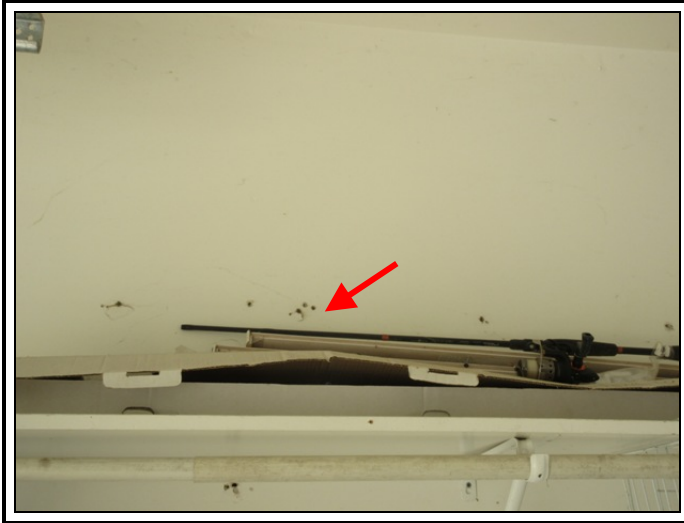
The wall between the garage and the living area makes up part of the fire protection for this home. The voids located on the left side will need to be repaired for fire safety.

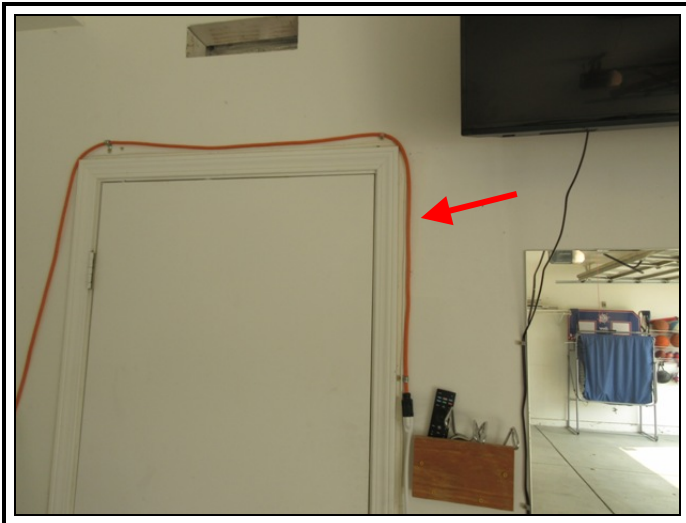
Unsafe Wiring – Wiring was installed with the use of an extension cord. This type of wiring was not designed for permanent use. Proper hard wiring is recommended.

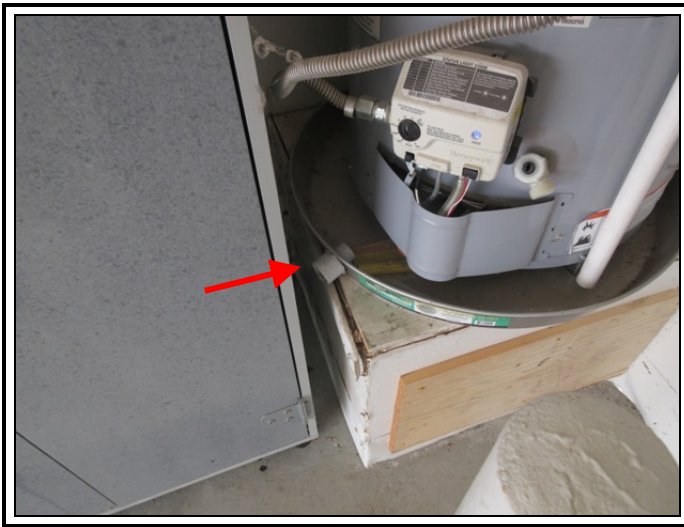
The water heater does sit on a collection pan.

The addition of a drip leg from the collection pan to the floor is recommended

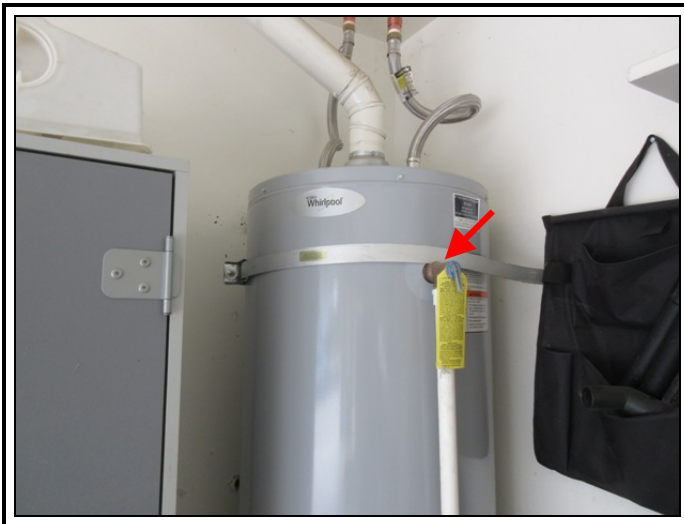
The upper strap is too close to the TMP valve. Adjustment is needed.

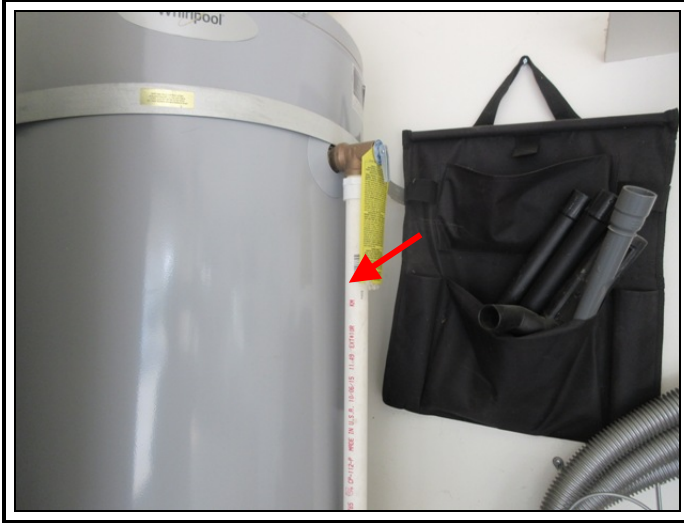
The drip leg for this valve should be plumbed to the exterior of the building using ¾" copper, galvanized or CPVC piping material. PVC is not permitted.

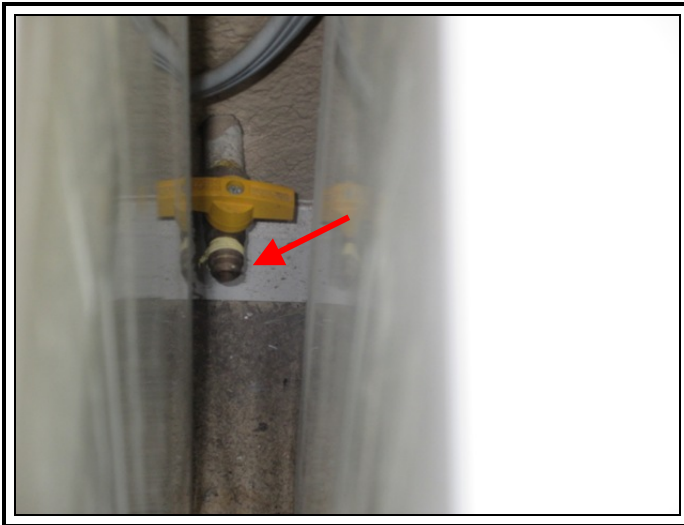
Proper capping of the open gas line is needed for safety.

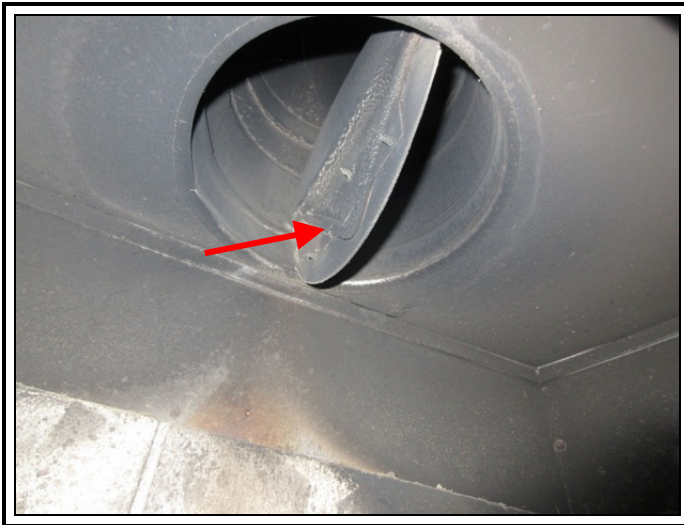
A damper stop is not installed. The installation of a damper stop is needed to prevent a gas accumulation within the firebox.

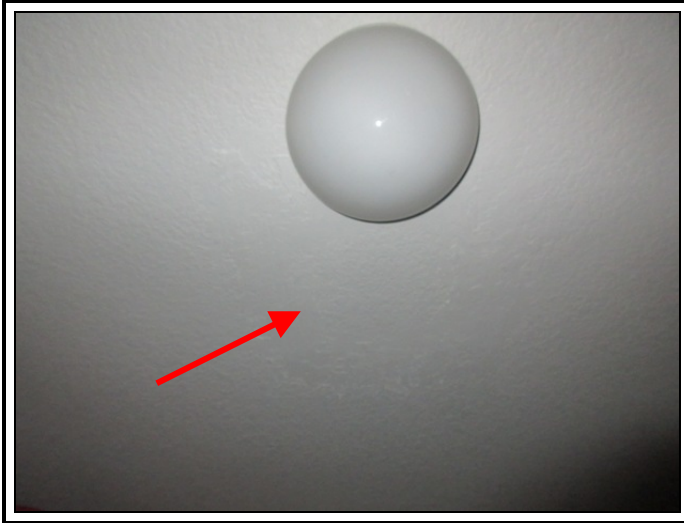
Ceiling – Previous repairs were noted within the closet area.

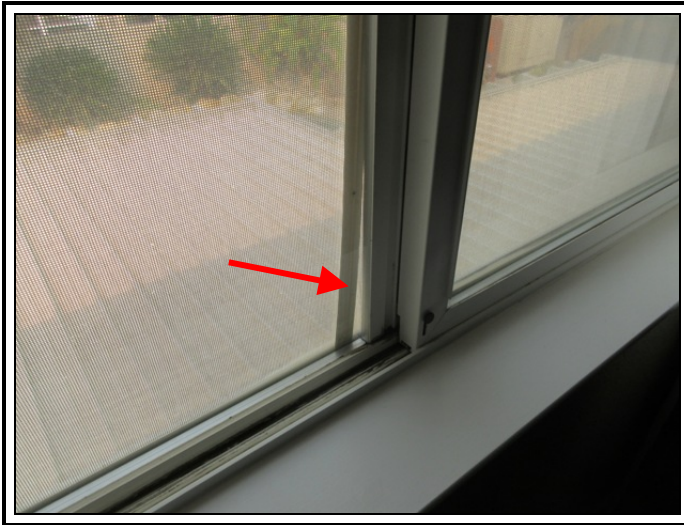
Windows - The exterior vinyl window trim is in need of repair.
