**Report #:** 73100

**Service Address:** 160 Shepard Street, Hercules, CA 94547

# WOOD DESTROYING PESTS AND ORGANISMS INSPECTION REPORT

Building No: 160	Street : Shepard Street	City : Hercules	Zip : 94547	Inspection Date : 08/04/2021	Page : 1/13
---------------------	----------------------------	--------------------	----------------	---------------------------------	----------------

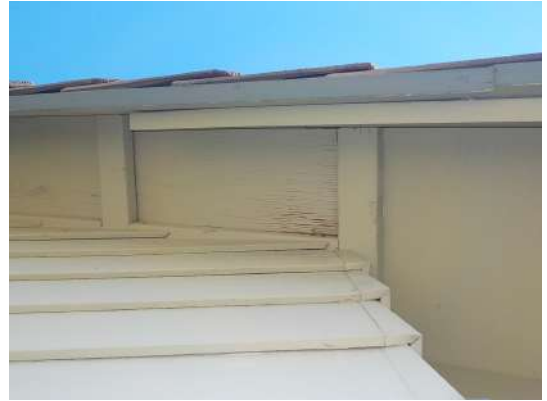
3A:

3A. FINDING: THERE IS EVIDENCE OF WOOD DECAY FUNGI (DRY ROT) DAMAGE AT THE 1ST STORY PLYWOOD SHEATHING OF THE ROOF OVERHANG.

RECOMMENDATION: REMOVE THE ROOF COVERING TO EXPOSE THE DAMAGED AREAS IF NECESSARY. REMOVE ALL STRUCTURALLY DAMAGED WOOD MEMBERS AND REPLACE WITH NEW MATERIAL. APPLY TIMBOR (ACTIVE INGREDIENT, DISODIUM OCTABORATE TETRAHYDRATE) ADJACENT TO THE INFECTED AREAS FOR THE CONTROL OF WOOD DECAY FUNGI AS NECESSARY. INSTALL ROOF COVERING TO THE EXPOSED AREAS ONLY. GUARANTEE APPLIES TO ROOF COVERING IN REPAIRED AREAS ONLY.

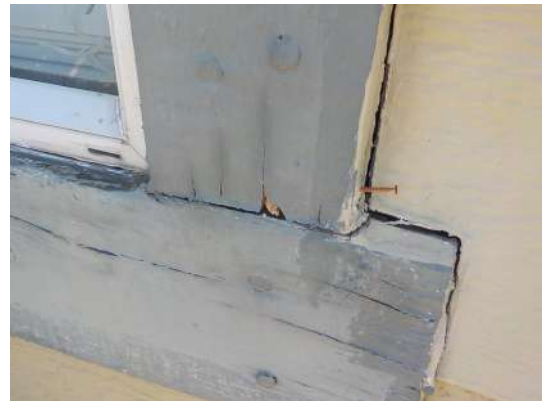
3B:

THERE IS WOOD DECAY FUNGI (DRY ROT) DAMAGE AT THE 2X4/2X6 TRIM .

REMOVE ALL DAMAGED WOOD AND REPLACE WITH NEW MATERIAL. APPLY TIMBOR (ACTIVE INGREDIENT, DISODIUM OCTABORATE TETRAHYDRATE) TO THE ADJACENT INFECTED AREAS AS NECESSARY FOR THE CONTROL OF WOOD DECAY FUNGI (DRY ROT).

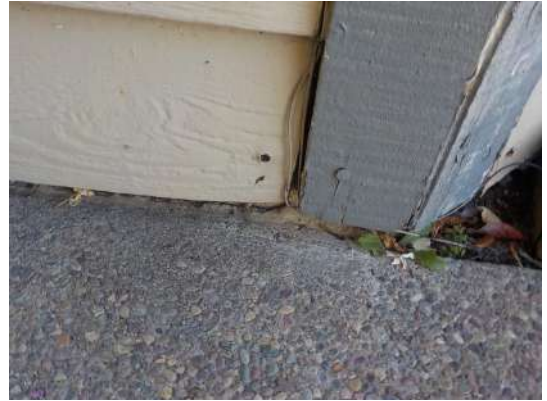
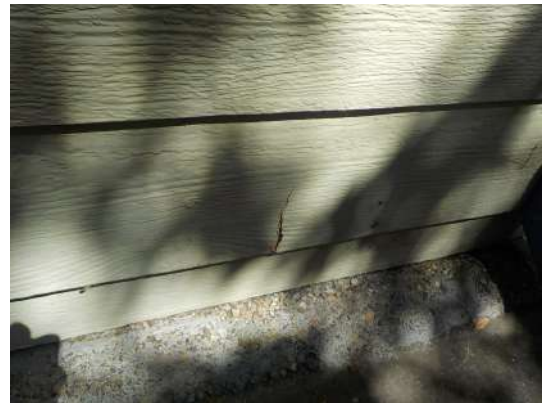
3C:

THERE IS WOOD DECAY FUNGI (DRY ROT) DAMAGE AT THE PRESSBOARD SIDING .

REMOVE ALL DAMAGED WOOD AND REPLACE WITH NEW MATERIAL. APPLY TIMBOR (ACTIVE INGREDIENT, DISODIUM OCTABORATE TETRAHYDRATE) TO THE ADJACENT INFECTED AREAS AS NECESSARY FOR THE CONTROL OF WOOD DECAY FUNGI (DRY ROT).

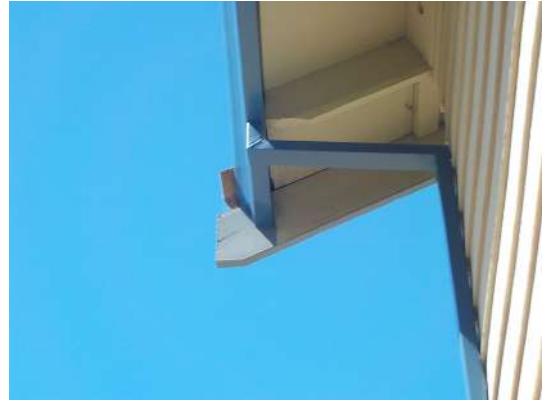
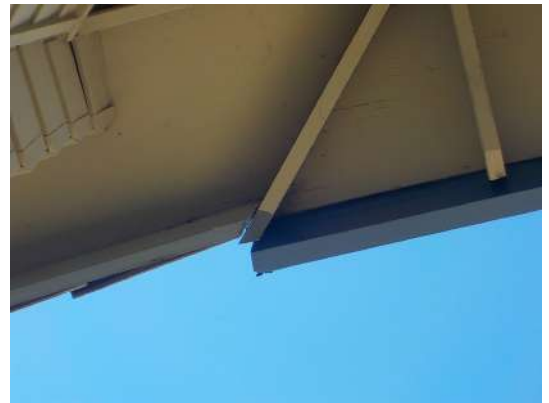
3D:

THERE IS EVIDENCE OF WOOD DECAY FUNGI (DRY ROT) DAMAGE AT THE 2ND STORY PLYWOOD SHEATHING OF THE ROOF OVERHANG.

REMOVE THE ROOF COVERING TO EXPOSE THE DAMAGED AREAS IF NECESSARY. REMOVE ALL STRUCTURALLY DAMAGED WOOD MEMBERS AND REPLACE WITH NEW MATERIAL. APPLY TIMBOR (ACTIVE INGREDIENT, DISODIUM OCTABORATE TETRAHYDRATE) ADJACENT TO THE INFECTED AREAS FOR THE CONTROL OF WOOD DECAY FUNGI AS NECESSARY. INSTALL ROOF COVERING TO THE EXPOSED AREAS ONLY. GUARANTEE APPLIES TO ROOF COVERING IN REPAIRED AREAS ONLY.

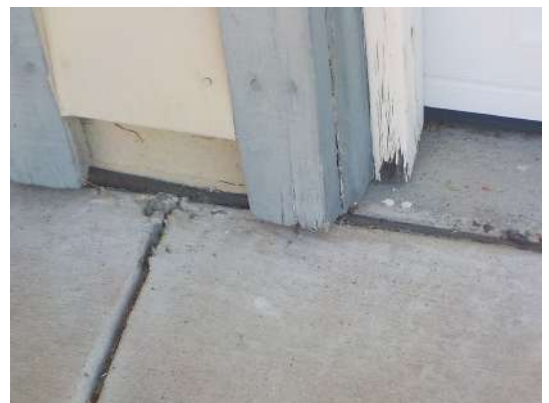
3E:

THERE IS EVIDENCE OF WOOD DECAY FUNGI (DRY ROT) AT THE 2X4 TRIM .

CUT BACK TO SOUND WOOD TO CORRECT THE CONDITION. APPLY TIMBOR (ACTIVE INGREDIENT, DISODIUM OCTABORATE TETRAHYDRATE) ADJACENT TO THE INFECTED AREAS FOR THE CONTROL OF WOOD DECAY FUNGI AS NECESSARY.

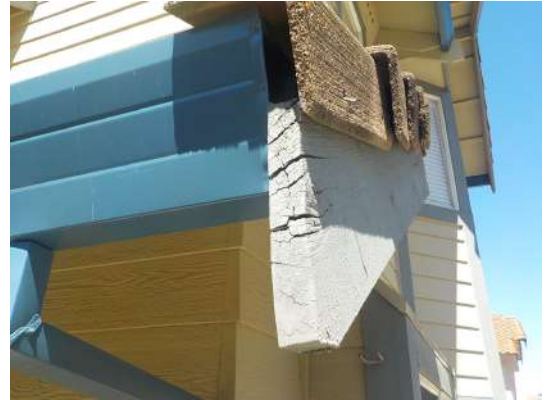
3F:

THERE IS WOOD DECAY FUNGI (DRY ROT) DAMAGE AT THE BARGE RAFTER .

RECOMMENDATION: REMOVE THE DAMAGED PORTIONS OF WOOD AND REPLACE WITH NEW MATERIAL. APPLY TIMBOR (ACTIVE INGREDIENT: DISODIUM OCTABORATE TETRAHYDRATE) TO THE ADJACENT INFECTED AREAS AS NECESSARY FOR THE CONTROL OF WOOD DECAY FUNGI (DRY ROT).

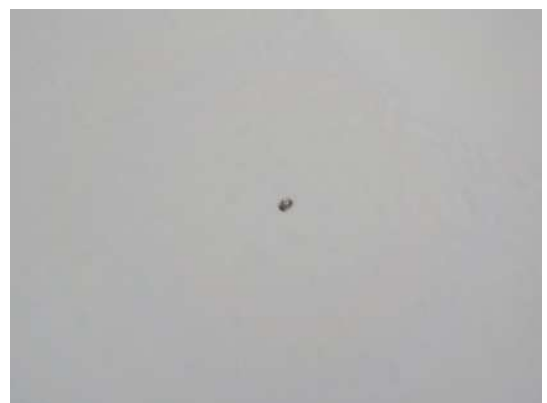
4A:

4A. FINDING: THERE IS DETERIORATION AT THE MASTER BATHROOM TUB

RECOMMENDATION: REPAIR THE TUB AS NECESSARY.

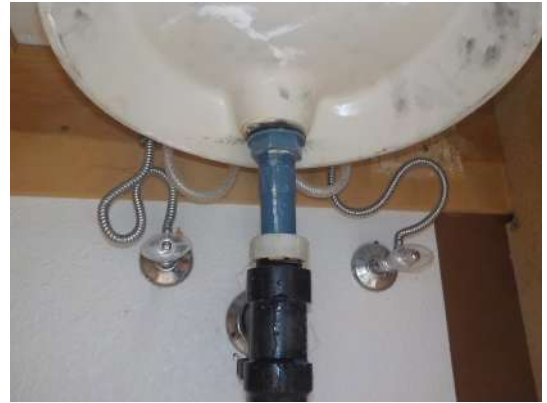
**4B:**

4B. FINDING: THERE IS A PLUMBING LEAK AT THE LEFT SIDE MASTER BATHROOM SINK .

RECOMMENDATION: OWNER SHOULD CONTACT A LICENSED PLUMBER TO MAKE THE NECESSARY

REPAIRS.

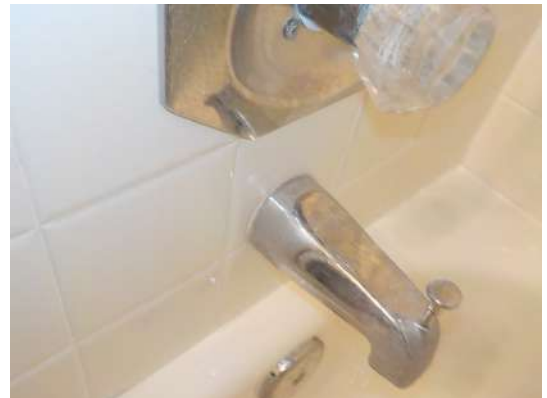
**4C:**

GROUT AND/OR CAULKING IS CRACKED, MISSING AND/OR LOOSE AT DOWNSTAIRS HALL BATHROOM TUB FAUCET .

RE-GROUT AND/OR CAULK AS NECESSARY.

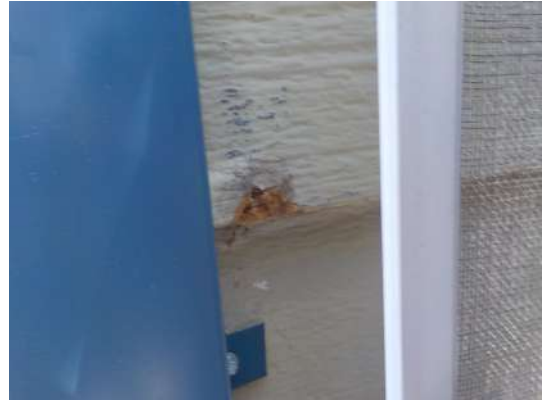
4D:

THERE IS MOISTURE DAMAGE AT THE SIDING .

REMOVE ALL DAMAGED WOOD AND REPLACE WITH NEW MATERIAL.

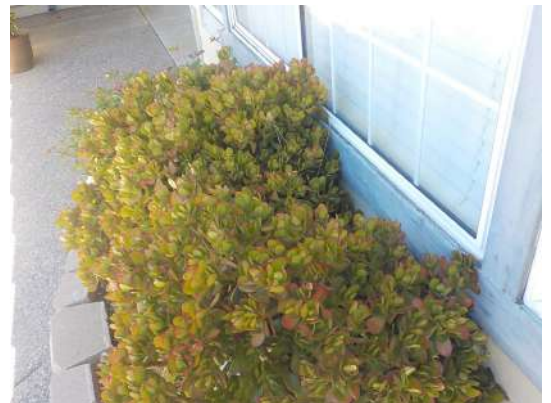
4E:

THERE IS CONTACT BETWEEN THE TREES AND/OR FOLIAGE AND THE RESIDENCE CAUSING POSSIBLE MOISTURE INTRUSION.

CUT BACK TREES/FOLIAGE TO CORRECT CONDITION. IF ADDITIONAL DAMAGE IS FOUND A SUPPLEMENTAL REPORT WILL BE ISSUED REFLECTING ALL FINDINGS.

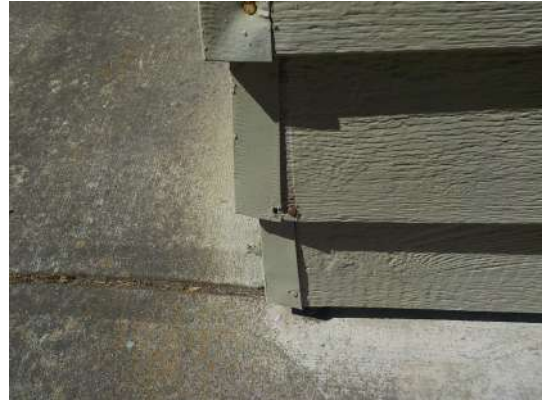
4G:

THERE IS A VOID IN THE SIDING DUE TO THE CORNER TRIM BEING UNINSTALLED , WHICH COULD LEAD TO MOISTURE INTRUSION.

RE-SECURE TRIM TO CORRECT THIS CONDITION.
