WOOD DESTROYING PESTS AND ORGANISMS INSPECTION REPORT

Building No. 943	Street Stillspring Court	City Vacaville	Zip 95687	Date of Inspection August 16, 2021	Number of Pages 4

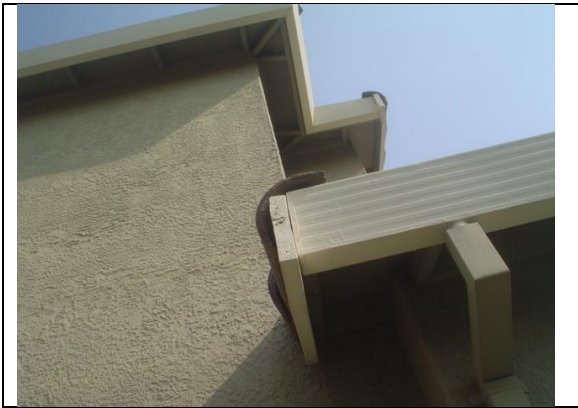
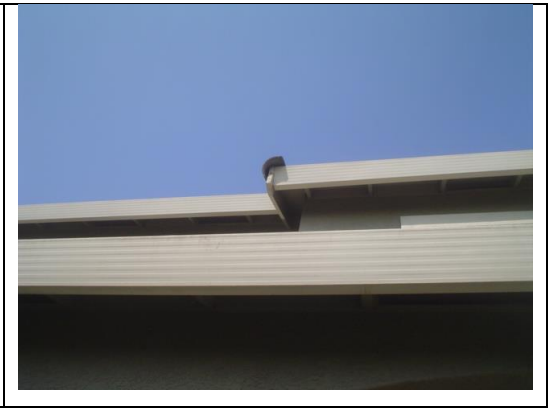
1 Finding: Fungi (wood-rot) damage found in the fascia rafter areas. Indicated on the diagram by “1”, and some areas shown in Fig.1 images on the back pages of this report.

Recommendation: Repair/replace fungi damaged wood members as needed.
