**WOOD DESTROYING PESTS AND ORGANISMS INSPECTION REPORT**

Building No. 401	Street Donaldson Court	City Suisun City	Zip 94585	Date of Inspection <b>July 8, 2021</b>	Number of Pages 4
---------------------	---------------------------	---------------------	--------------	---	----------------------

Company Report  
 # R8564

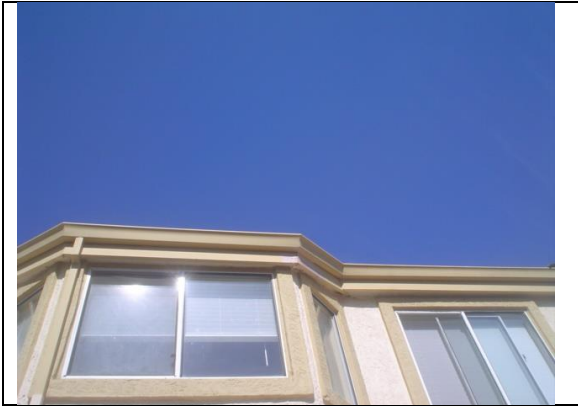
**1 Finding:** Fungi (wood-rot) damage found at fascia. Indicated on the diagram by “1”, and some areas shown in Fig.1 images on the back pages of this report.

**Recommendation:** Repair/replace fungi damaged wood members as needed.

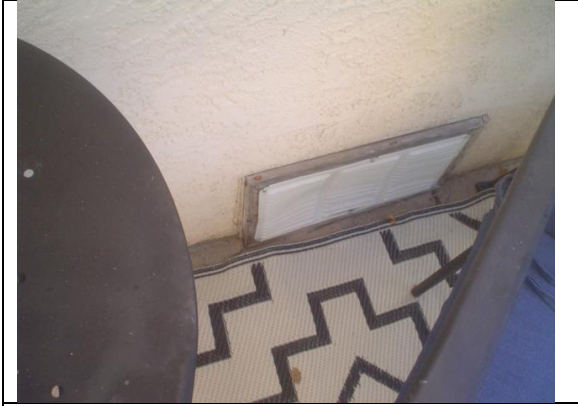
**2 Finding:** Fungi (wood-rot) damage found in the trim at foundation vent openings. Indicated on the diagram by “2”, and some areas shown in Fig.2 images on the back pages of this report.

**Recommendation:** Repair/replace fungi damaged wood members as needed.
