WOOD DESTROYING PESTS AND ORGANISMS INSPECTION REPORT

Building No. 2712	Street Soho Lane	City Fairfield	Zip 94533	Date of Inspection August 5, 2021	Number of Pages 4
----------------------	---------------------	-------------------	--------------	---	----------------------

Company Report
 # R8629

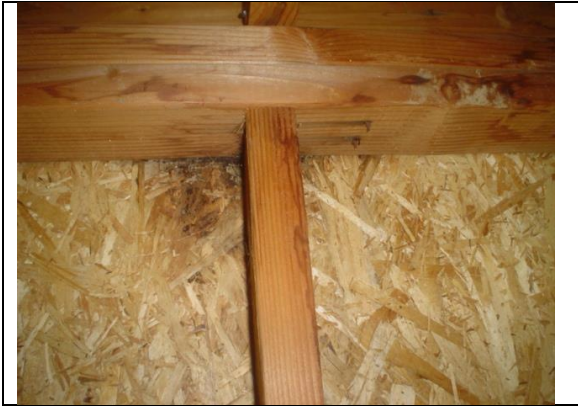
1 Finding: Fungi (wood-rot) damage found in the wall sheathing of porch. Indicated on the diagram by “1”, and some areas shown in Fig.1 images on the back pages of this report.

Recommendation: Repair/replace fungi damaged wood members as needed.

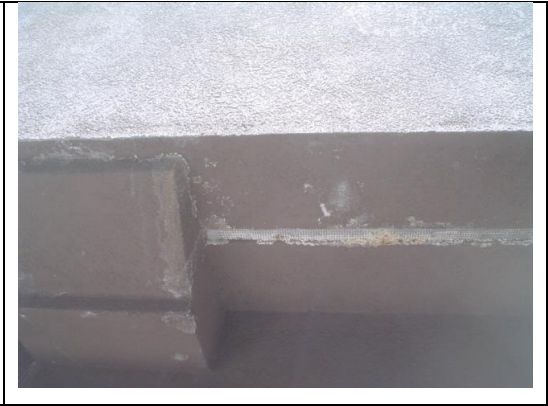
2 Finding: Stains at stucco indicate a large amount of previous moisture was present at interior areas. Indicated on the diagram by “2”, and some areas shown in Fig.2 images on the back pages of this report.

Recommendation: Owner should employ others to remove stucco from areas as needed to expose interior framing and/or other wood members to allow for further inspection. A further inspection should be performed.

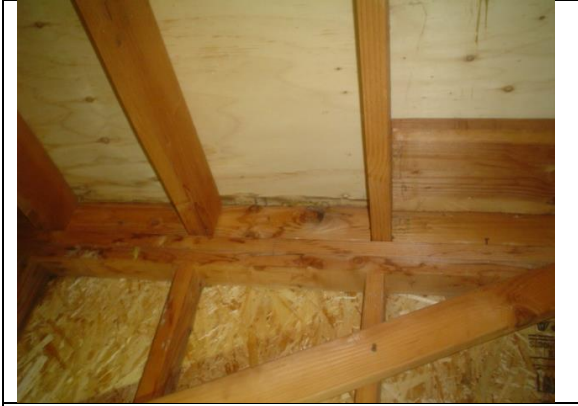
3 Finding: Stains below porch/deck surface indicate previous leaks. Indicated on the diagram by “3”, and some areas shown in Fig.3 images on the back pages of this report.

Recommendation: Contact a licensed water proofing contractor for inspection, and to perform any corrections that may be found necessary.
