WOOD DESTROYING PESTS AND ORGANISMS INSPECTION REPORT

Building No. 1736	Street Lindo Street	City Benicia	Zip 94510	Date of Inspection September 16, 2021	Number of Pages 4
Sheppard Termite Services 707-208-2102 or 707-452-0422 PR#4624 SheppardTermite@sbcglobal.net				Company Report # R8732	
Ordered By: Windy Rodriguez Plata Realty		Property Owner and/or Party of Interest: DocuSigned by:

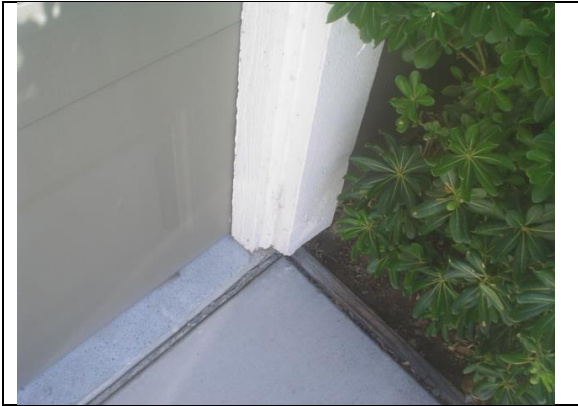
1 Finding: Fungi (wood-rot) damage found in the base of garage door jamb. Indicated on the diagram by “1”, and some areas shown in Fig.1 images on the back pages of this report.

Recommendation: Repair/replace fungi damaged wood members as needed.

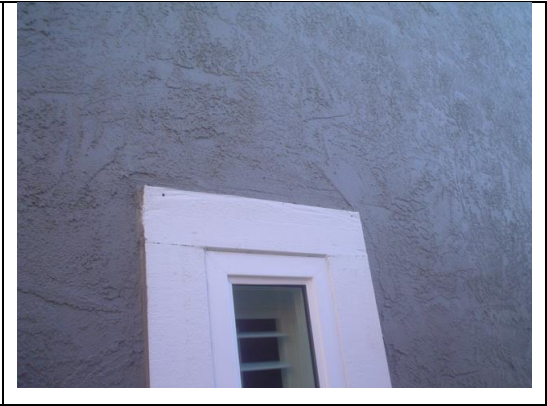
2 Finding: Fungi (wood-rot) damage found in the exterior trim. Indicated on the diagram by “2”, and some areas shown in Fig.2 images on the back pages of this report.

Recommendation: Replace damaged trim as needed.
