**INSPECTION DATE:** December 18, 2021

**REPORT NUMBER:** A71421

**PROPERTY INSPECTED:** 538 Thomas Circle  
Suisun City, CA 94585

The property inspected is a 3 bedroom, 2 bath single family home. The weather at the commencement of the inspection was clear with a temperature reading of approximately 49 degrees Fahrenheit.

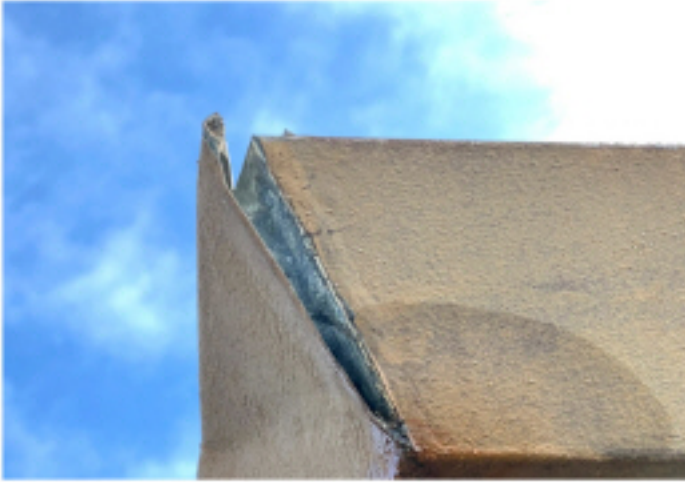
**PHOTO #1**

1. The gutter at the NW corner of the garage is separated at the seam. Suggest the gutter be repaired by a qualified licensed contractor. (See Photo #1)

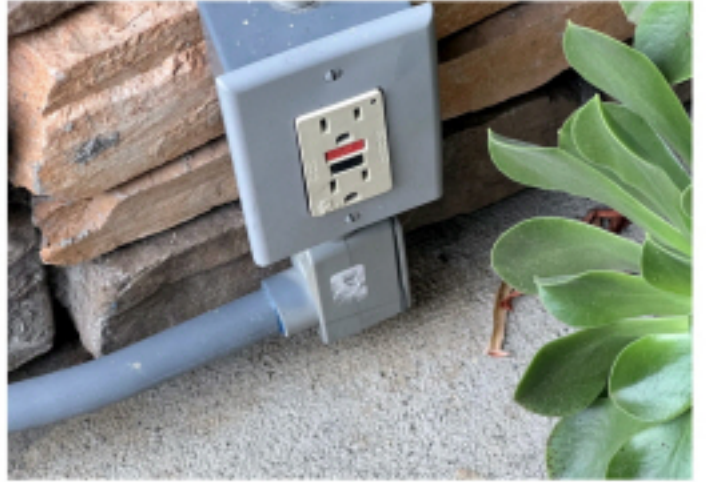
**PHOTO #2**

1. A weatherproof faceplate is not present at the exterior electrical outlet at the front entry. Suggest a weatherproof faceplate be installed by a qualified licensed contractor. (Safety Concern, See Photo #2)

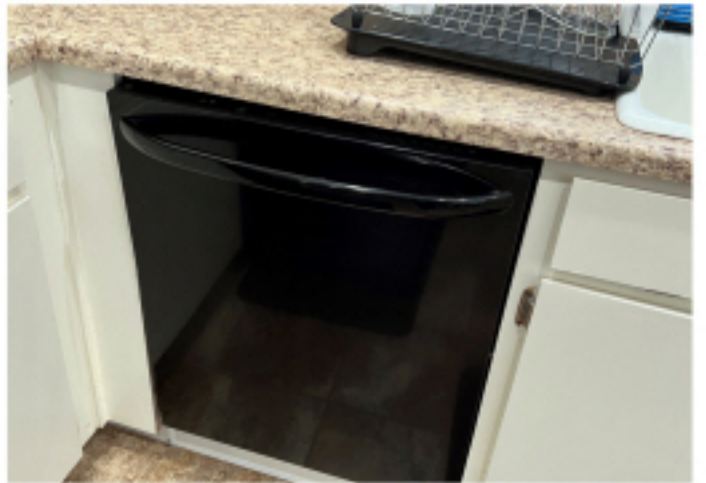
**PHOTO #4**

1. The dishwasher is inoperable (would not respond to the operating controls). Suggest the dishwasher be repaired or replaced by a qualified licensed contractor as found needed. (See Photo #4)

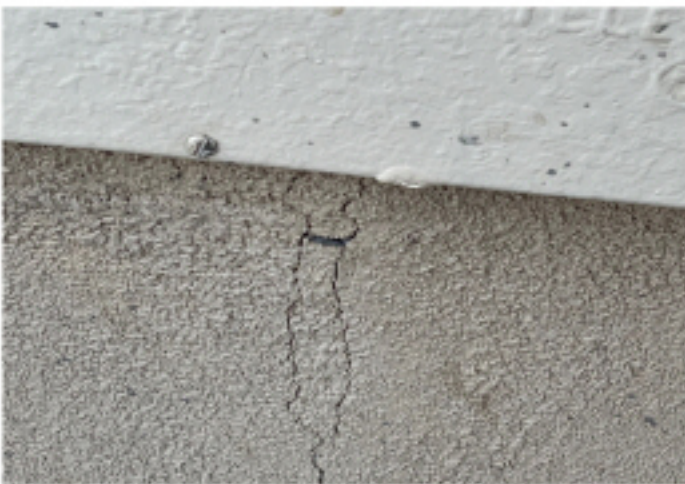
**PHOTO #5**

1. The stucco is cracked at various locations from apparent common settling. Suggest the cracks be sealed with an exterior grade caulking material by a qualified licensed contractor. (See Photo #5)
2. The paint at the barge rafters is weathered at various locations. Suggest the wood members be painted by a qualified licensed contractor to prolong the life of the wood. (See Photo #6)
