WOOD DESTROYING PESTS AND ORGANISMS INSPECTION REPORT

Building No. 285	Street Larkspur Drive	City Vacaville	Zip 95687	Date of Inspection August 16, 2021	Number of Pages 5
---------------------	--------------------------	-------------------	--------------	--	----------------------

Company Report
 # R8648

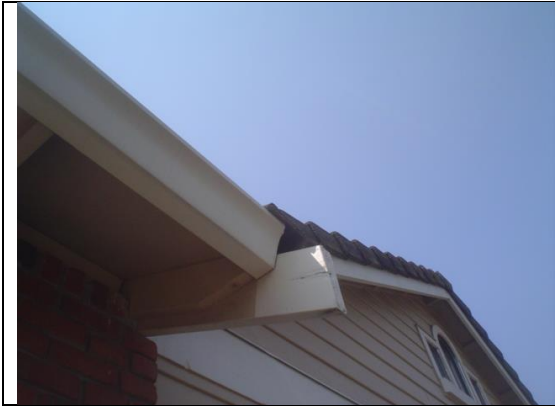
Fig.1a

1 Finding: Fungi (wood-rot) damage found in the fascia rafter areas. Indicated on the diagram by “1”, and some areas shown in Fig.1 images on the back pages of this report.

Recommendation: Repair/replace fungi damaged wood members as needed.

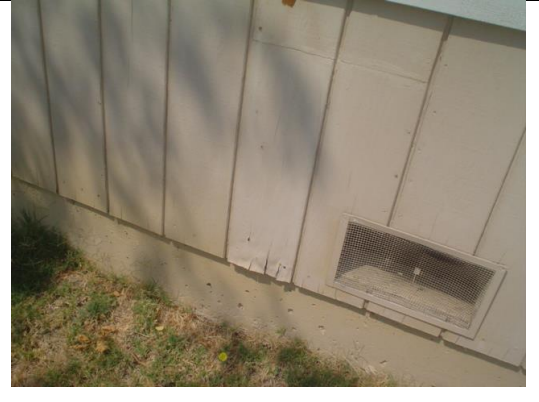
Fig.2a

2 Finding: Fungi (wood-rot) damage found in the exterior siding and trim. Indicated on the diagram by “2”, and some areas shown in Fig.2 images on the back pages of this report.

Recommendation: Replace damaged siding and trim as identified during our original inspection. Further inspect upon opening of enclosed areas.

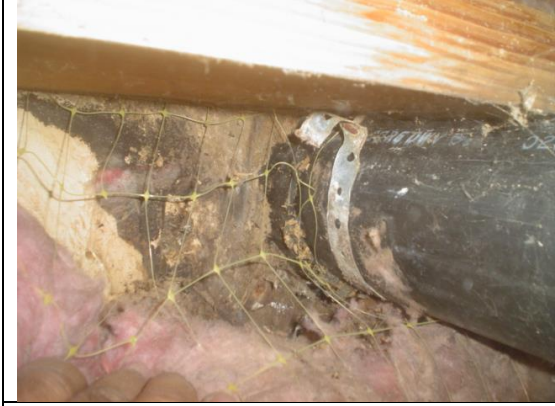
3 Finding: Fungi (wood-rot) damage found in the subfloor adjacent to master bathroom toilet. Indicated on the diagram by “3”, and some areas shown in Fig.3 images on the back pages of this report.

Recommendation: Remove tile flooring. Repair/replace damaged wood members as identified during our original inspection. Further inspect upon opening of enclosed areas. Install new underlayment and vinyl sheet floor covering, reset toilet.

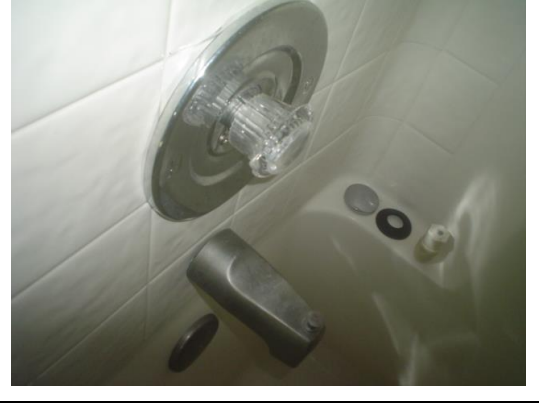
4 Finding: Void space between the tub spout and shower wall noted. Indicated on the diagram by “4”, and some areas shown in Fig.4 images on the back pages of this report.

Recommendation: Adjust spout and/or caulk seal as needed.
