INSPECTION DATE: June 24, 2022

REPORT NUMBER: A61271

PROPERTY INSPECTED: 512 Vieira St

Rio Vista, CA 94571

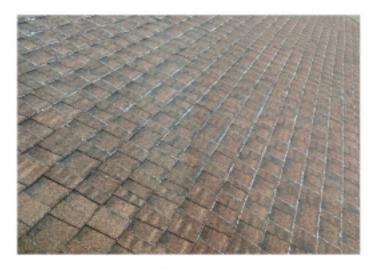
1. The edges of several roofing shingles appear worn and the seams at the plumbing vent roof jacks appear poorly sealed (as viewed from the roof eaves). Suggest the roof be further inspected by a licensed roofing contractor and be repaired as found needed. (See Photo #1 and Photo #2)

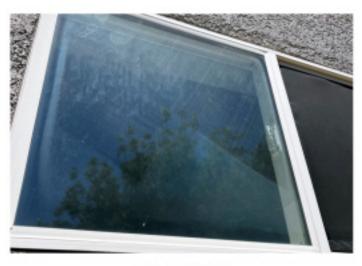
PHOTO #3

Condensation stains were noted between the glass panes of the sliding window at the master bathroom from an apparent failed vacuum seal. Suggest the glass panes be replaced by a licensed window contractor. (Stationary Side, See Photo #3)
