WOOD DESTROYING PESTS AND ORGANISMS INSPECTION REPORT

Building No. 1608	Street Motta St.	City Woodland	Zip 95776	Date of Inspection 5/11/23	Number of Pages 4
Woodland-Davis Termite & Pest Control, Inc. 18 N. East Street, Suite 201 Woodland, CA 95776 (530) 662-1234 • (530) 756-1234 • (530) 795-1234 • (707) 678-1234 • (530) 661-2329 (FAX)

1608	Motta St.	Woodland	5/11/23	2023-0446
Bldg. No	Street	City	Date of Insp.	Co. Report No.

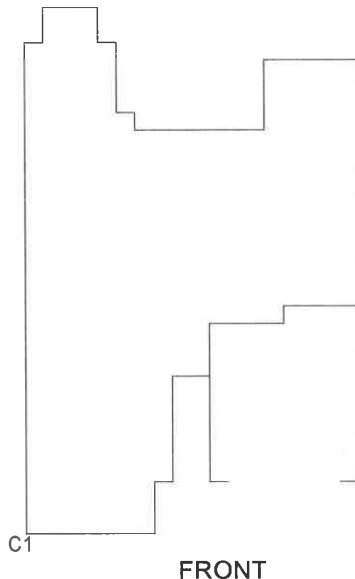
Finding C1	There is dry rot damage to the trim at the area(s) indicated on the diagram.
Recommendation C1	Remove all of the dry rot damaged wood and repair the area with an appropriate material or replace the damaged wood with new. (SECTION 1)
