**REPORT NUMBER:** A71421

**PROPERTY INSPECTED:** 865 Studding Sail St  
Vacaville, CA 95687

The property inspected is a 4 bedroom, 2 bath single family home. The weather at the commencement of the inspection was clear with a temperature reading of approximately 68 degrees Fahrenheit.

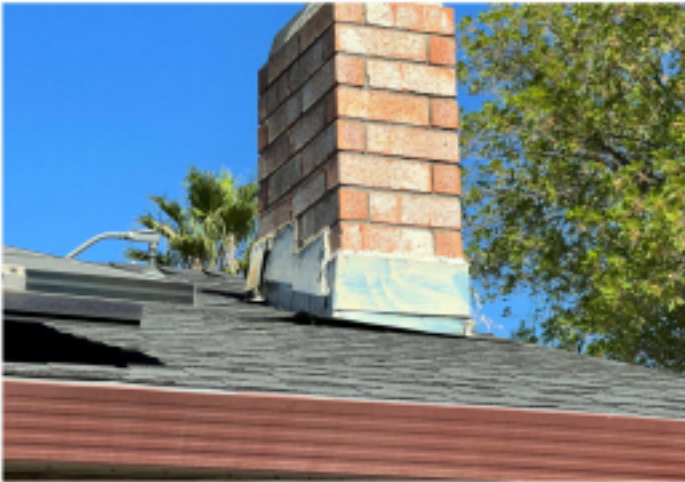
**PHOTO #1**

1. The seams at the chimney flashing appear poorly sealed (as viewed from the roof eaves). Suggest the roof be further inspected by a licensed roofing contractor and be repaired as found needed. (See Photo #1)

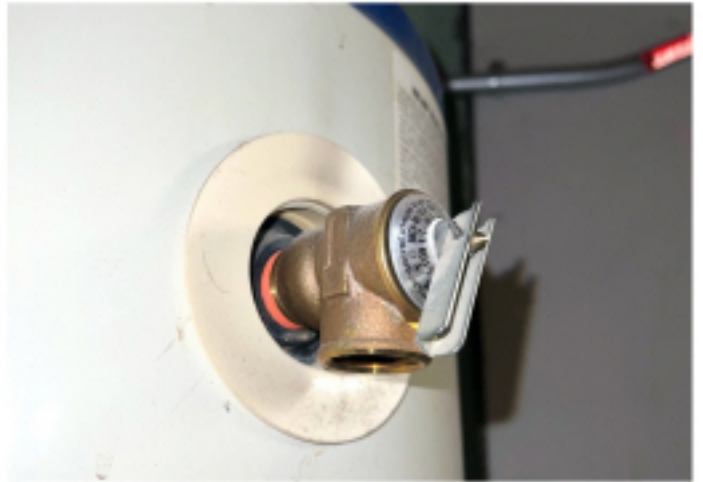
**PHOTO #2**

1. The discharge pipe to the water heater temperature/pressure relief valve is missing. Suggest a code compliant discharge pipe be installed by a qualified licensed contractor. (Safety Concern, See Photo #2)
2. The water heater is improperly braced for earthquake safety. Suggest the water heater be braced with code compliant seismic straps by a qualified licensed contractor. (Safety Concern,, See Photo #3)

THE DISCHARGE PIPE TO THE WATER HEATER TPR VALVE IS MISSING

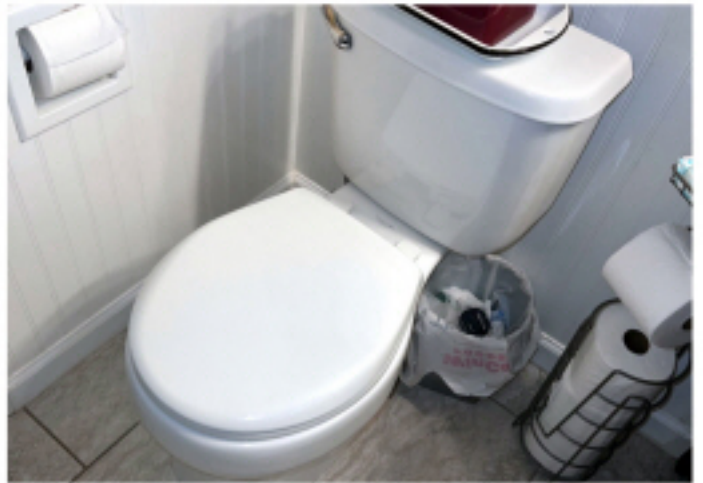
**PHOTO #4**

1. The toilet is loosely secured to the floor. Suggest the anchoring bolt nuts be tightened by a qualified licensed contractor. (See Photo #4)
2. The bathtub drain leaks in the sub area. Suggest the drain line be repaired by a qualified licensed contractor. (See Photo #5)

THE TOILET IS LOOSELY  
 SECURED TO THE FLOOR

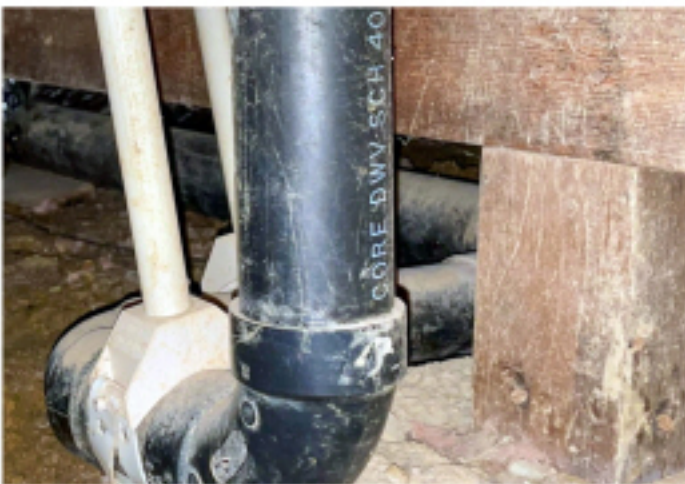
**PHOTO #5**

THE BATHING DRAIN  
 LEAKS IN THE SUB AREA

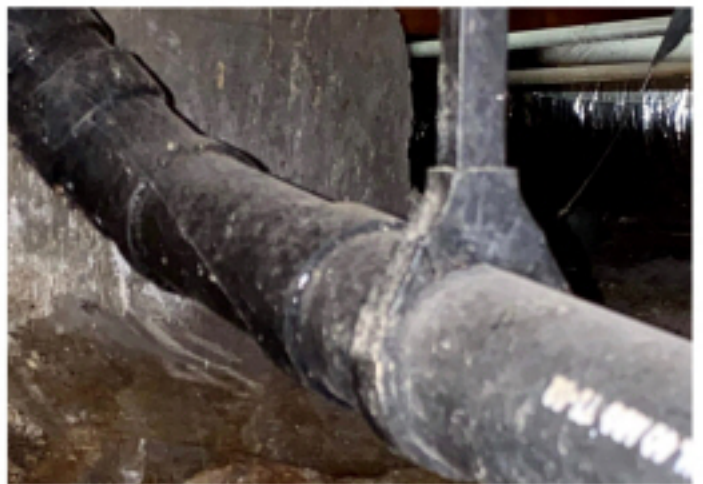
**PHOTO #6**

1. The sink drain leaks in the sub area. Suggest the drain line be repaired by a qualified licensed contractor. (See Photo #6)
2. The floor underlayment appears moisture damaged near the shower from apparent leakage at the shower enclosure. Please refer to the structural pest report for additional comments and recommendations, if any. (See Photo #7 and Photo #8).

THE SINK DRAIN LEAKS  
IN THE SUB AREA

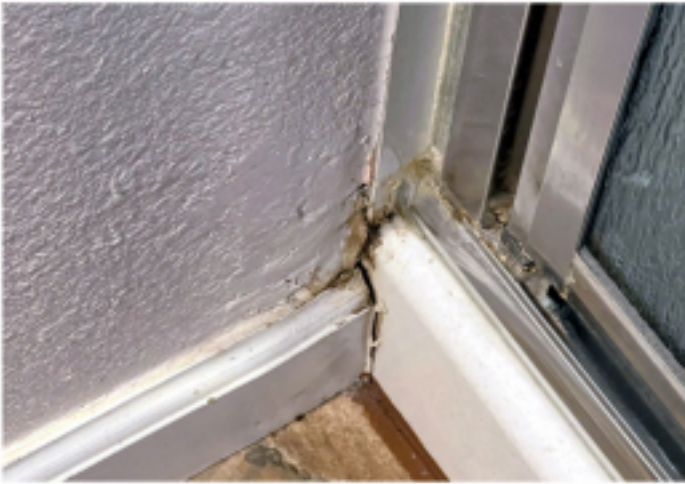
**PHOTO #7**

THE FLOOR UNDERLAYMENT  
APPEARS MOISTURE DAMAGED  
FROM LEAKAGE AT THE  
SHOWER ENCLOSURE

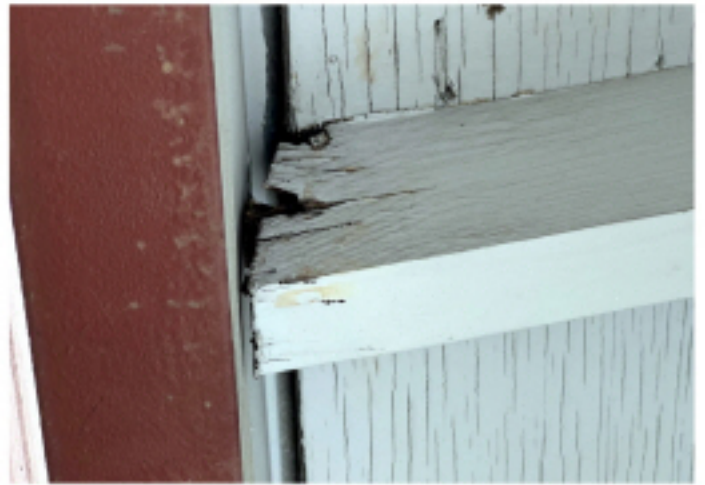
**PHOTO #10**

1. The roof eaves appear moisture damaged at various locations. Please refer to the structural pest report for additional comments and recommendations, if any. (See Photo #10 and Photo #11)

THE ROOF EAVES APPEAR  
 MOISTURE DAMAGED AT  
 VARIOUS LOCATIONS.
