INSPECTION DATE: August 1, 2022

REPORT NUMBER: A61421-2

PROPERTY INSPECTED: 1869 Brookwood Dr
Vacaville, CA 95687

The property inspected is a 3 bedroom, 2 bath single family home. The weather at the commencement of the inspection was clear with a temperature reading of approximately 82 degrees Fahrenheit.

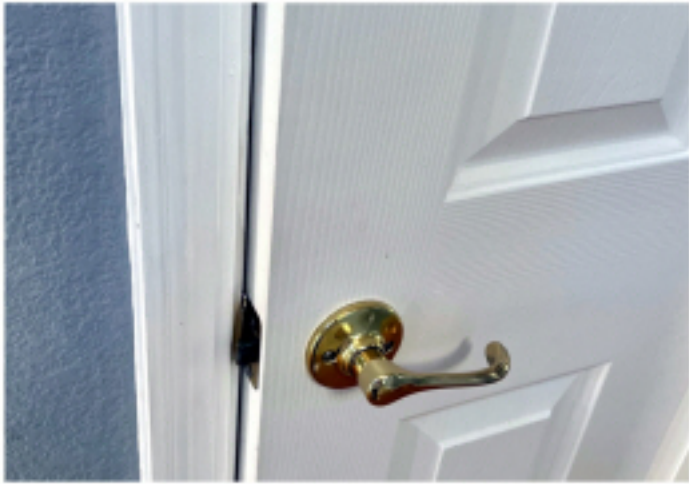
PHOTO #1

1. The side of the closet door rubs against the door jamb and is difficult to open and close. Suggest the door be repaired by a qualified licensed contractor. (See Photo#1 and Photo #2)
2. The window screen to the sliding window is missing. Suggest a window screen be installed.
