INSPECTION DATE: April 28, 2021

REPORT NUMBER: A71631

PROPERTY INSPECTED: 1501 Henry St
Fairfield, CA 94533

The property inspected is a 5 bedroom, 4 bath single family home. The weather at the commencement of the inspection was clear with a temperature reading of approximately 82 degrees Fahrenheit.

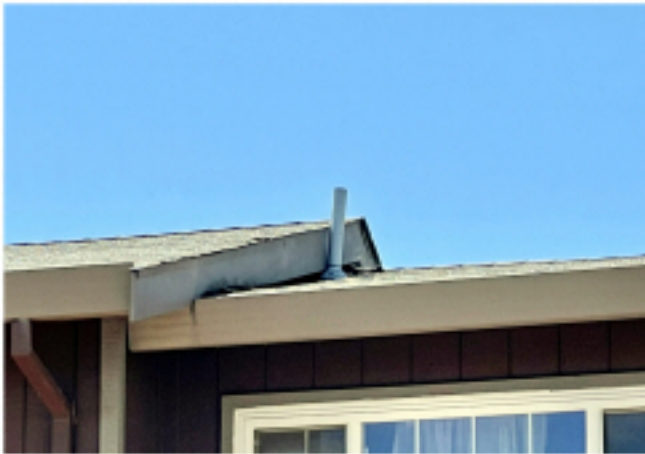
PHOTO #1

1. The seams at the plumbing vent roof jacks appear poorly sealed (as viewed from the roof eaves). Suggest the roof be further inspected by a licensed roofing contractor and be repaired as found needed. (See Photo #1)

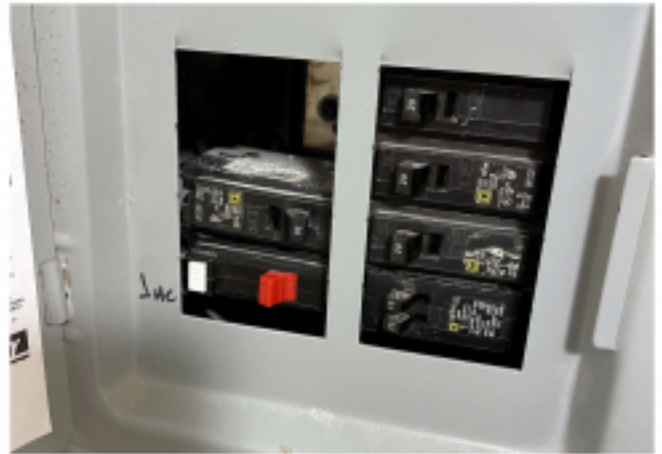
PHOTO #2

1. Two knock out plates are missing from the inner cover of the sub panel exposing the bus bar. Suggest the panel opening be sealed with knock out replacements by a qualified licensed contractor. (Safety Concern, See Photo #2)

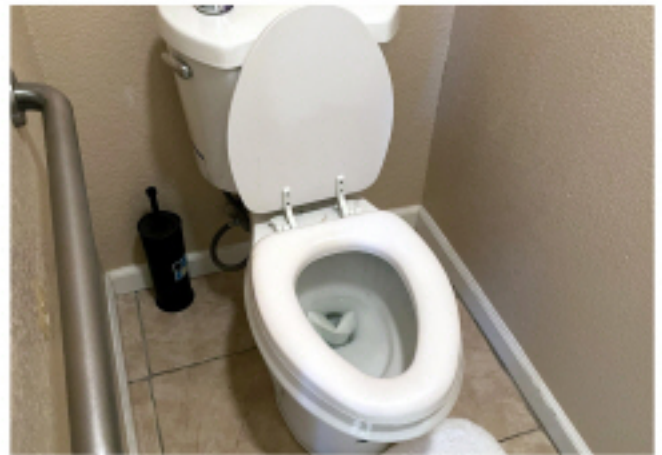
PHOTO #4

1. The toilet is loosely secured to the floor. Suggest the toilet be reset with a new wax seal by a qualified licensed contractor. (See Photo #4)

THE TOILET IS LOOSELY
SECURED TO THE FLOOR

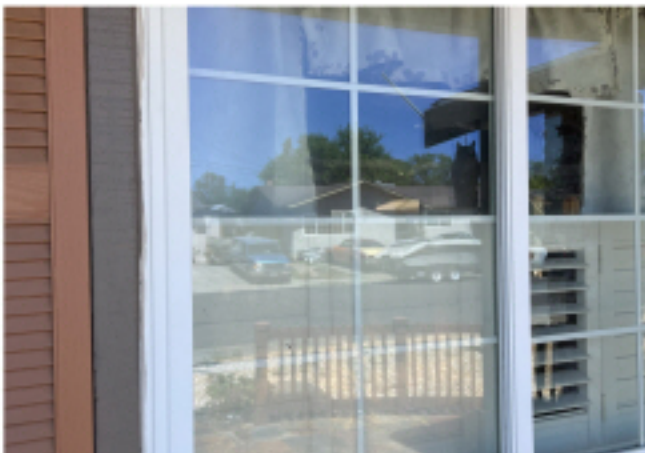
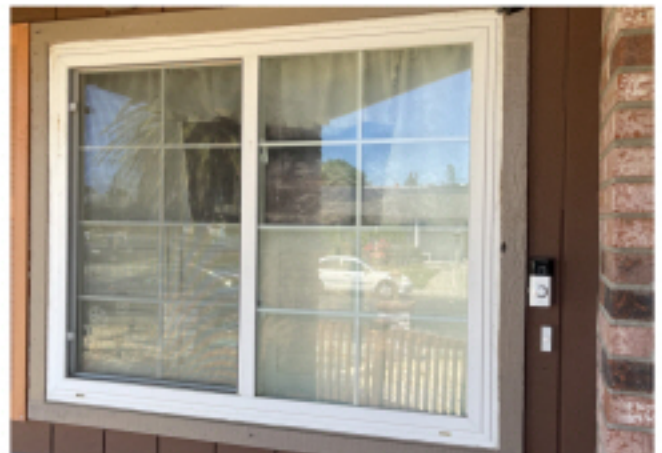
1. Condensation stains were noted between the glass panes of the two sliding windows from apparent failed vacuum seals. Suggest the glass panes be replaced by a licensed window contractor. (Stationary Sides, See Photo #5 and Photo #6)

CONDENSATION STAINS NOTED
BETWEEN THE GLASS
PANES OF THE TWO
SLIDING WINDOWS

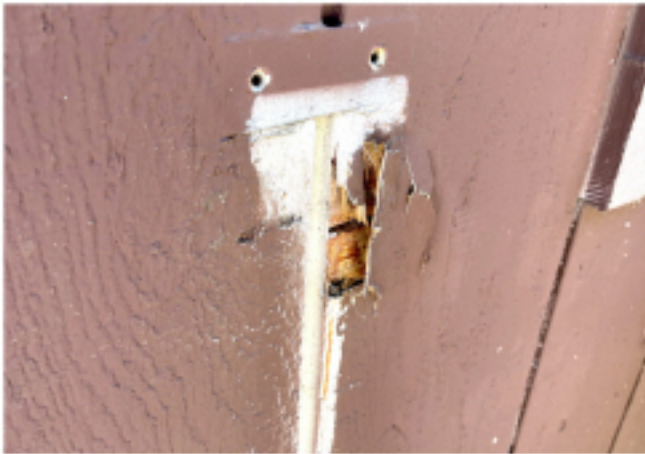
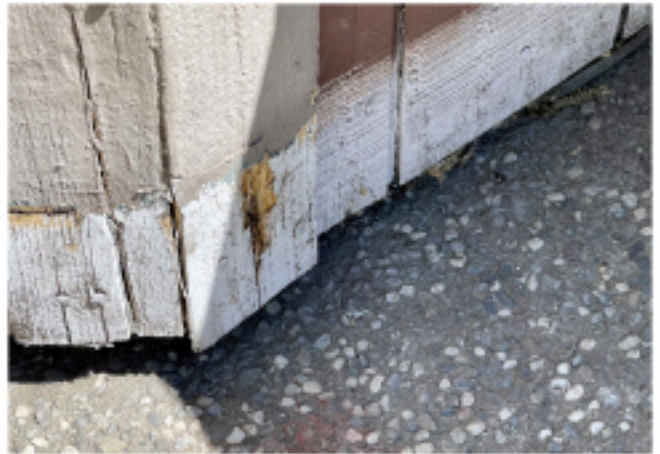
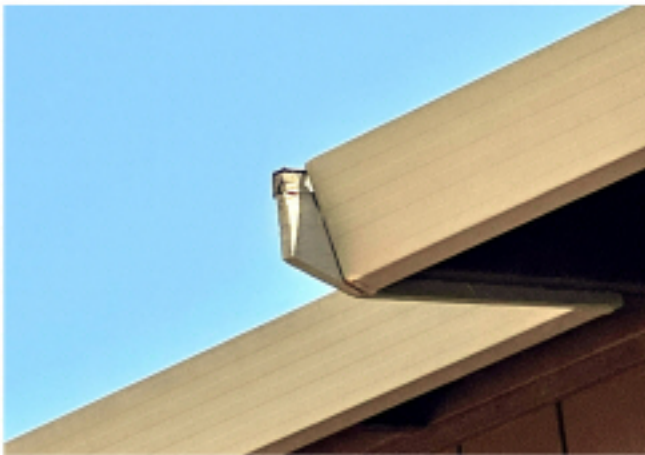
1. The wood siding, trim and roof eaves appear moisture damaged at various locations. Please refer to the structural pest report for additional comments and recommendations, if any. (See Photo #7, Photo #8 and Photo #9)
2. The exterior door and door jamb at the Upper Level South Bedroom appear moisture damaged. Please refer to the structural pest report for additional comments and recommendations, if any. (See Photo #10)
3. The wood stairs at the South wall of the house appear moisture damaged at various locations. Please refer to the structural pest report for additional comments and recommendations, if any. (See Photo #11)

THE WOOD SIDING, TRIM
AND ROOF EAVES APPEAR
MOISTURE DAMAGED

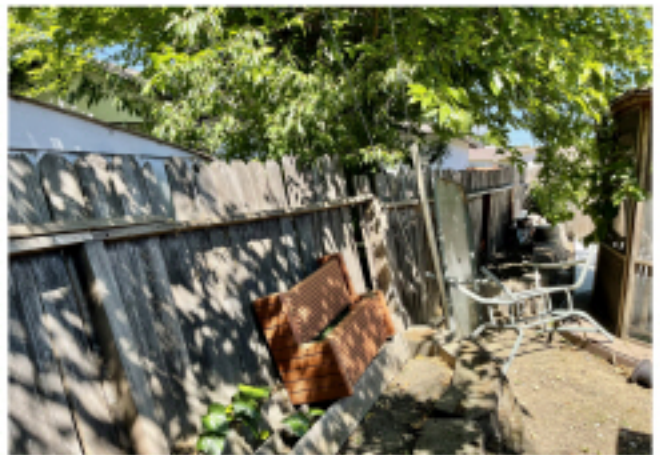
PHOTO #12

1. Several wood fence posts and slats at the West fence line are broken and loose. Suggest the fence be repaired by a qualified licensed contractor. (See Photo #12)

SEVERAL WOOD FENCE POSTS
AND SLATS AT THE WEST
FENCE LINE ARE BROKEN
AND LOOSE
