INSPECTION DATE: April 15, 2021

REPORT NUMBER: A71271

PROPERTY INSPECTED: 692 E L Street
Benicia, CA 94510

The property inspected is a 3 bedroom, 3 bath single family home. The weather at the commencement of the inspection was clear with a temperature reading of approximately 51 degrees Fahrenheit.

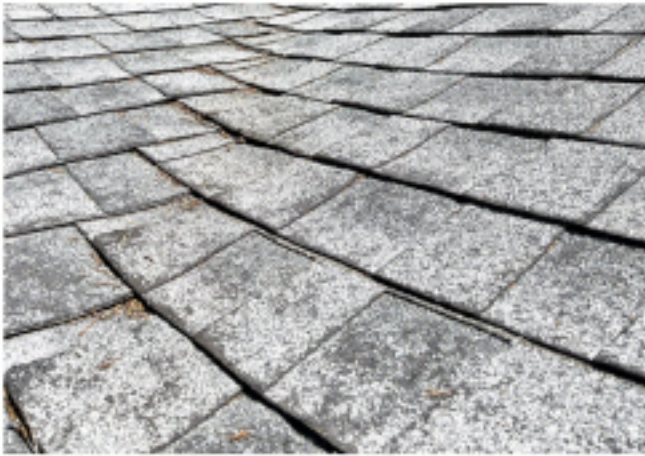
PHOTO #1

1. A moderate granule loss to several roofing shingles was noted at the South roof exposure. Suggest the roof be further inspected by a licensed roofing contractor and be repaired as found needed. (See Photo #1)
2. Tree branches are in contact with the roof. Suggest the tree branches be trimmed away from the roof by a qualified licensed contractor. (See Photo #2)
3. The gutter at the West wall of the house leaks at the seam. Suggest the seam be sealed with an exterior grade caulking material by a qualified licensed contractor. (See Photo #3)

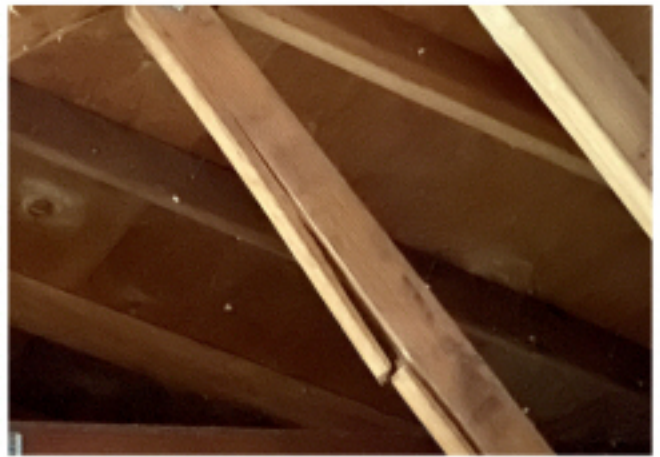
PHOTO #4

1. One truss in the attic near the attic access opening is cracked. Suggest the damaged truss be repaired by a qualified licensed contractor. (See Photo #4)

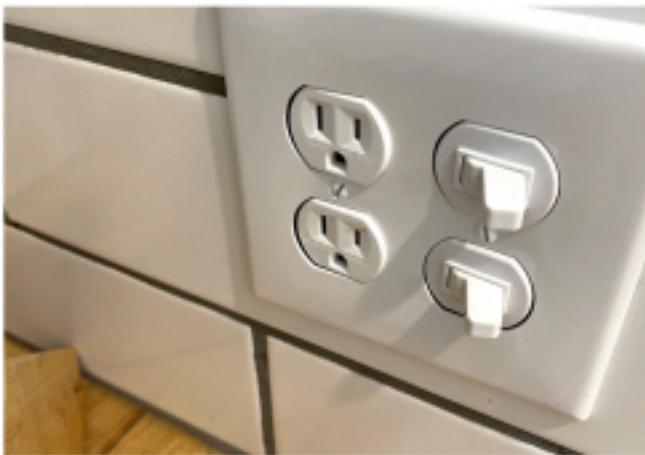
PHOTO #5

1. The electrical outlets at the kitchen are not ground fault protected. Suggest the GFCI electrical outlets be installed by a qualified licensed contractor. (Safety Concern, See Photo #5)

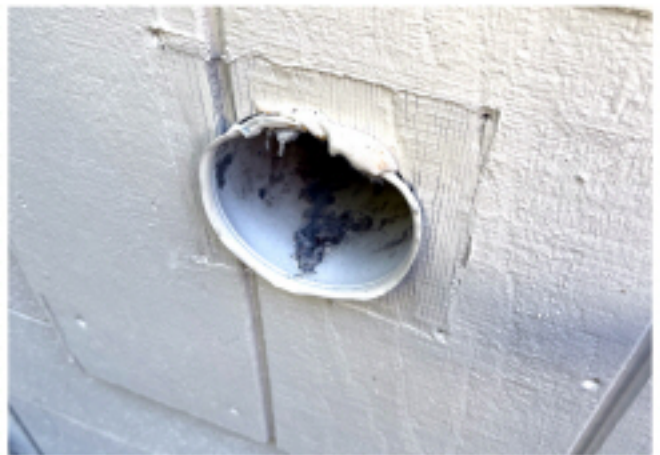
PHOTO #6

1. The rain guard to the dryer vent opening at the West wall of the house is missing. Suggest a rain guard be installed by a qualified licensed contractor. (See Photo #6)

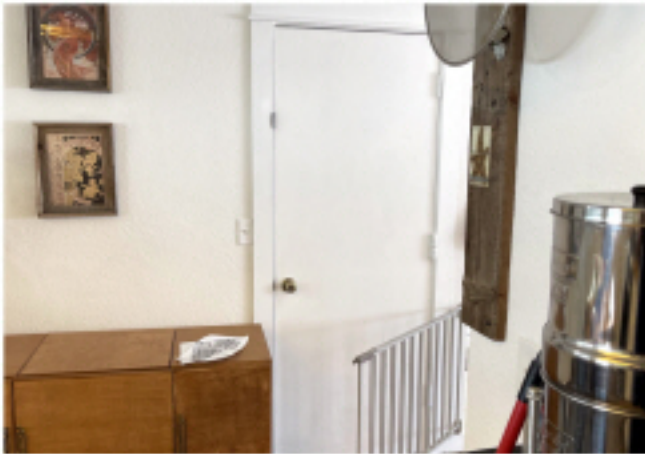
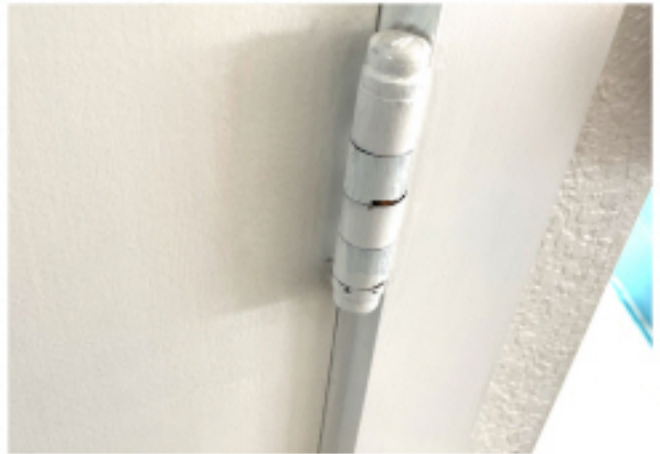
PHOTO #7

1. The self-closing door hinge to the fire door between the kitchen and garage is inoperable. Suggest the self-closing door hinge be repaired or replaced by a qualified licensed contractor as found needed to maintain a fire barrier between the garage and house interior. (Safety Concern, See Photo #7 and Photo #8)

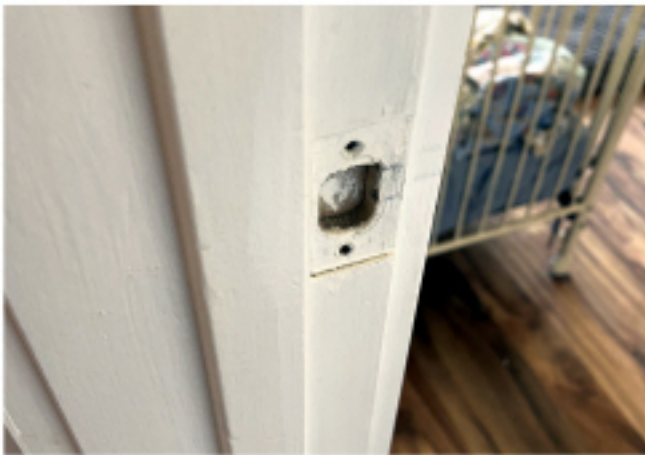
PHOTO #9

1. The strike plate to the entry door is missing. Suggest a strike plate be installed by a qualified licensed contractor. (See Photo #9)

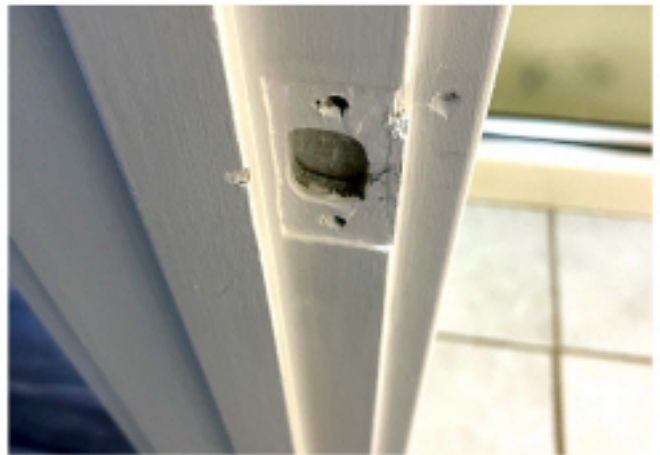
PHOTO #10

1. The strike plate to the entry door is missing. Suggest a strike plate be installed by a qualified licensed contractor. (See Photo #10)

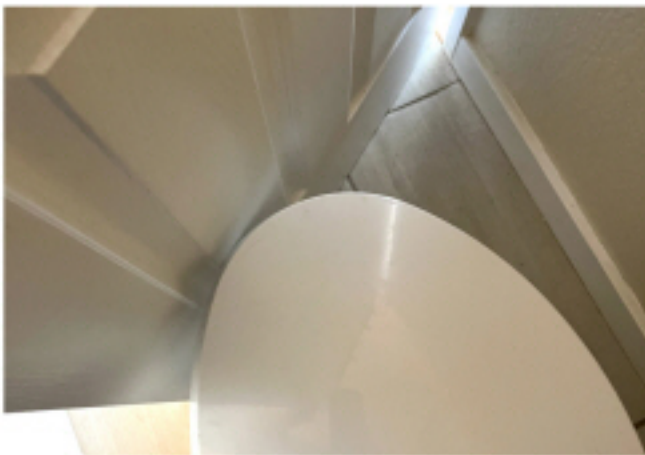
PHOTO #11

1. The entry door strikes the toilet when opening the door. Suggest a hinge-pin door stopper be installed by a qualified licensed contractor. (See Photo #11)

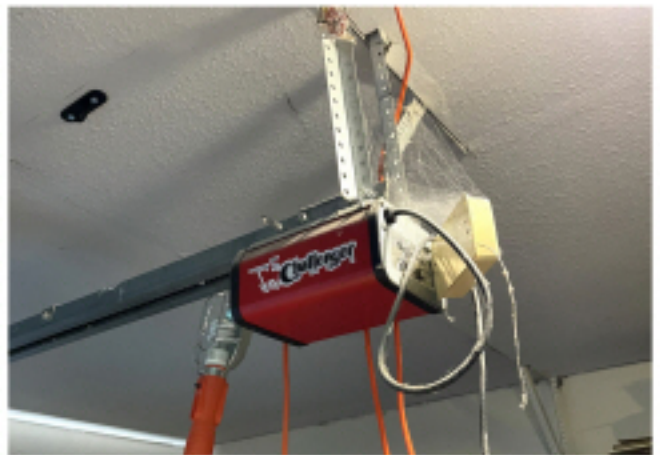
PHOTO #12

1. The garage door opener is inoperable. Suggest the garage door opener be repaired or replaced by a qualified licensed contractor as found needed. (See Photo #12)

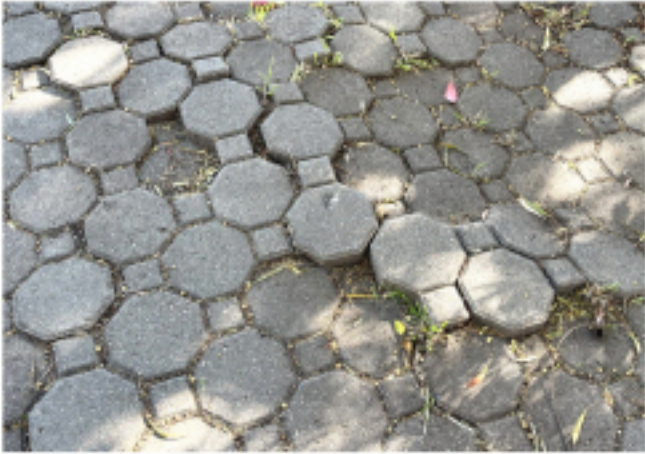
PHOTO #13

1. Several bricks at the walkway near the driveway are uneven from apparent tree roots. Suggest the walkway be repaired by a qualified licensed contractor. (Trip Hazard, See Photo #13)
2. The concrete walkway at the front entry is cracked and uneven from apparent tree roots and/or settling. Suggest the walkway be repaired by a qualified licensed contractor. (Trip Hazard, See Photo #14)
