PAUL E. JONES
NAPI CERT. # 30667

INSPECTION DATE: May 12, 2023

REPORT NUMBER: A71271

PROPERTY INSPECTED: 1608 Motta St
Woodland, CA 95776

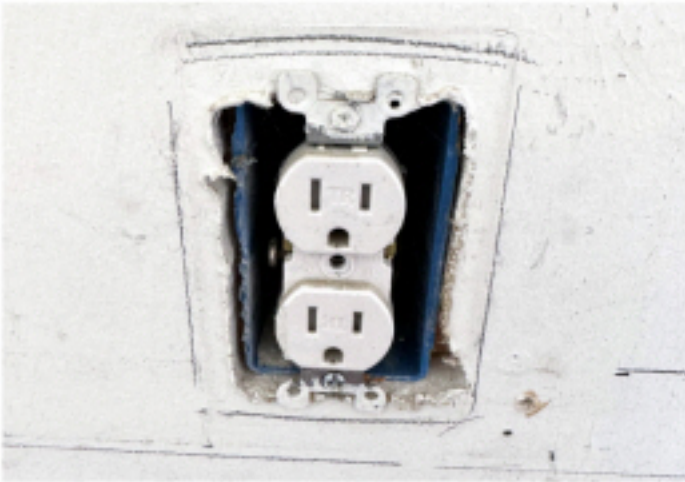
PHOTO #1

1. The faceplate to one electrical outlet at the garage interior is missing. Suggest a faceplate be installed by a qualified licensed contractor. (Safety Concern, See Photo #1)
2. The doorbell operating switch is not secured to the wall and is loose. Suggest the operating switch be repaired by a qualified licensed contractor. (See Photo #2)

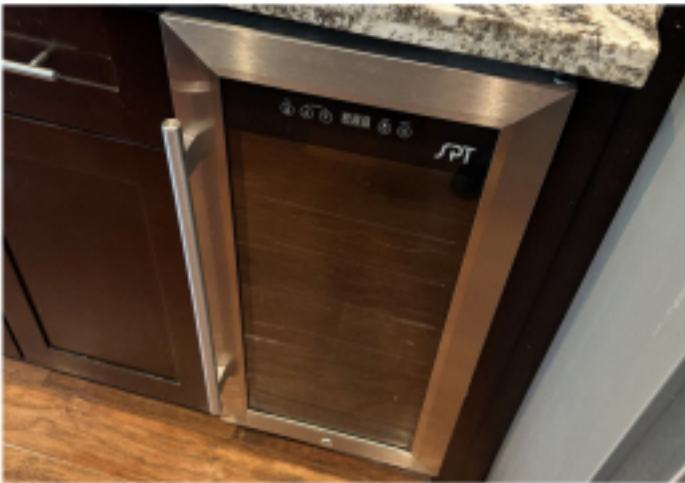
PHOTO #3

1. The wine refrigerator was found inoperable (would not respond to the operating controls). Suggest the wine refrigerator be repaired or replaced by a qualified licensed contractor as found needed. (See Photo #3)

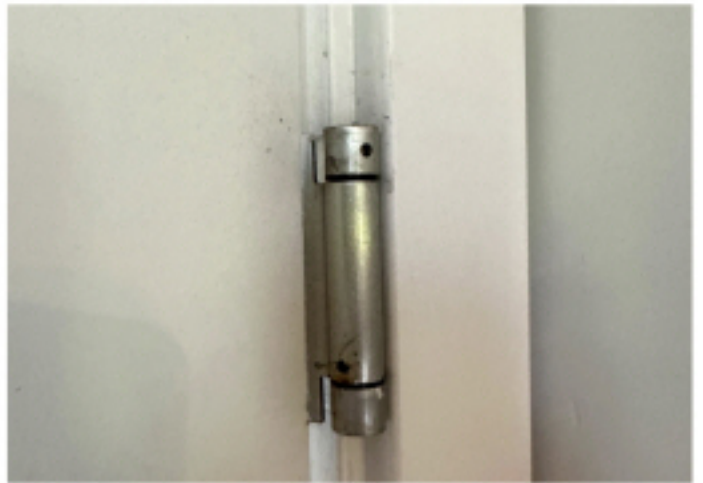
PHOTO #4

1. The two self-closing door hinges to the fire door between the laundry room and garage are inoperable. Suggest the self-closing door hinges be repaired or replaced by a qualified licensed contractor as found needed to maintain a fire barrier between the garage and house interior. (Safety Concern, See Photo #4)

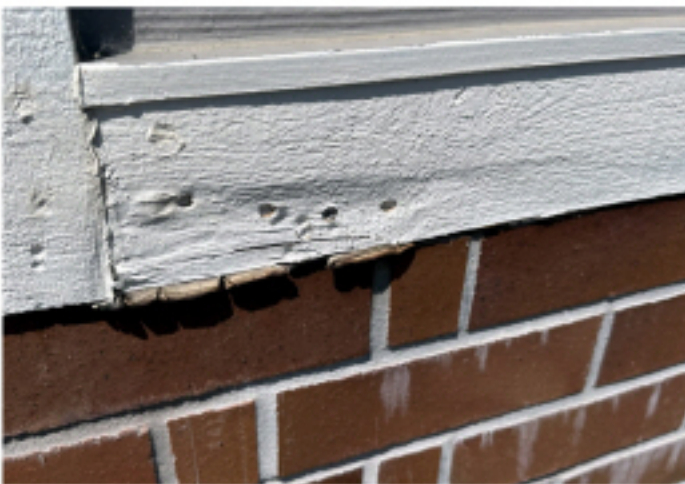
PHOTO #5

1. The wood wall trim near the SE corner of the house appears moisture damaged. Please refer to the structural pest report for additional comments and recommendations, if any. (See Photo #5)

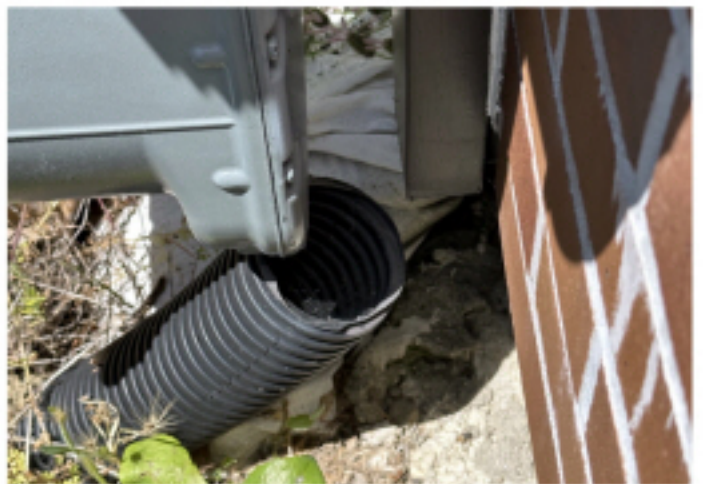
PHOTO #6

1. The subsurface drain hoses to two downspouts at the South wall of the house are not attached to the downspouts. Suggest the drain hoses be repaired by a qualified licensed contractor. (See Photo #6)
