INSPECTION DATE: October 19, 2023

REPORT NUMBER: A71211

PROPERTY INSPECTED: 3600 Thompson Ct
Fairfield, CA 94534

The property inspected is a 4 bedroom, 2.5 bath single family home. The weather at the commencement of the inspection was clear with a temperature reading of approximately 79 degrees Fahrenheit.

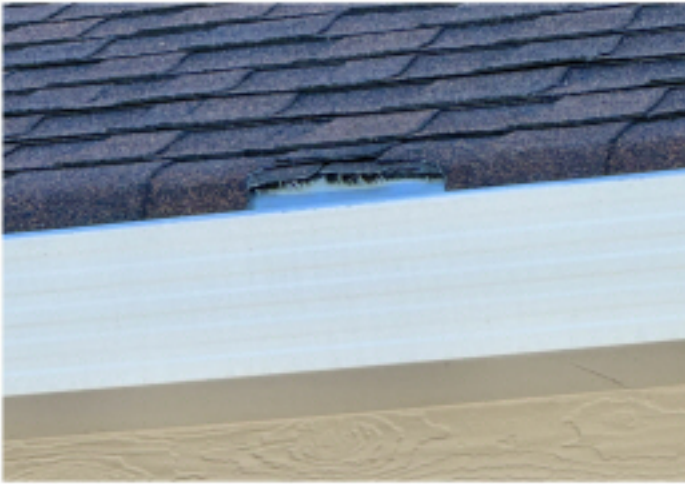
PHOTO #1

1. A few roofing shingles at the garage roof cover appear damaged and the seams at the plumbing vent jacks appear poorly sealed. Suggest the roof be further inspected by a licensed roofing contractor and be repaired as found needed. (See Photo #1 and Photo #2)

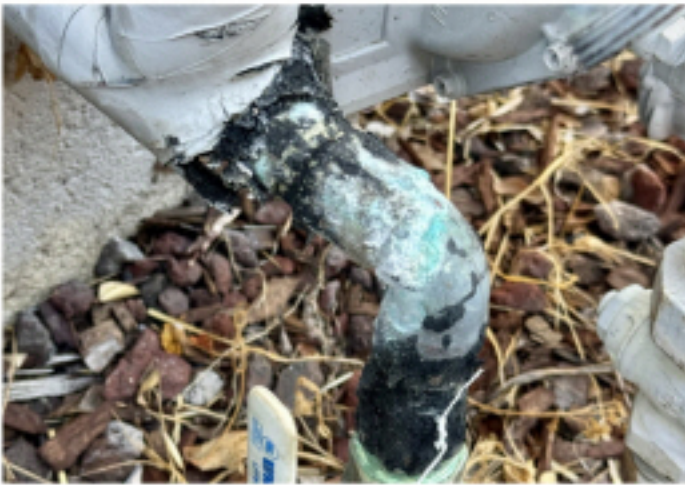
PHOTO #3

1. The water main leaks above the gate valve. Suggest the water main be repaired by a qualified licensed contractor. (See Photo #3)

THE WATER MAIN LEAKS ABOVE THE GATE VALVE

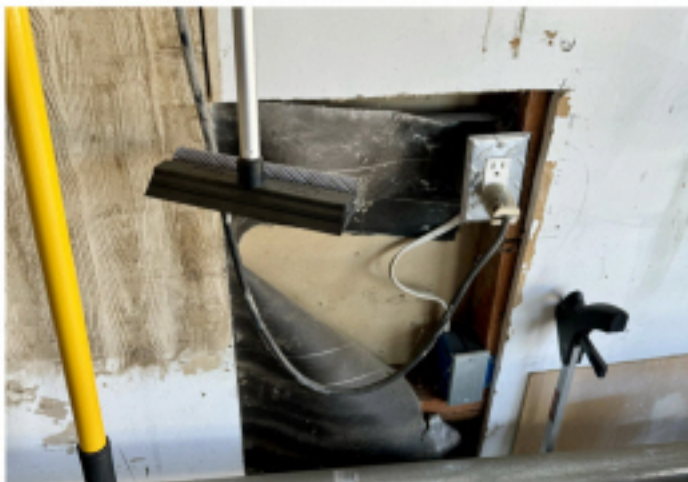
PHOTO #7

1. An approximate 15" by 30" opening was noted in the drywall at the South wall of the garage interior exposing the wall cavity. Suggest the wall opening be sealed with fire-rated drywall by a qualified licensed contractor to maintain a fire barrier between the garage and house interior. (Safety Concern, See Photo #7)

AN APPROX 15" X 30" OPENING NOTED IN THE SOUTH WALL EXPOSING THE WALL CAVITY

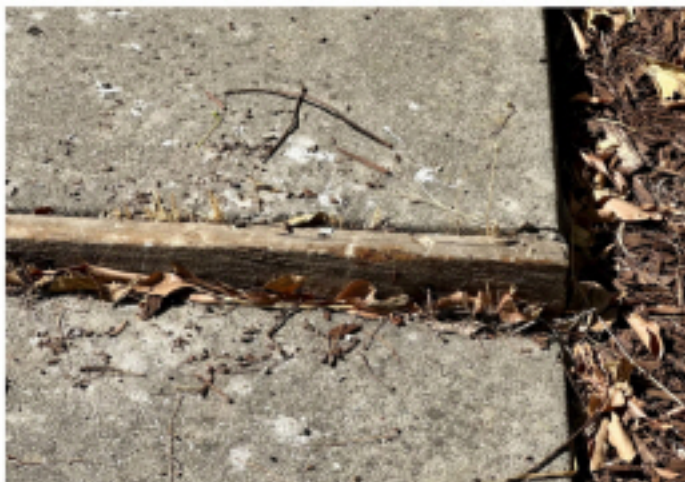
PHOTO #8

1. Sections of the concrete walkway at the front entry and near the South wall of the house are cracked and lifted from apparent common settling and/or tree roots. Suggest the walkways be repaired by a qualified licensed contractor. (Trip Hazard, See Photo #8)
2. Sections of the concrete patio near the garage is cracked and uneven from apparent common settling. Suggest the patio be repaired by a qualified licensed contractor. (Trip Hazard, See Photo #9)

THE CONCRETE WALKWAY
AT THE FRONT ENTRY AND
SOUTH WALL OF THE HOUSE
ARE CRACKED AND UNEVEN

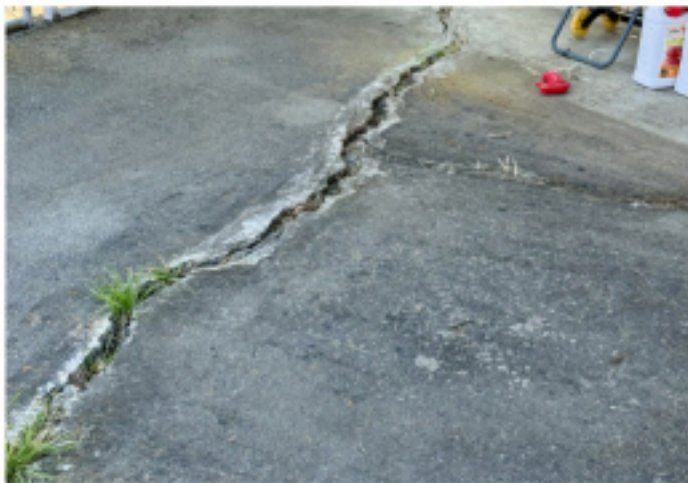
PHOTO #9

THE CONCRETE PATIO
NEAR THE EAST WALL OF
THE GARAGE IS CRACKED
AND UNEVEN
