INSPECTION DATE: April 21, 2025

REPORT NUMBER: A12721

PROPERTY INSPECTED: 3665 Sun View Way
Concord, CA 94520

The property inspected is a 3 bedroom, 2 bath single family home. The weather at the commencement of the inspection was clear with a temperature reading of approximately 62 degrees Fahrenheit.

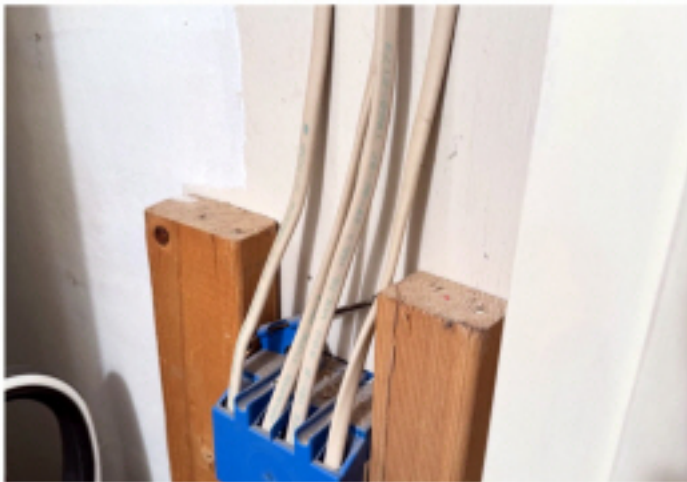
PHOTO #1

1. ROMEX wiring is exposed at the water heater closet. Suggest the wiring be housed in a protective raceway (in conduit or behind wallboard) to protective the wiring from physical damage. (Safety Concern, See Photo #1)

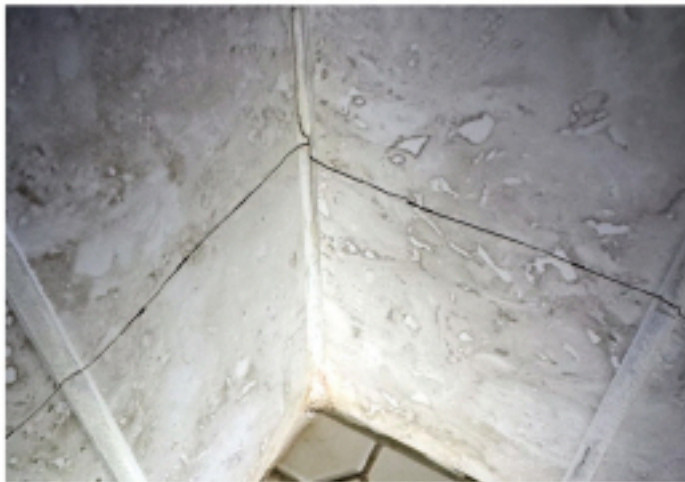
PHOTO #2

1. Approximately 4 tiles near the base of the shower surround are cracked. Suggest the damaged tiles be replaced or sealed with an epoxy sealant by a qualified licensed contractor as found needed. (See Photo #2)
2. The seams at the corners and base of the shower surround are poorly sealed. Suggest the seams be sealed with grout by a qualified licensed contractor as found needed. (See Photo #3)

APPROXIMATELY FOUR
TILES NEAR THE BASE OF
THE SHOWER SURROUND ARE
CRACKED

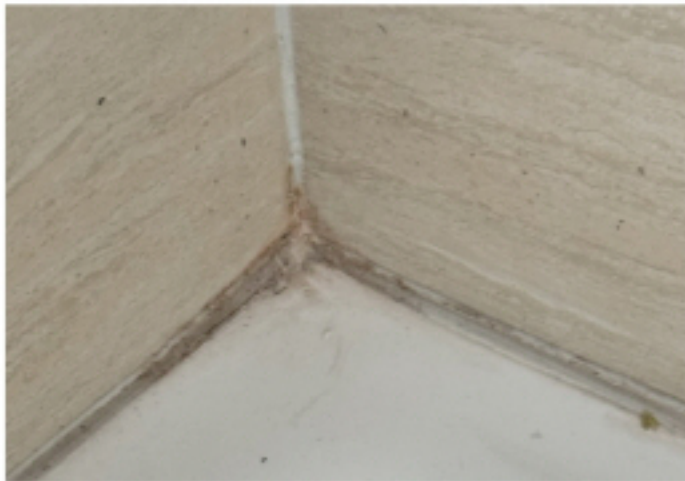
PHOTO #4

1. The seams at the base of the bathtub surround are poorly sealed. Suggest the seams be sealed with grout by a qualified licensed contractor as found needed. (See Photo #4)

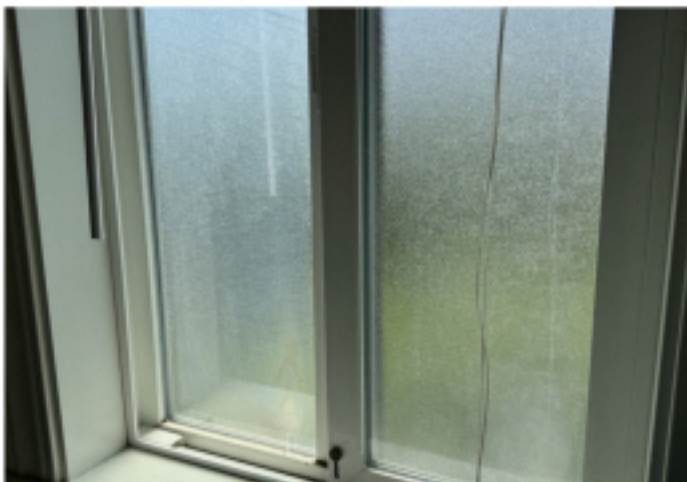
PHOTO #5

1. Condensation stains were noted between the frosted glass panes of the two sliding windows from apparent failed vacuum seals. Suggest the glass panes be replaced by a licensed window contractor. (See Photo #5)

CONDENSATION STAINS
NOTED BETWEEN FROSTED
GLASS PANES OF THE
TWO SLIDING WINDOWS

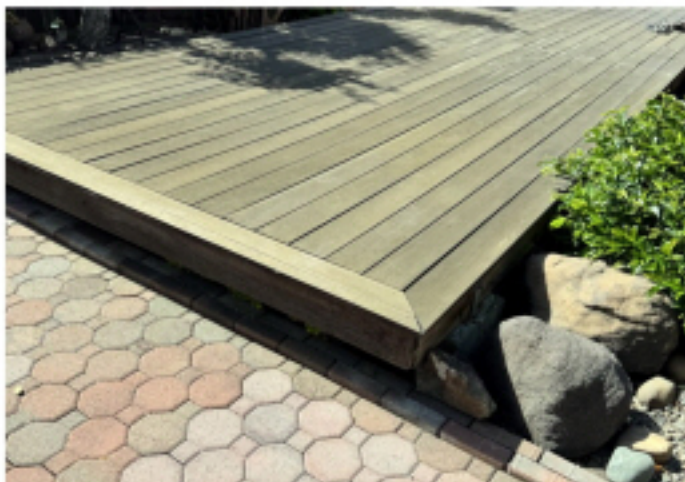
PHOTO #6

1. The inspection of the deck was limited due to a low clearance between the deck and ground. Please refer to the structural pest report for additional comments and recommendations, if any. (See Photo #6)

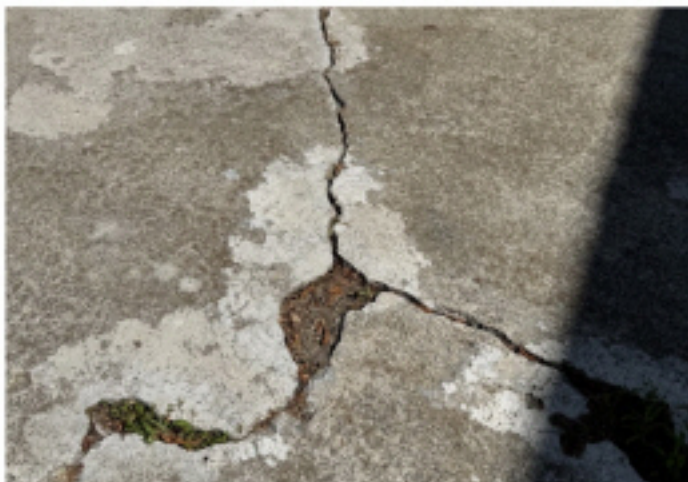
PHOTO #7

1. Sections of the concrete driveway is cracked and uneven from apparent common settling. Suggest the driveway be repaired by a qualified licensed contractor. (Trip Hazard, See Photo #7)

SECTION OF THE CONCRETE
DRIVEWAY IS CRACKED AND
UNEVEN
