B2021-0531 Just Residence

WELL INSPECTION REPORT

PROPERTY: 3974 Ciarlo Lane

Eaton Job Number: 21786

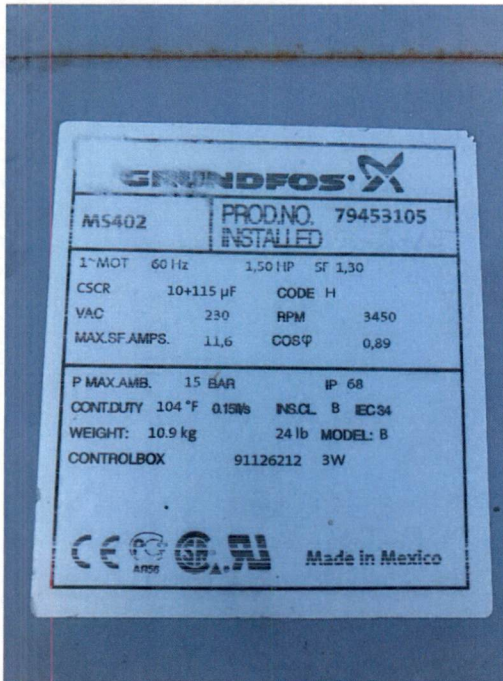
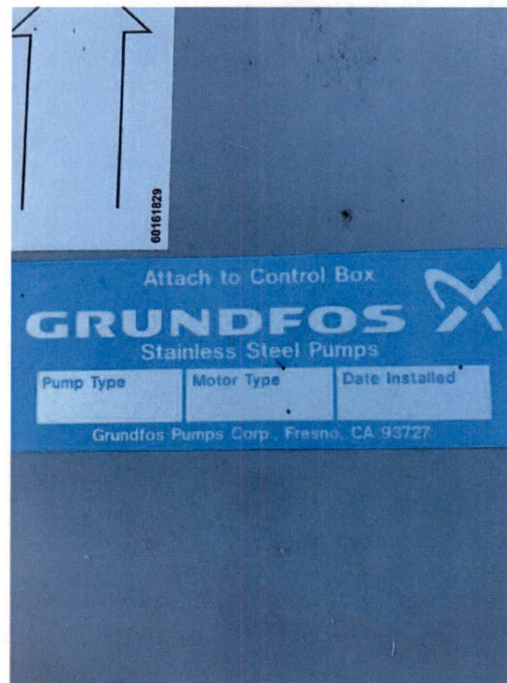
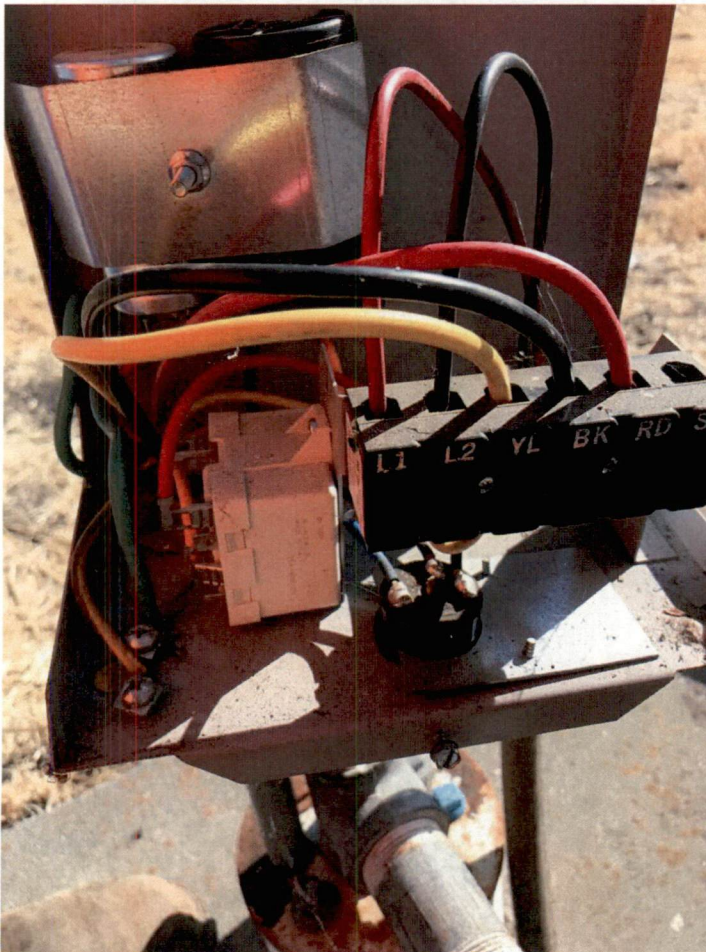
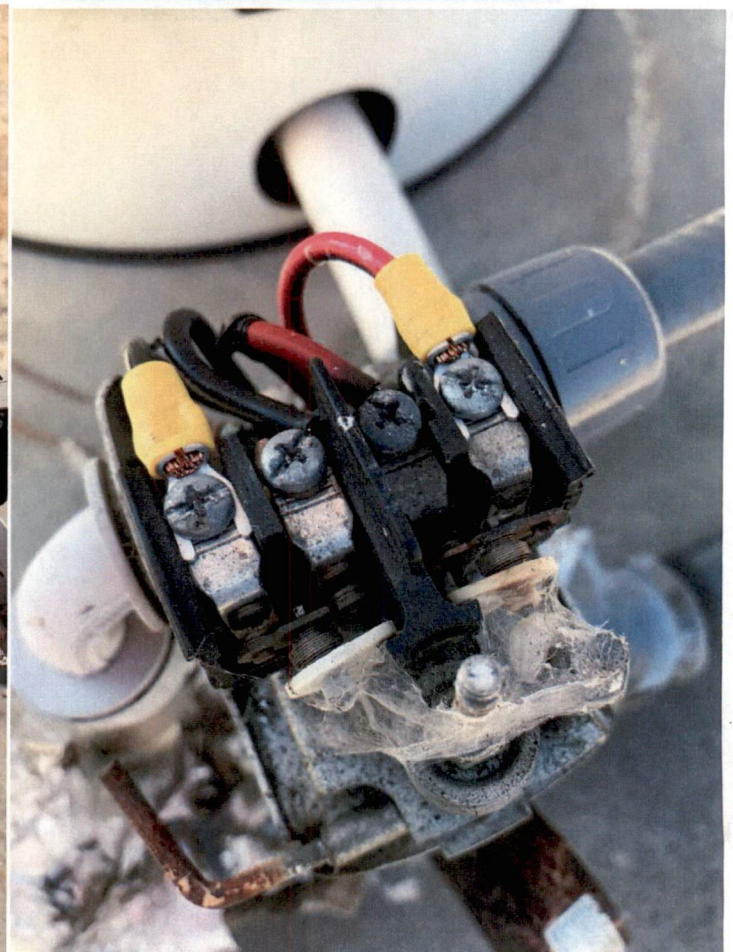
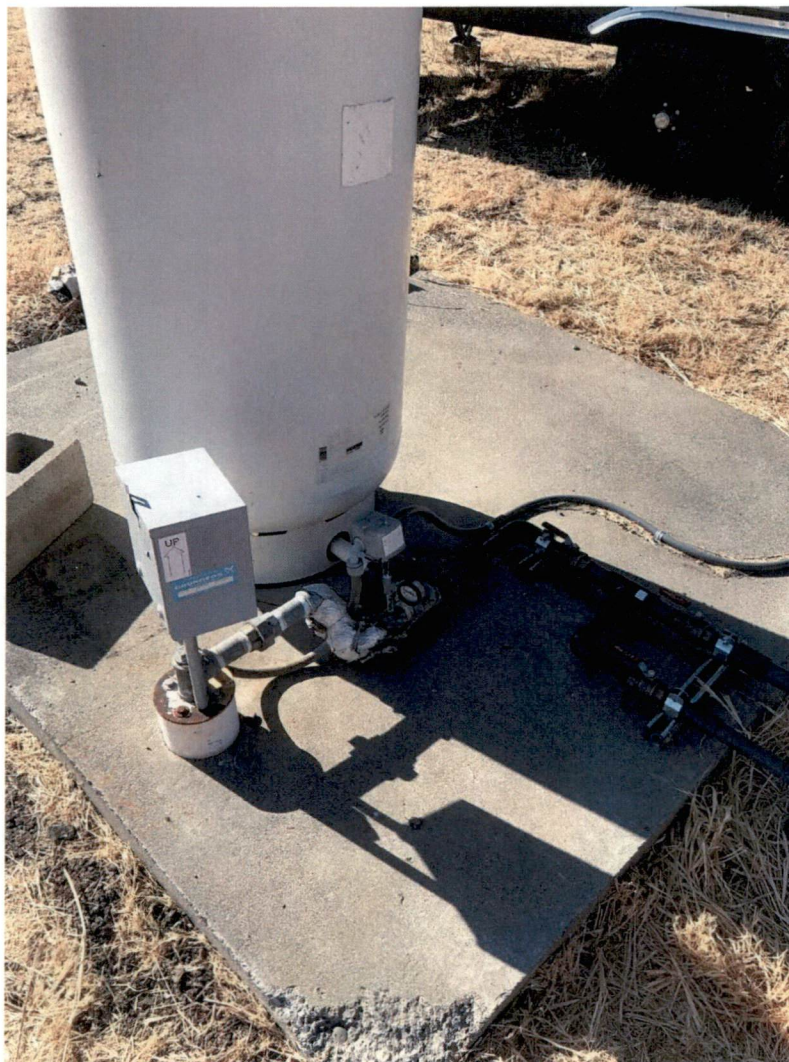
NOTES: During the inspection there was a few items that we noticed need to be replaced or added to the pumping system. A well vent needs to be added to the well seal and a pressure releif should be added to the discharge to protect the system if it over pressures. The tank also seems to have a ruptured bladder and should be replaced with a new one, also the pressure switch should be changed out since the contacts are burnt. We tried to get the depth of the well but we could not get our sounder past 280' in the well. We tried to perform a four hour flow test for fire protection but we were only able to run the pump for a hour an ten minutes before the pump broke suction. The pump produces a high volume of water under great pressure. We tried chocking back the pump to decrese the volume without harming any of the pumping equipment. We were only able to slow it down to 11.7 gallons per minute at 60psi.

Installed	Condition	Comments
<u>Sanitary Well Seal:</u>	Yes	Fair	
<u>Back Flow Preventer:</u>	Yes	Fair	Old But Works
<u>Pressure Switch:</u>	Yes	Poor	Burnt Contacts
<u>Pressure Gauge:</u>	Yes	Fair	
<u>Pressure Relief:</u>	No	N/A	Should Be Installed
<u>Air Vent:</u>	No	N/A	Should Be Installed
<u>Bleed Back Valve:</u>	N/A	N/A	
<u>Air Volume Control:</u>	N/A	N/A	
<u>Panel:</u>	Yes	Fair	Grundfo Control Box
<u>Sand Separator or Filter:</u>	N/A	N/A	
<u>Low Flow Protection:</u>	N/A	N/A	
<u>Plumbing Equipment:</u>	Yes	Fair	1-1/4"
<u>Concrete Pad:</u>	Yes	Fair	84"x84"
<u>Bacteriological Filtration:</u>	N/A	N/A

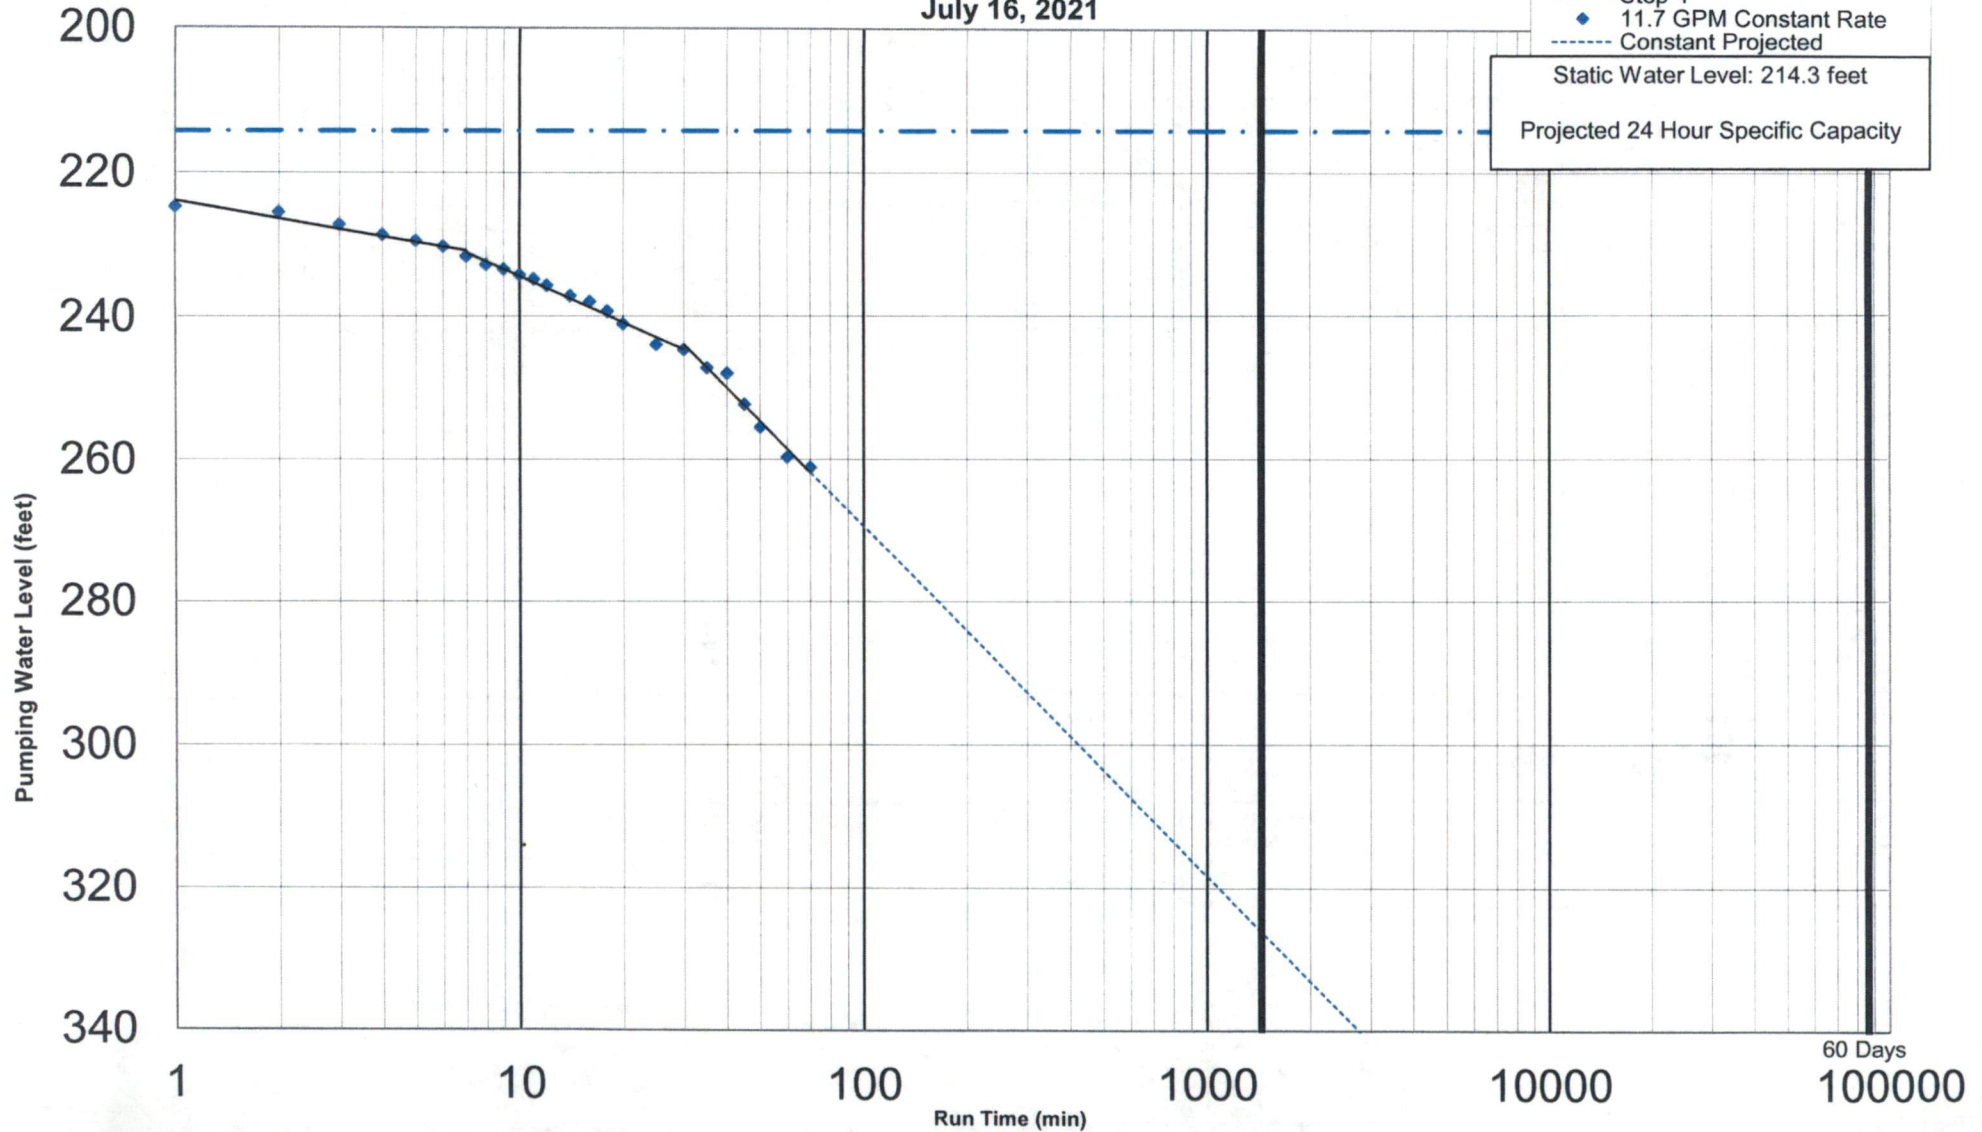
Static Water Level: 214.3 Feet								
Step Test Results								
GPM	PWL	Yield	24 Hr Projected		\$/kW H: \$0.15		Sand	Notes
			PWL	Yield	HP Motor	\$/Acre Ft		
Constant Rate Test Results								
11.7	261.17	0.2	326.09	0.1	2	\$103.88	0.0 ppm

Constant Rate	
SWL: 214.3	
11.7	GPM
1	224.75
2	225.5
3	227.17
4	228.58
5	229.42
6	230.25
7	231.67
8	232.83
9	233.42
10	234.25
11	234.83
12	235.75
14	237.17
16	238
18	239.33
20	241.08
25	243.92
30	244.67
35	247.25
40	248
45	252.33
50	255.58
60	259.75
70	261.17

Projected 24 Hour Specific Capacity	
11.7 Constant Rate	0.1 gpm/ft dd
Step	gpm/ft dd
Step	gpm/ft dd
Step	gpm/ft dd
Step	gpm/ft dd
