WOOD DESTROYING PESTS AND ORGANISMS INSPECTION REPORT

Building No. 454	Street MANZANTIA AVENUE	City Fairfield	ZIP 94533	Date of Inspection 10/24/2023	Number of Pages 5
---------------------	----------------------------	-------------------	--------------	----------------------------------	----------------------

GENERAL DESCRIPTION: Two-story single family residence, stucco and wood siding, composite roof, occupied/furnished, attached garage	Inspection Tag Posted: Garage
	Other Tags Posted:

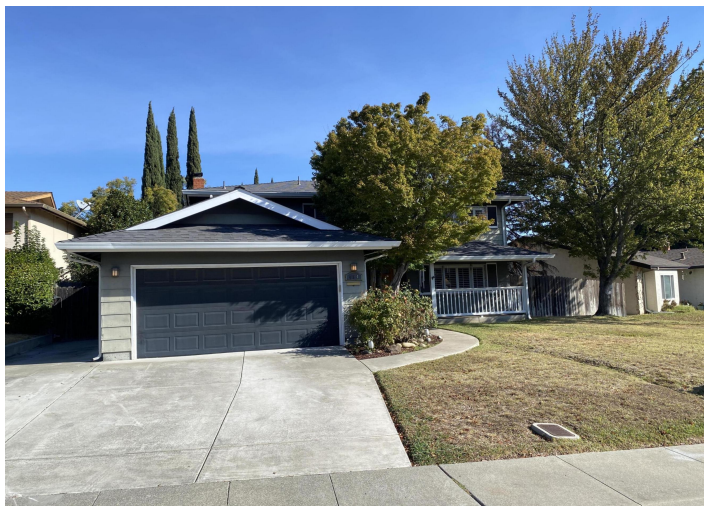
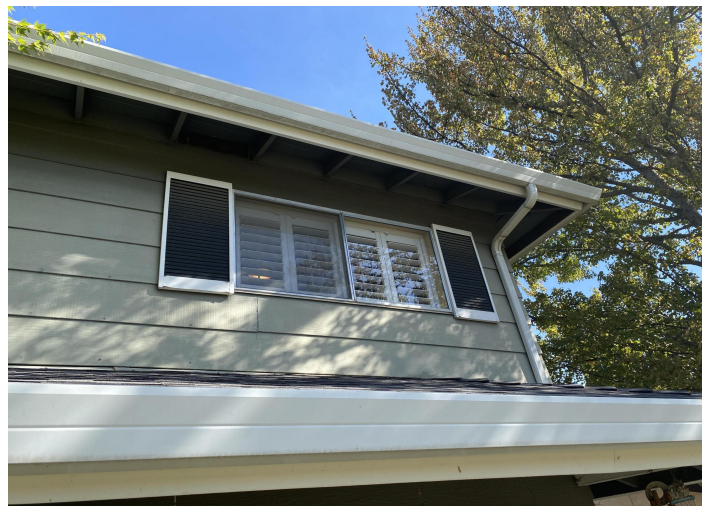
FINDING: The exterior window shutters appear to have peeling and/or bubbling paint exposing wood rendering it vulnerable to potential infection by fungus/dry-rot.

4A - PEELING PAINT (SHUTTERS)

RECOMMENDATION: Owner or interested parties are advised to employ the services of an appropriate licensed painting contractor to scrape these surfaces and apply new paint or other wood sealer.

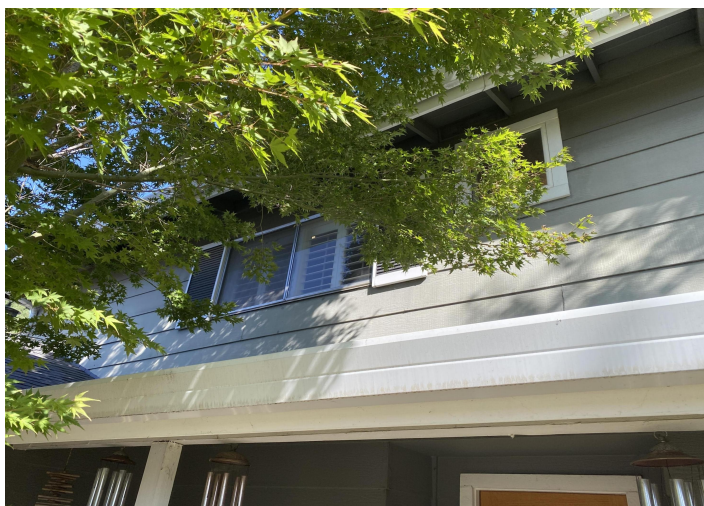
4A - PEELING PAINT (SHUTTERS)
