INSPECTION DATE: September 6, 2023

REPORT NUMBER: A21291

PROPERTY INSPECTED: 7868 Spencer Ln
Vacaville, CA 95688

The property inspected is a 3 bedroom, 2 bath single family home (per county records). The weather at the commencement of the inspection was clear with a temperature reading of approximately 92 degrees Fahrenheit.

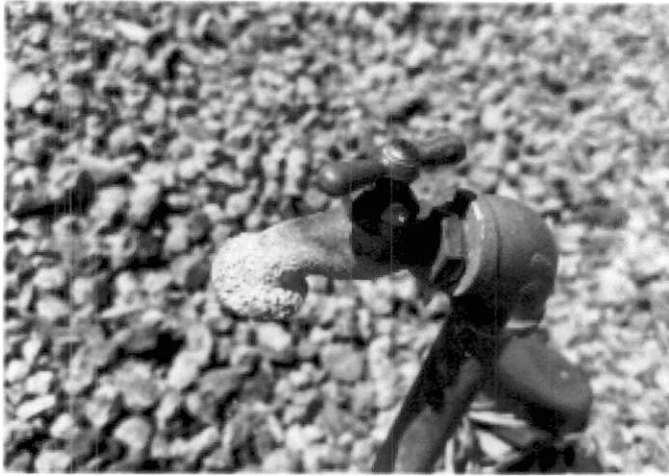
PHOTO #1

1. The hose bibb near the driveway will not shut off completely and water drips from the spout. Suggest the hose bibb be repaired or replaced by qualified licensed contractor as found needed. (See Photo #1)

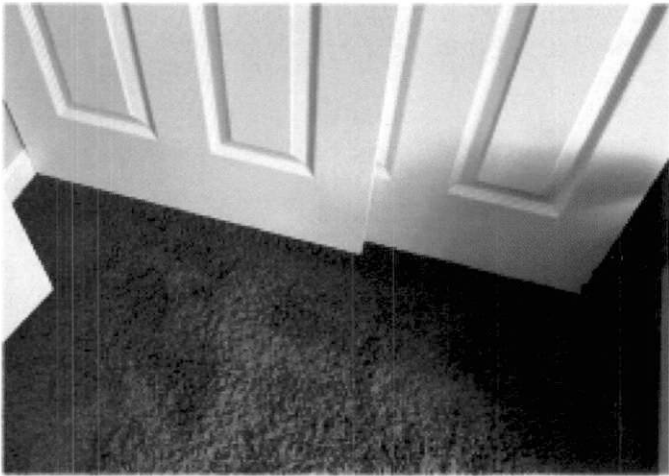
PHOTO #3

1. The center guide at the base of the sliding closet doors is missing. Suggest a center guide be installed by a qualified licensed contractor. (See Photo #3)

THE CENTER GUIDE AT THE BASE OF THE SLIDING CLOSET DOORS IS MISSING

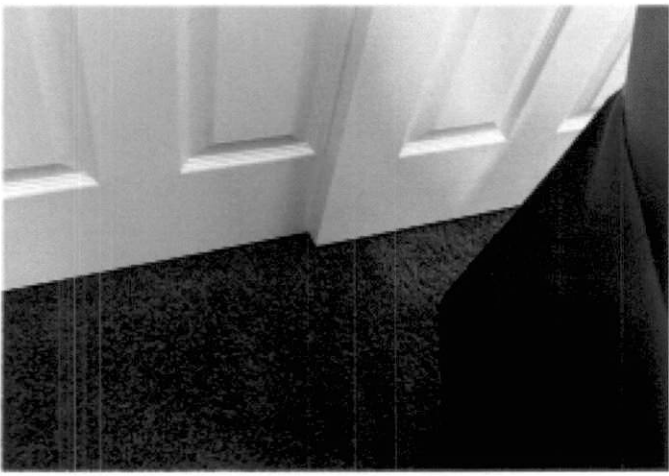
PHOTO #5

1. Condensation stains were noted between the glass panes of the sliding window from an apparent failed vacuum seal. Suggest the glass panes be replaced by a licensed window contractor. (Stationary Side, See Photo #4)
2. The center guide at the base of the sliding closet doors is missing. Suggest a center guide be installed by a qualified licensed contractor. (See Photo #5)

THE CENTER GUIDE AT THE BASE OF THE SLIDING CLOSET DOORS IS MISSING

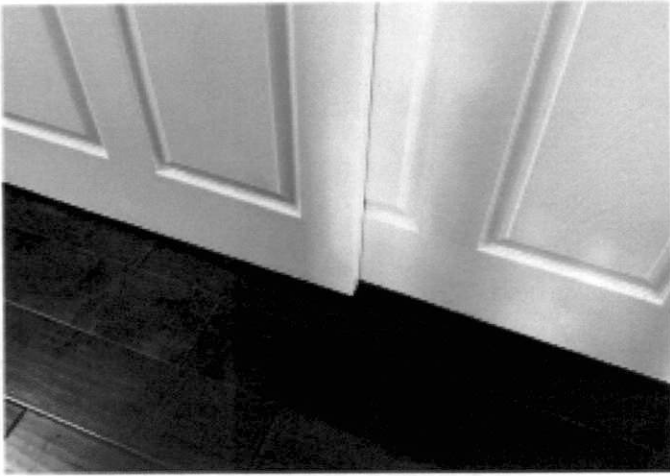
PHOTO #7

2. The center guide at the base of the sliding closet doors is missing. Suggest a center guide be installed by a qualified licensed contractor. (See Photo #7)
