**INSPECTION DATE:** November 2, 2022

**REPORT NUMBER:** A21323

**PROPERTY INSPECTED:** 896 Granada Ln  
Vacaville, CA 95688

The property inspected is a 4 bedroom, 3.5 bath single family home. The weather at the commencement of the inspection was clear with a temperature reading of approximately 56 degrees Fahrenheit.

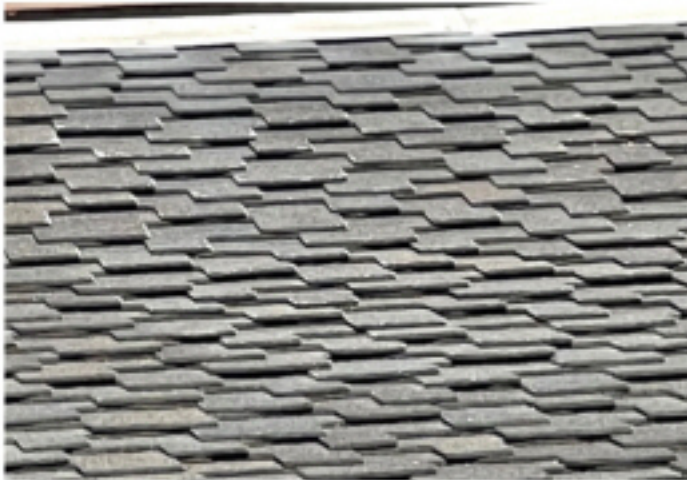
**PHOTO #1**

1. The edges of numerous roofing shingles at the South roof exposure appear worn (as viewed from the roof eaves). Suggest the roof be further inspected by a licensed roofing contractor. (See Photo #1)

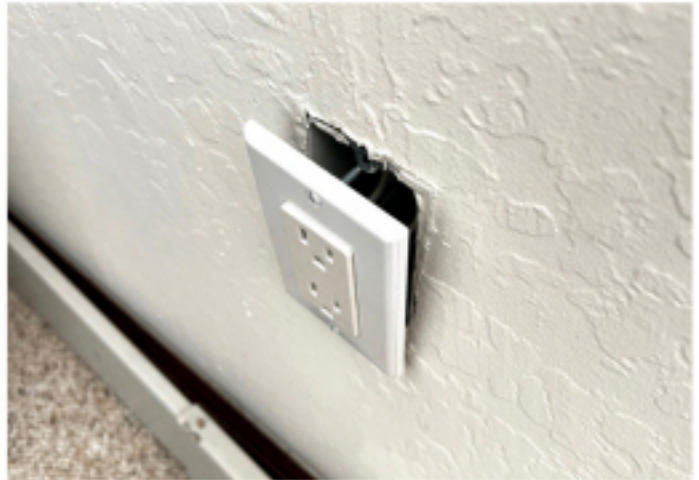
**PHOTO #2**

1. One electrical outlet at the South wall of the bedroom is poorly secured to the outlet box and is loose. Suggest the electrical outlet be repaired by a qualified licensed contractor. (Safety Concern, See Photo #2)

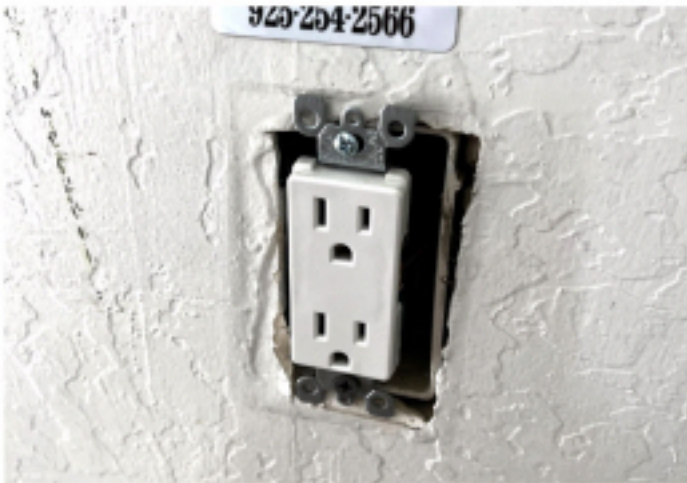
**PHOTO #3**

1. The faceplate to one electrical outlet at the garage interior is missing. Suggest a faceplate be installed by a qualified licensed contractor. (See Photo #3)

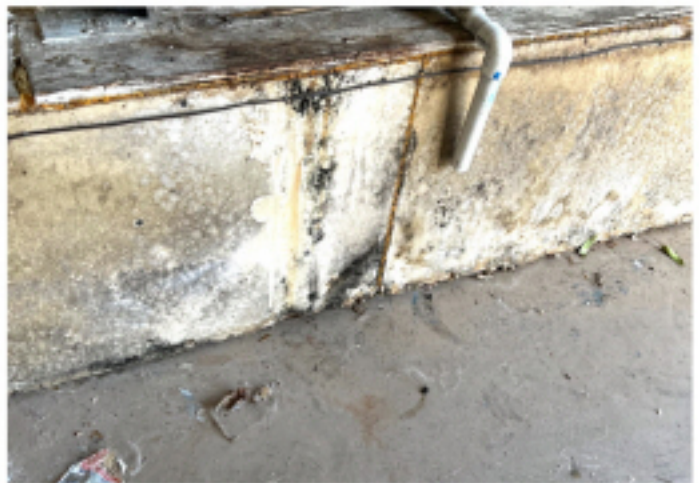
**PHOTO #4**

1. The drywall at the face of the water heater stand is damaged from an apparent past plumbing leak (no active leak was found). Suggest the damaged drywall be replaced by a qualified licensed contractor. (See Photo #4)

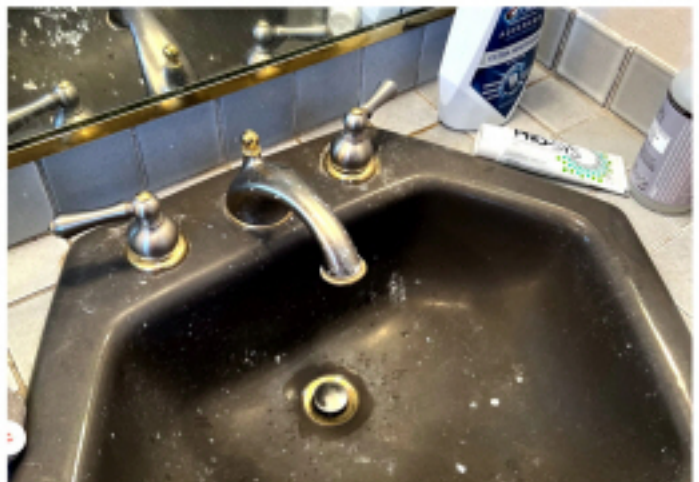
**PHOTO #6**

1. The pop-up drain stopper at the right sink basin is inoperable. Suggest the drain stopper assembly be repaired or replaced by a qualified licensed contractor as found needed. (See Photo #6)

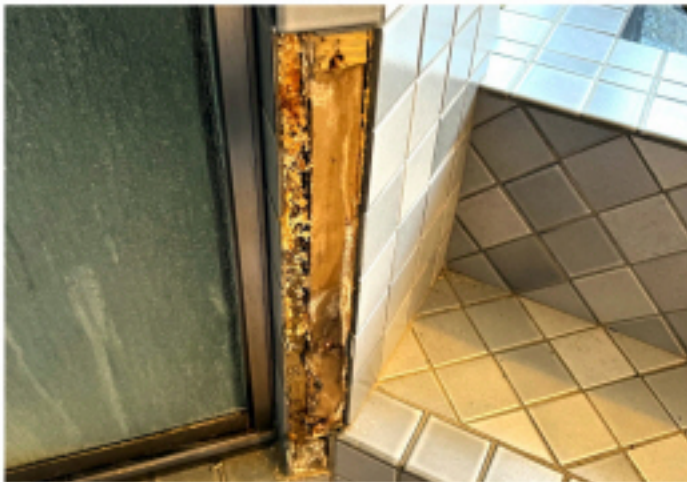
**PHOTO #7**

2. Numerous tiles at the shower surround are missing near the shower door. Suggest the shower surround be repaired by a qualified licensed contractor. (See Photo #7)

SEVERAL WALL TILES  
OUTSIDE THE SHOWER  
SURROUNDING ARE MISSING

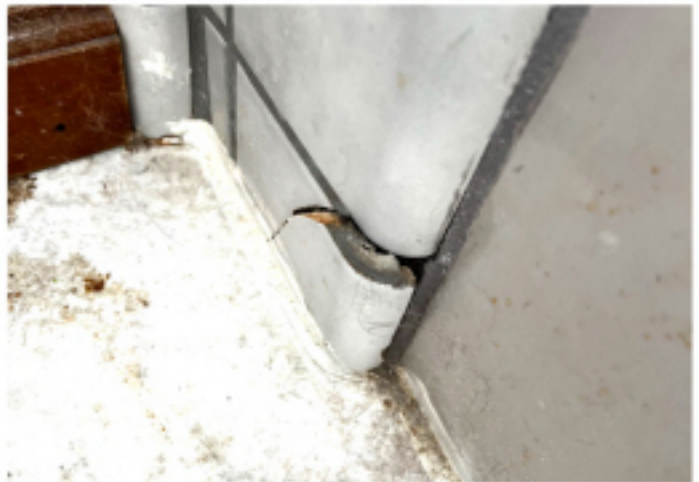
1. Numerous tiles at the bathtub surround are broken. Suggest the bathtub surround be repaired by a qualified licensed contractor. (See Photo #8)
2. The seam at the base of the bathtub surround is poorly sealed. Suggest the seam be sealed with a caulking material by a qualified licensed contractor. (See Photo #9)

SEVERAL TILES AT THE  
BATHTUB SURROUND ARE  
BROKEN

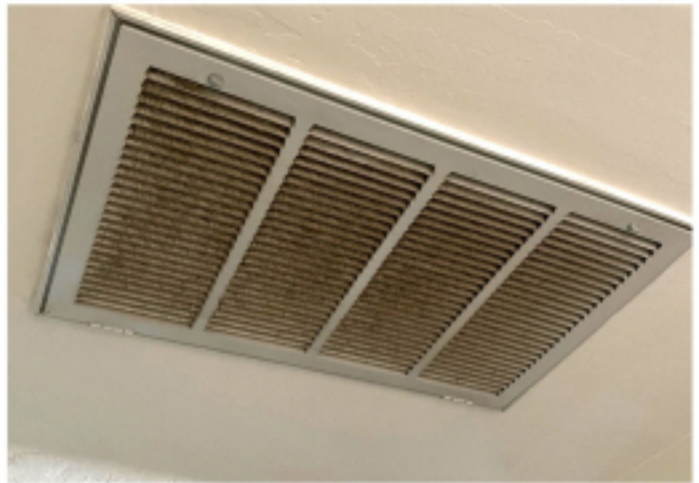
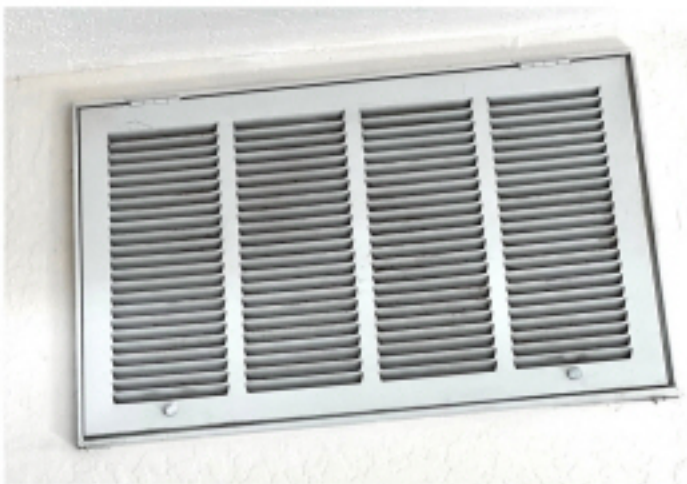
1. The filters at the two air return registers are dirty. Suggest the filters be replaced as a part of normal maintenance. (See Photo #10 and Photo #11)

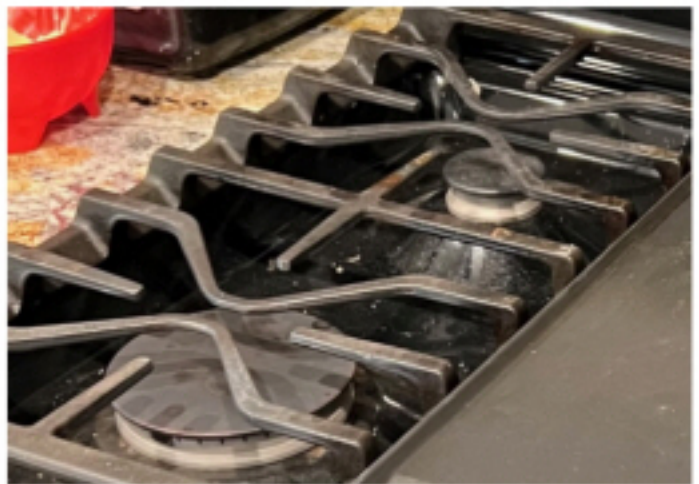
**PHOTO #12**

1. The two left burners at the gas cooktop are inoperable (burners would not ignite). Suggest the cooktop be repaired by a qualified licensed contractor. (See Photo #12)

TWO BURNERS AT THE  
GAS COOKTOP ARE  
INOPERABLE

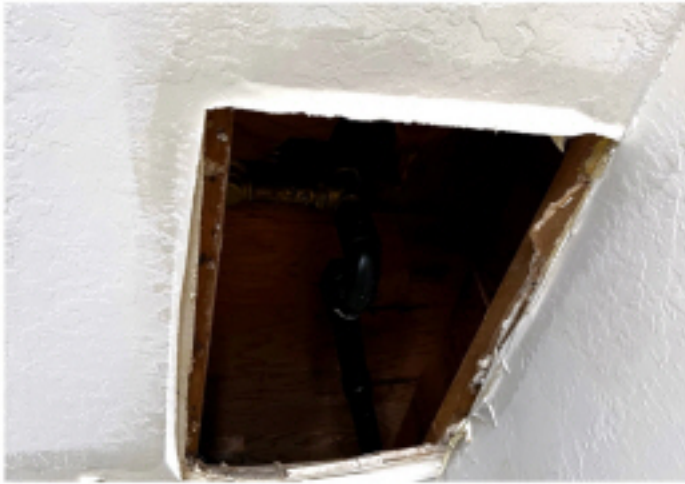
**PHOTO #13**

1. An approximate 2' x 3' opening was noted in the drywall at the front entry ceiling from an apparent past plumbing leak repair (no active leak was found). Suggest the ceiling be repaired by a qualified licensed contractor. (See Photo #13)

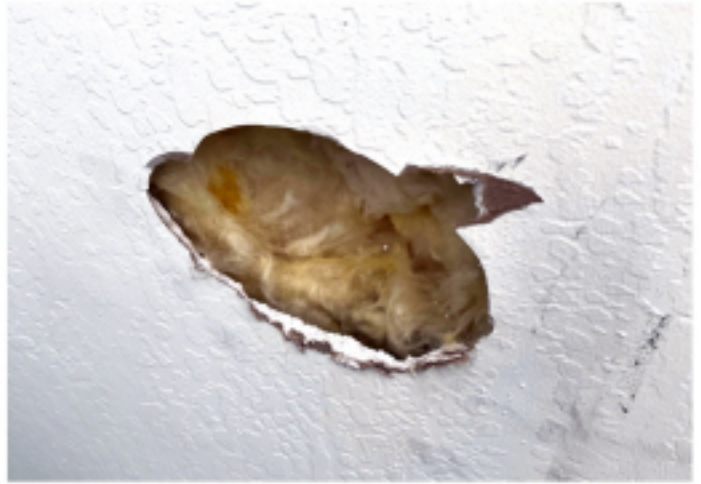
**PHOTO #14**

1. An approximate 8" diameter hole was noted in the South wall of the bedroom. Suggest the wall be repaired by a qualified licensed contractor. (See Photo #14)

APPROX 8" DIA HOLE  
NOTED IN THE SOUTH  
WALL

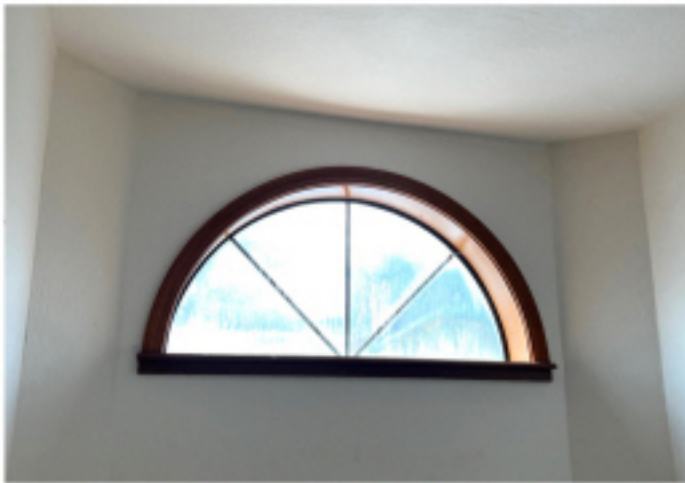
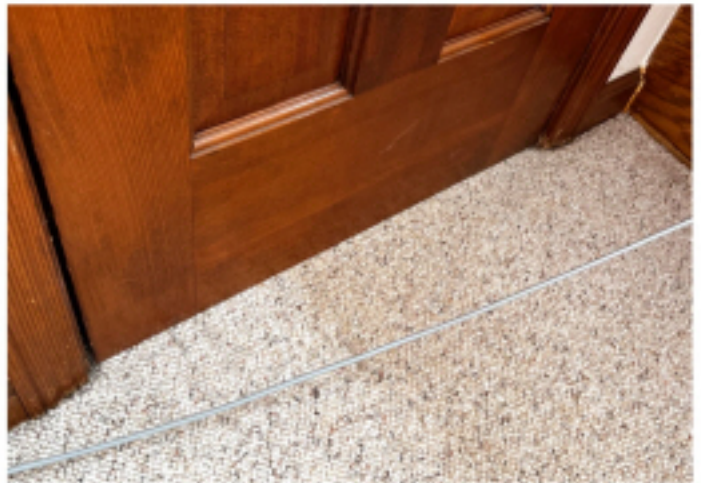
1. Condensation stains noted between the glass panes of the fixed window from an apparent failed vacuum seal. Suggest the glass panes be replaced by a licensed window contractor. (See Photo #15)
2. The base of the closet door drags on the carpet floor covering and is difficult to open and close. Suggest the door be repaired by a qualified licensed contractor. (See Photo #16)

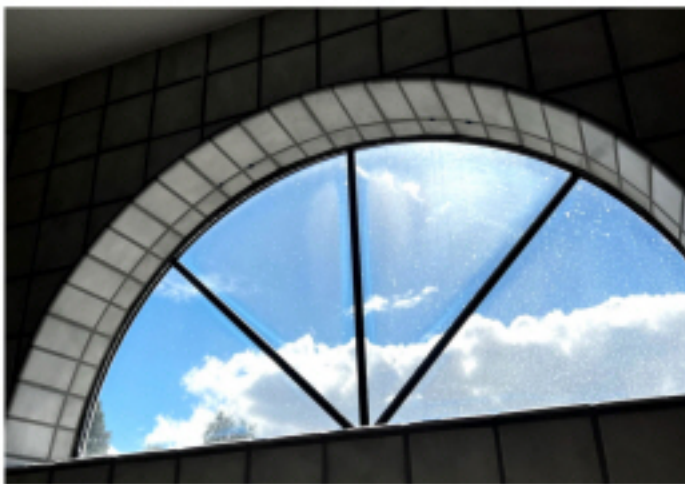
**PHOTO #17**

1. Condensation stains noted between the glass panes of the fixed window from an apparent failed vacuum seal. Suggest the glass panes be replaced by a licensed window contractor. (See Photo #17)

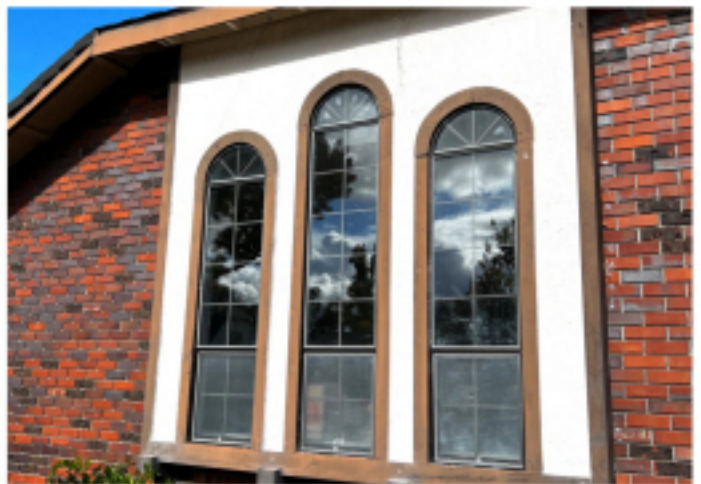
**PHOTO #18**

1. Condensation stains were noted between the glass panes of the three double hung windows from apparent failed vacuum seals. Suggest the glass panes be replaced by a licensed window contractor. (See Photo #18)

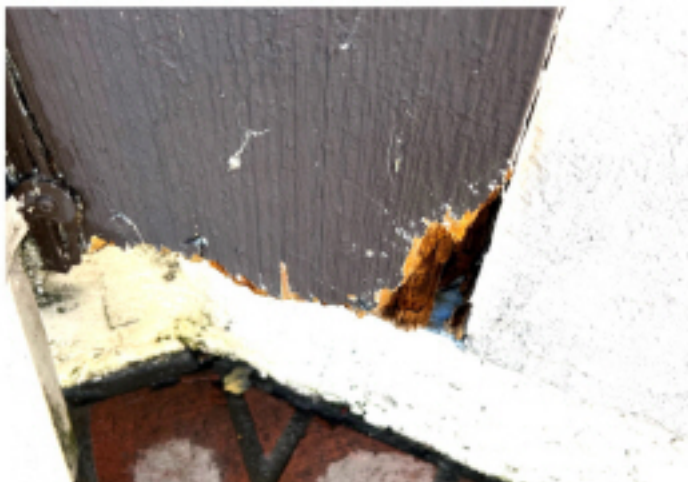
**PHOTO #20**

1. Two wood trim boards at the North wall of the house appear moisture damaged. Please refer to the structural pest report for additional comments and recommendations, if any. (See Photo #20)

TWO WOOD TRIM BOARDS AT  
THE NORTH WALL OF THE  
HOUSE APPEAR MOISTURE  
DAMAGED
