INSPECTION DATE: April 29, 2021

REPORT NUMBER: A71637

PROPERTY INSPECTED: 161 Florence Ct
Vallejo, CA 94589

The property inspected is a 4 bedroom, 2 bath single family home. The weather at the commencement of the inspection was clear with a temperature reading of approximately 73 degrees Fahrenheit.

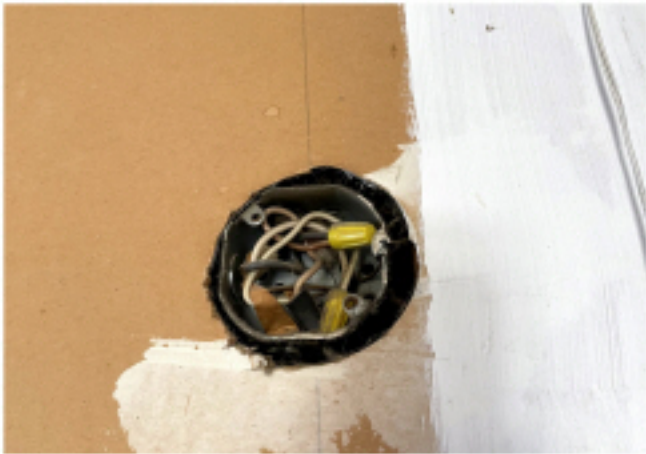
PHOTO #1

1. The cover plate to one junction box at the North wall of the garage interior is missing. Suggest a cover plate be installed by a qualified licensed contractor. (Safety Concern, See Photo #1)

THE COVER TO ONE JUNCTION BOX AT THE GARAGE IS MISSING

THE COVER TO ONE J-BOX AT THE NORTH WALL IS MISSING

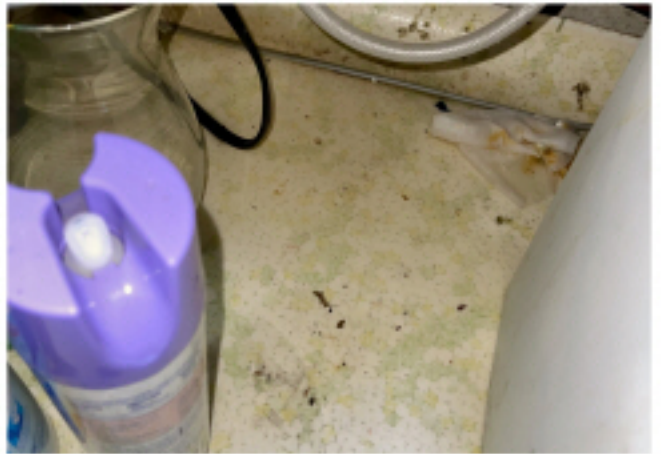
PHOTO #2

1. The shelf in the cabinet opening below the kitchen sink was found wet from an apparent plumbing leak (the location of the leak was not found). Suggest the sink plumbing be further inspected by a qualified licensed contractor. (See Photo #2)
2. The kitchen sink countertop underlayment is stained near the sink basin and the particleboard shelf in the cabinet opening below the sink appears moisture damaged. Please refer to the structural pest report for additional comments and recommendations, if any. (See Photo #3 and Photo #4)

A PLUMBING LEAK NOTED BELOW THE SINK

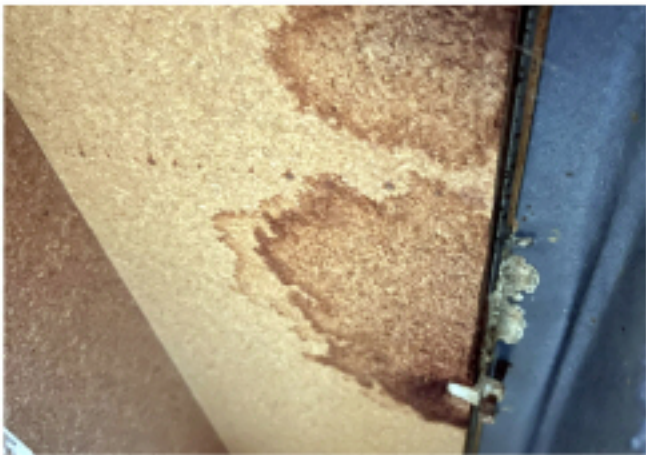
PHOTO #3

THE SINK COUNTERTOP UNDERLAYMENT IS STAINED. THE PARTICLE BOARD SHELF BELOW THE SINK APPEARS MOISTURE DAMAGED

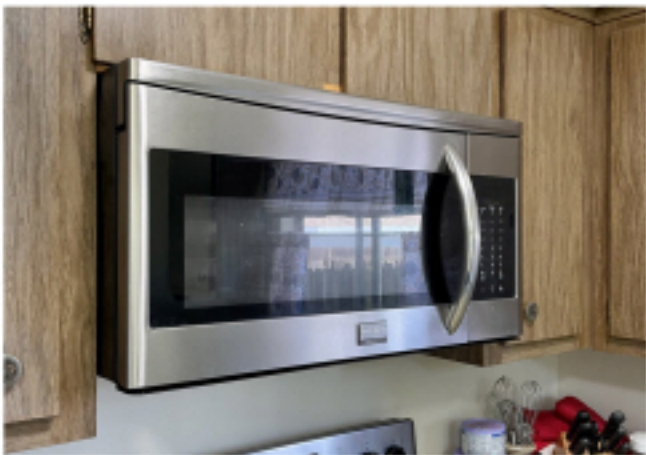
PHOTO #5

1. The microwave is inoperable (would not respond to the operating controls). Suggest the microwave oven be repaired or replaced by a qualified licensed contractor as found needed. (See Photo #5)

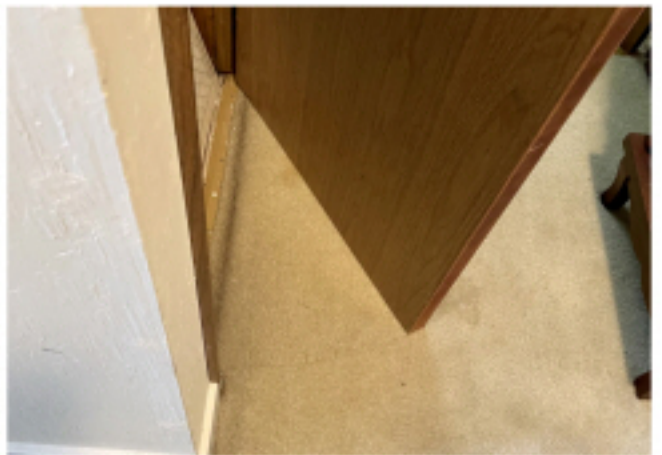
PHOTO #6

1. The base of the furnace closet door drags on the carpet and is difficult to open and close. Suggest the door be repaired by a qualified licensed contractor. (See Photo #6)

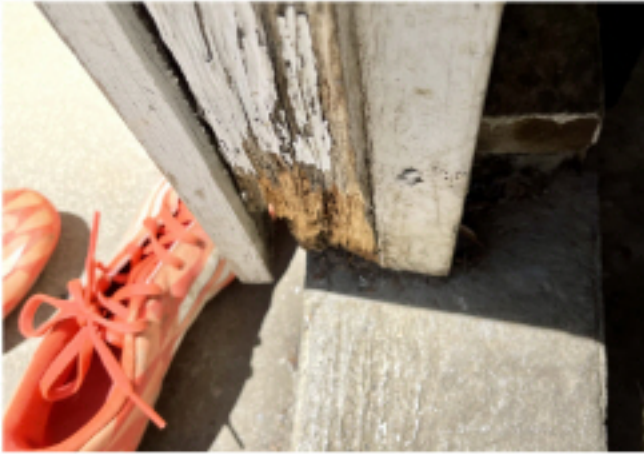
PHOTO #7

1. The base of the door jamb to the garage pedestrian door appears moisture damaged. Please refer to the structural pest report for additional comments and recommendations, if any. (See Photo #7)

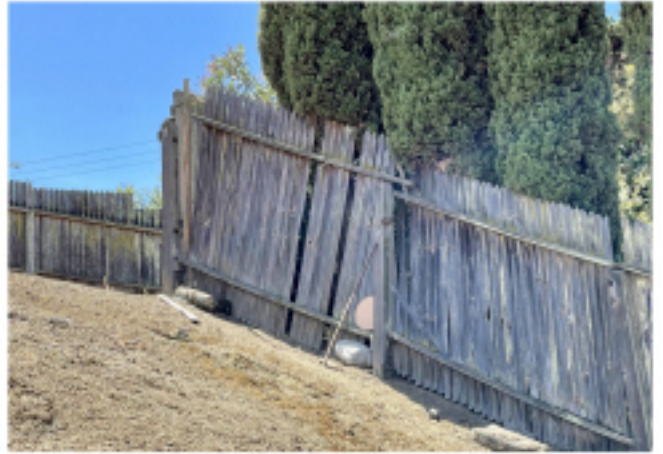
PHOTO #8

1. Several fence posts and slats at the South fence line are broken and loose. Suggest the fence be repaired by a qualified licensed contractor. (See Photo #8)

SEVERAL FENCE POSTS
AND SLATS AT THE SOUTH
FENCE LINE ARE
BROKEN/LOOSE
