INSPECTION DATE: July 6, 2021

REPORT NUMBER: A71421

PROPERTY INSPECTED: 401 Donaldson Ct
Suisun City, CA 94585

The property inspected is a 4 bedroom, 2.5 bath single family home. The weather at the commencement of the inspection was clear with a temperature reading of approximately 63 degrees Fahrenheit.

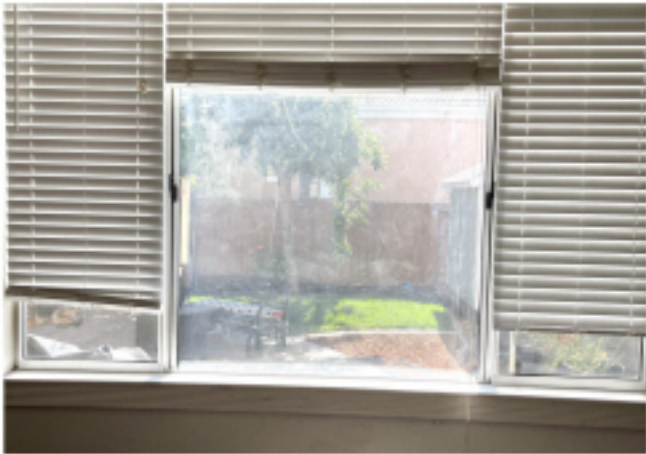
PHOTO #1

1. Condensation stains were noted between the glass panes of one sliding window from an apparent failed vacuum seal. Suggest the glass panes be replaced by a licensed window contractor. (Stationary Side, See Photo #1)
2. Condensation stains were noted between the glass panes of one fixed window from an apparent failed vacuum seal. Suggest the glass panes be replaced by a licensed window contractor. (See Photo #2)

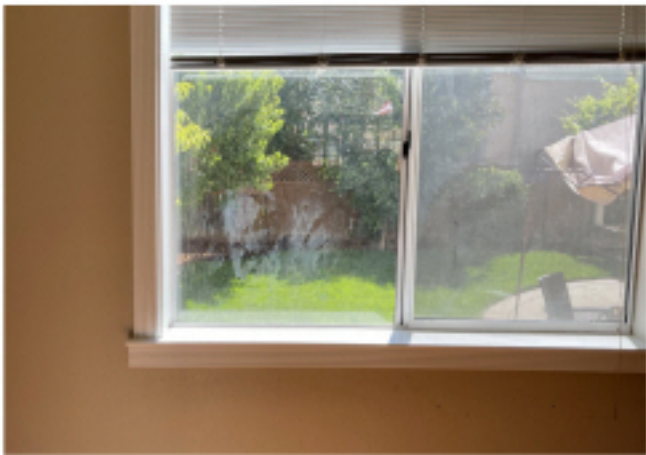
PHOTO #3

1. Condensation stains were noted between the glass panes of one sliding window from an apparent failed vacuum seal. Suggest the glass panes be replaced by a licensed window contractor. (Stationary Side, See Photo #3)

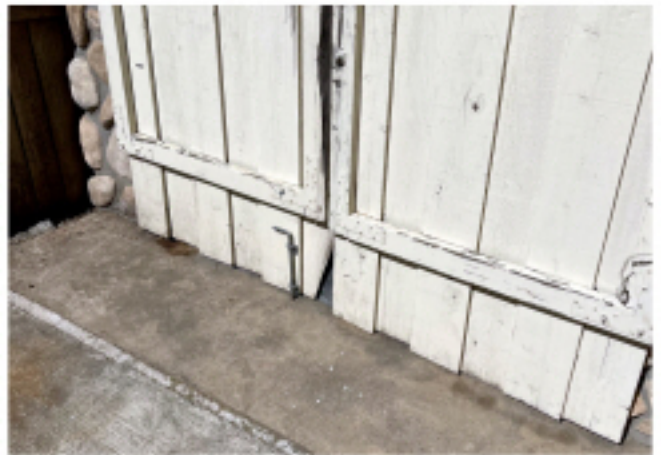
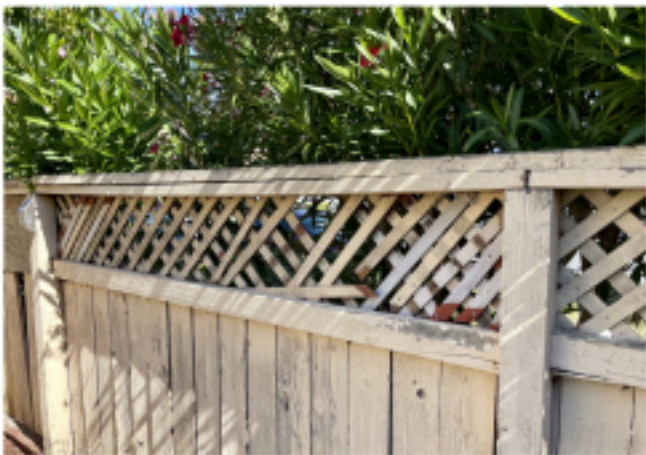
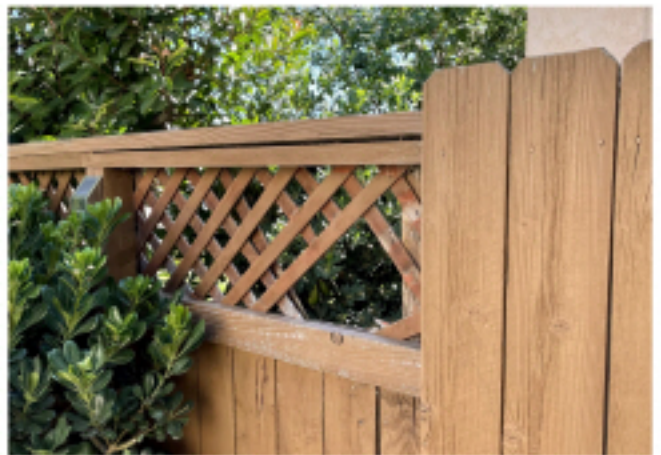
1. The double gates near the South wall of the house drag on the concrete walkway and several lattice privacy panels along the fence perimeter are broken. Suggest the gate and fence be repaired by a qualified licensed contractor. (See Photo #4, Photo #5 and Photo #6)

SEVERAL LATTICE PRIVACY PANELS ALONG THE FENCE PERIMETER ARE BROKEN. THE DOUBLE GATE DRAGS ON THE CONCRETE WALKWAY
