**INSPECTION DATE:** July 30, 2021

**REPORT NUMBER:** A71281

**PROPERTY INSPECTED:** 2712 Soho Ln  
Fairfield, CA 94533

The property inspected is a 3 bedroom, 2.5 bath single family home. The weather at the commencement of the inspection was clear with a temperature reading of approximately 91 degrees Fahrenheit.

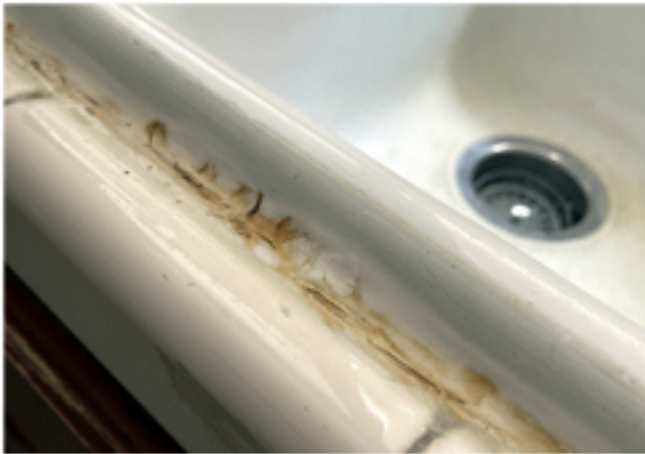
**PHOTO #1**

1. The seam at the sink rim is poorly sealed. Suggest the seam be sealed with a caulking material by a qualified licensed contractor as found needed. (See Photo #1)
2. Two edge tiles at the sink countertop near the dishwasher are cracked. Suggest the damaged tiles be replaced by a qualified licensed contractor. (See Photo #2)
3. One tile at the baseboard near the dishwasher is missing. Suggest a replacement tile be installed by a qualified licensed contractor. (See Photo #3)

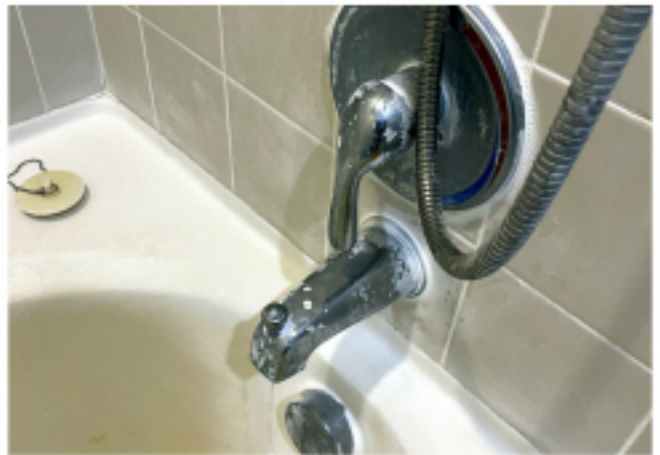
**PHOTO #4**

1. The bathtub faucet will not shut off completely and water drips continuously from the spout. Suggest the bathtub faucet be repaired by a qualified licensed contractor. (See Photo #4)
2. The seam at the base of the bathtub surround is poorly sealed. Suggest the seam be sealed with a caulking material by a qualified licensed contractor as found needed. (See Photo #5)

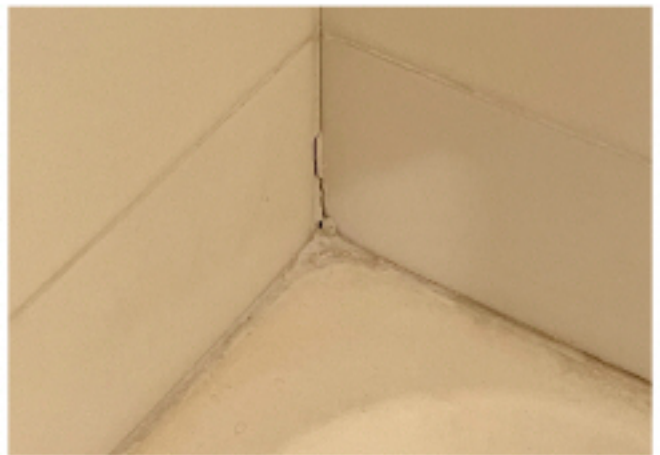
**PHOTO #6**

1. The seams at the corners and base of the bathtub surround are poorly sealed. Suggest the seams be sealed with a caulking material by a qualified licensed contractor as found needed. (See Photo #6)

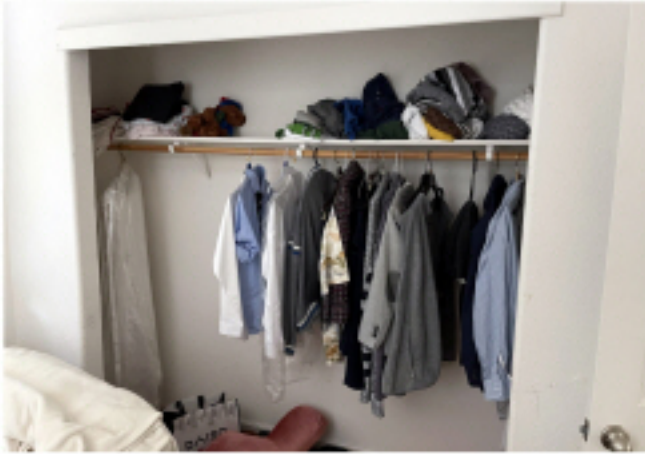
**PHOTO #7**

1. The sliding closet doors have been removed and were found in the garage. Suggest the closet doors be re-installed by a qualified licensed contractor. (See Photo #7)

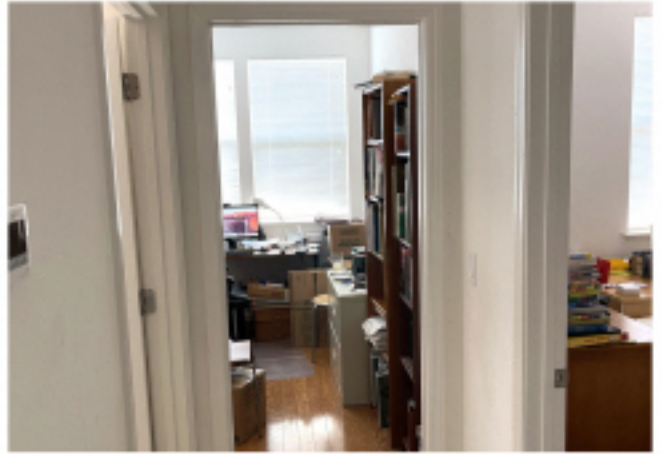
**PHOTO #8**

1. The entry door is missing. Suggest a door be installed by a qualified licensed contractor. (See Photo #8)

COMMENTS  
THE ENTRY DOOR IS MISSING
