**REPORT NUMBER:** A71921

**PROPERTY INSPECTED:** 4424 Fenwick Way  
North Highlands, CA 95660

The property inspected is a 3 bedroom, 2 bath single family home. The weather at the commencement of the inspection was clear with a temperature reading of approximately 70 degrees Fahrenheit.

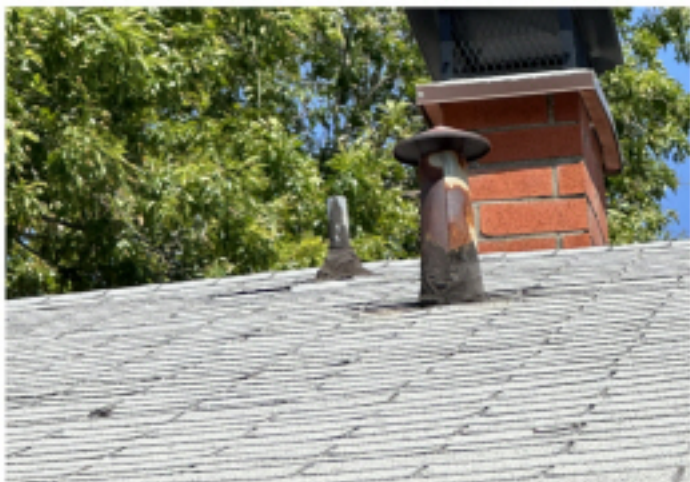
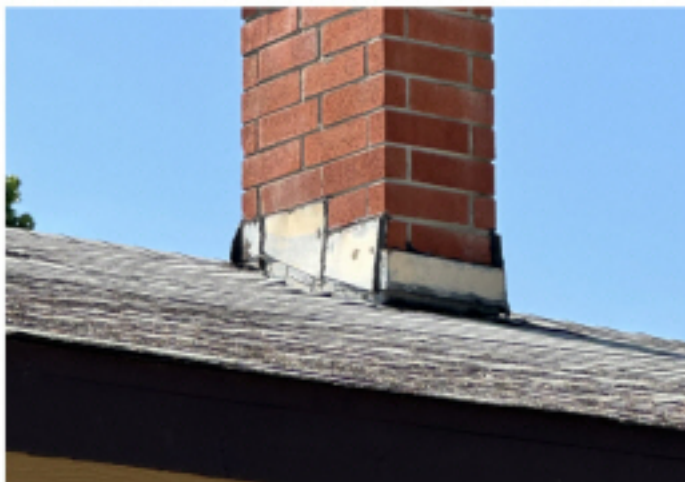
**PHOTO #1**

1. A few roofing shingles appear damaged and the seams at the plumbing vent roof jacks and chimney flashing appear poorly sealed. Suggest the roof be further inspected by a licensed roofing contractor and be repaired as found needed. (See Photo #1 and Photo #2)
2. Gutters and downspouts are not present at the roof overhangs above the dining room sliding glass door, overhead garage door and garage pedestrian door. Suggest gutters and downspouts be installed by a qualified licensed contractor to direct water away from the doors during periods of rainfall. (See Photo #3, Photo #4 and Photo #5)

A FEW ROOFING SHINGLES APPEAR DAMAGED. THE SEAMS AT THE ROOF JACKS AND CHIMNEY FLASHINGS APPEAR POORLY SEALED

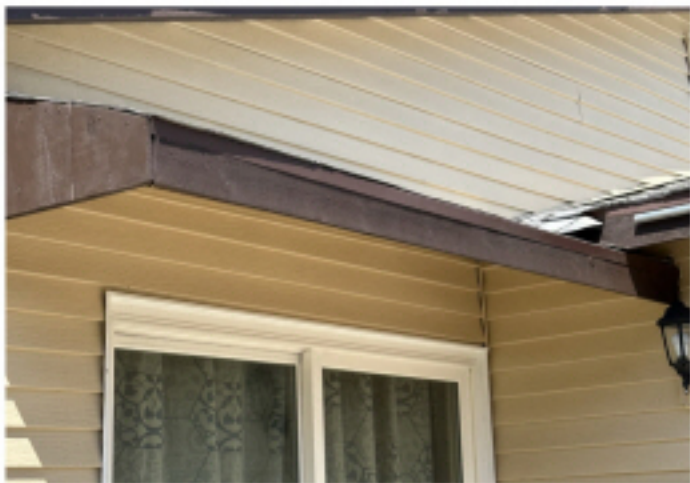
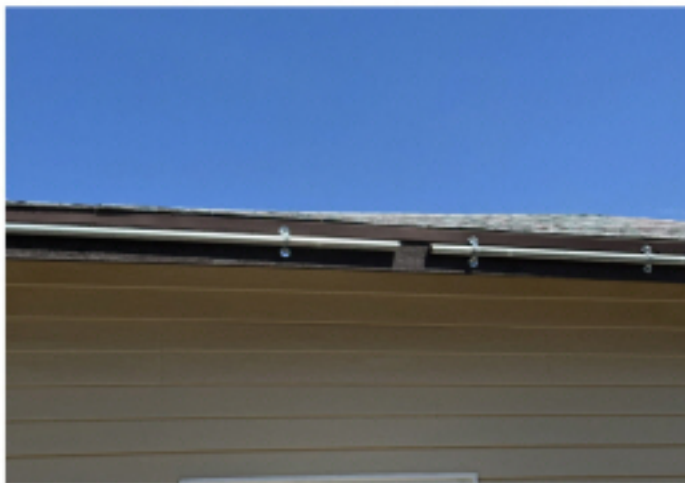
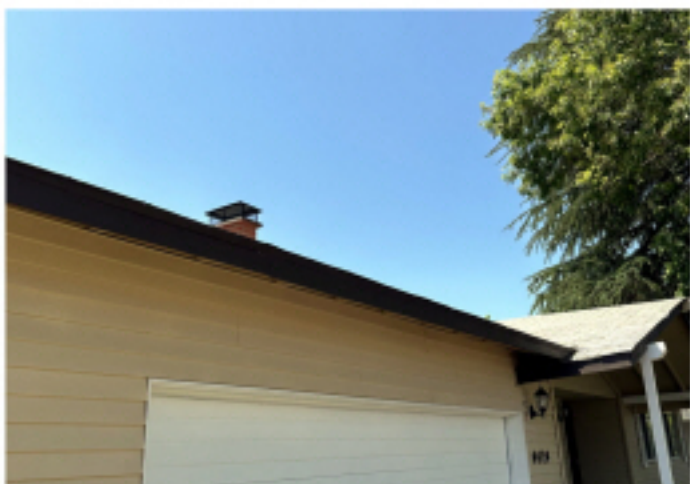
**PHOTO #3**

GUTTERS / DOWNSPOUT ARE MISSING ABOVE THE SLIDING GLASS DOOR, OVERHEAD GARAGE DOOR AND GARAGE PEDESTRIAN DOOR

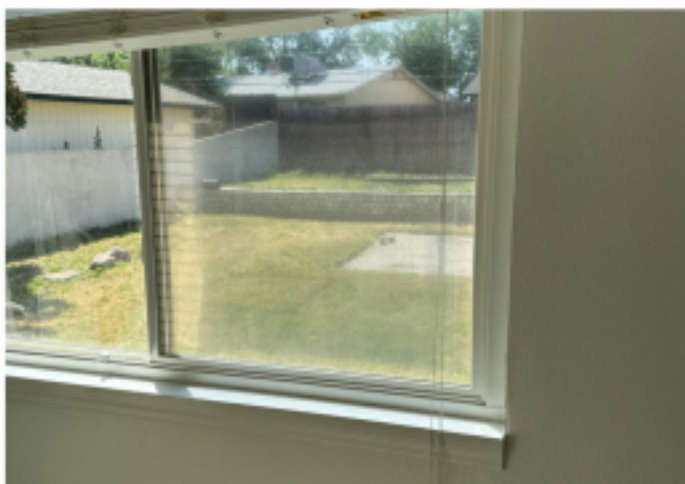
**PHOTO #6**

1. Condensation stains were noted between the glass panes of the sliding window at the dining room from an apparent failed vacuum seal. Suggest the glass panes be replaced by a licensed window contractor. (Sliding Side, See Photo #6)
2. The screen to the sliding glass door at the dining room is missing. Suggest a screen be installed.

COMMENTS  
CONDENSATION STAINS NOTED BETWEEN THE GLASS PANE OF THE SLIDING WINDOW
