Free 50-Point Inspection Report

John Torres
4424 Fenwick Way
North Highlands CA 95660

Detailed 50-Point Inspection

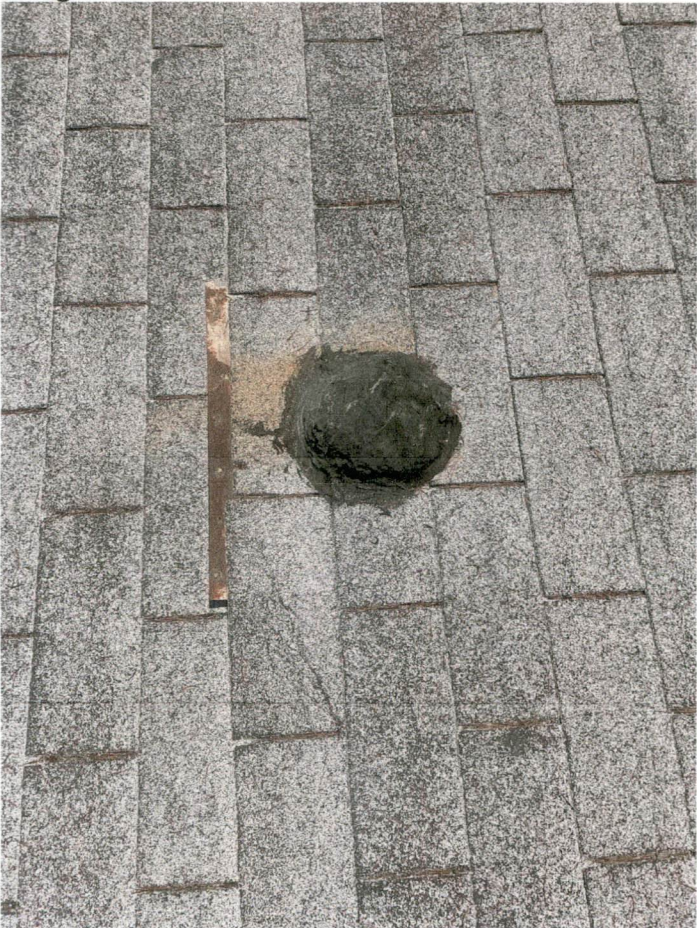
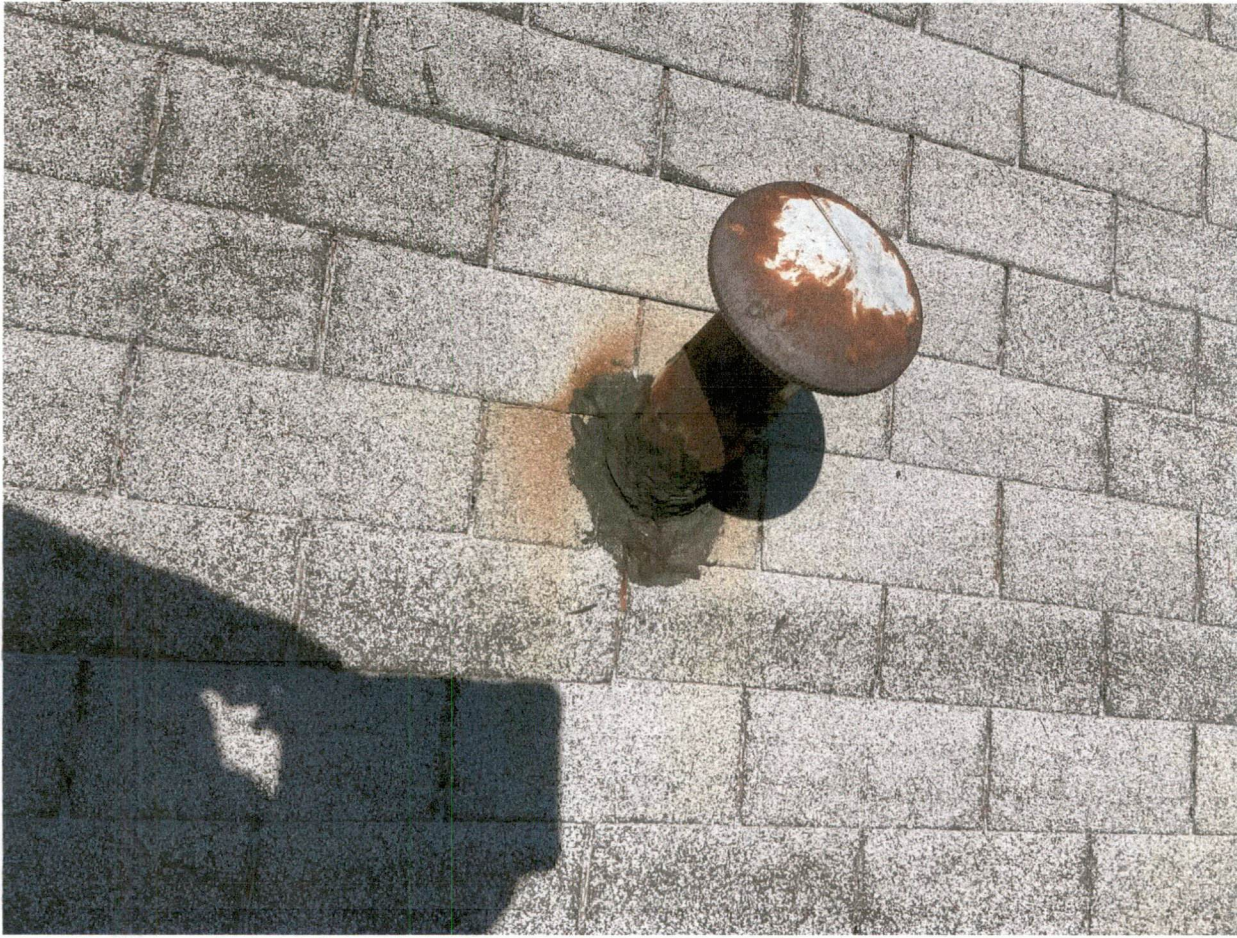
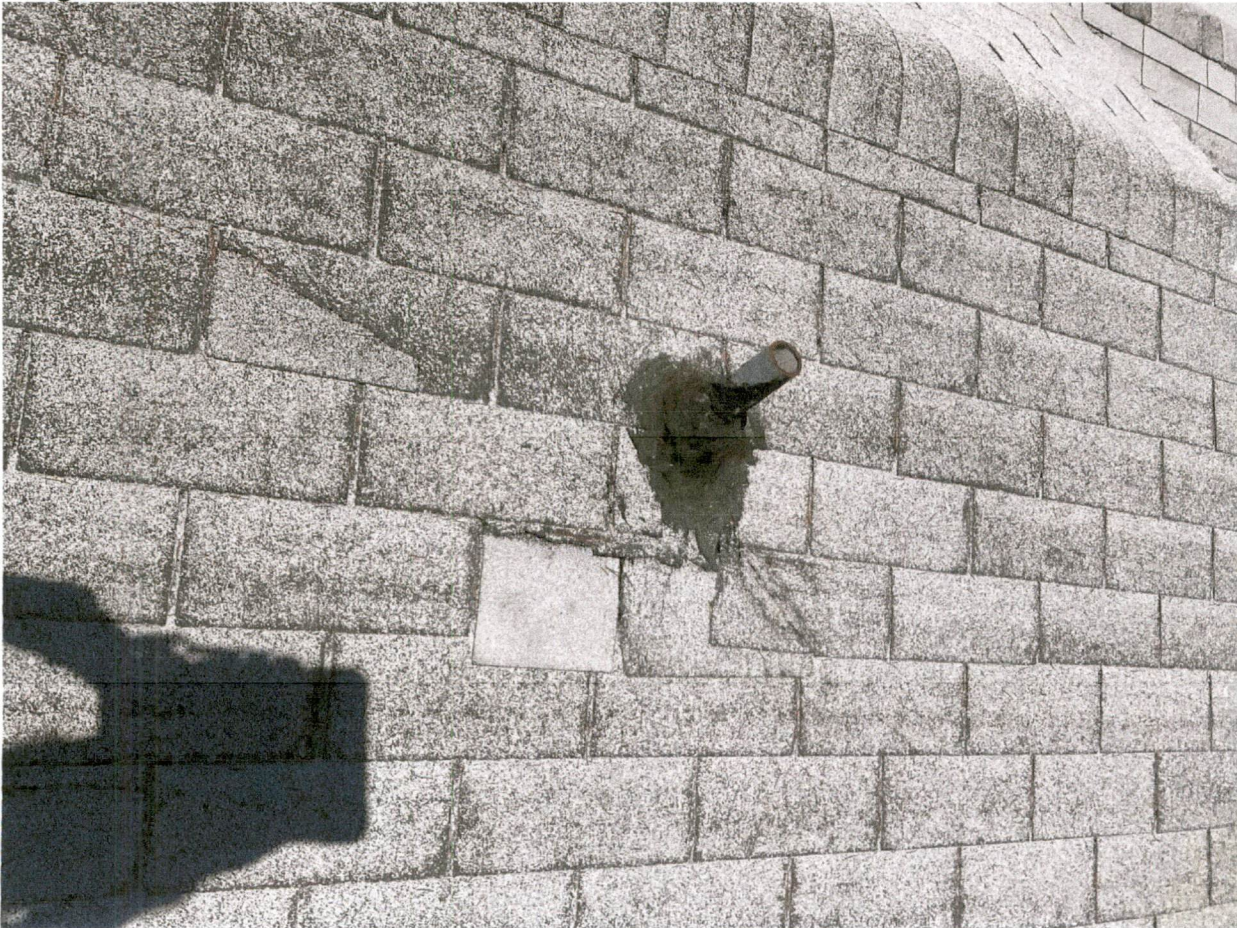
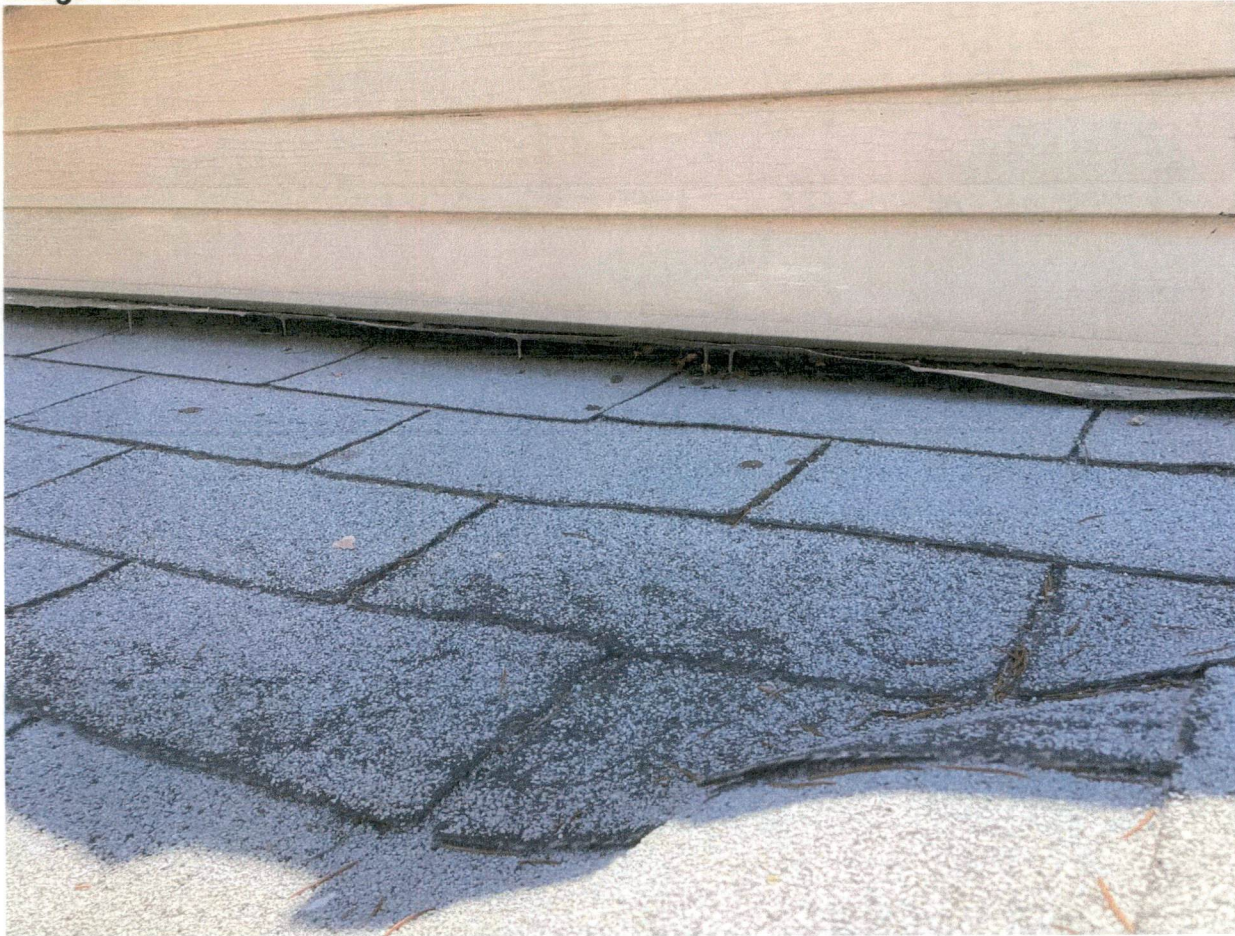
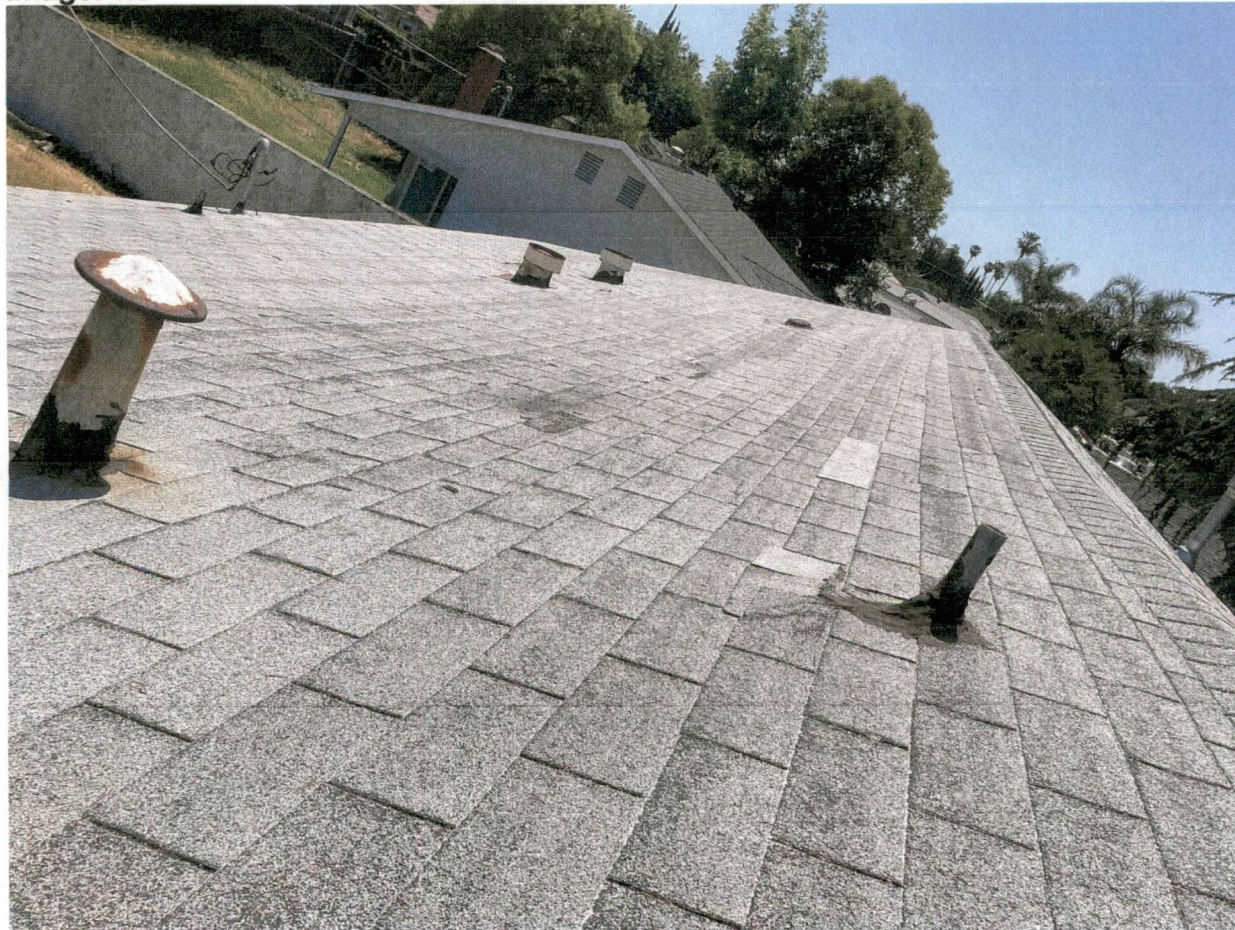
The current roof is showing significant signs of: age, wear, color loss, granule loss, delamination, rusted flashings, damaged/missing shingles, fiberglass showing through, and previous repairs done. These signs are common, and expected, when the roof has reached the end of its life. For these reasons, a re-roof is recommended, but not required at this time.

Due to age and wear re-roof is advised (see line item 1-5 years life remaining). High chance of damaging surrounding shingles when repairing.
