TWIN HOME INSPECTION

1222 Swan Lake Dr
Fairfield, CA 94533

Julie Broussard
DECEMBER 20, 2023

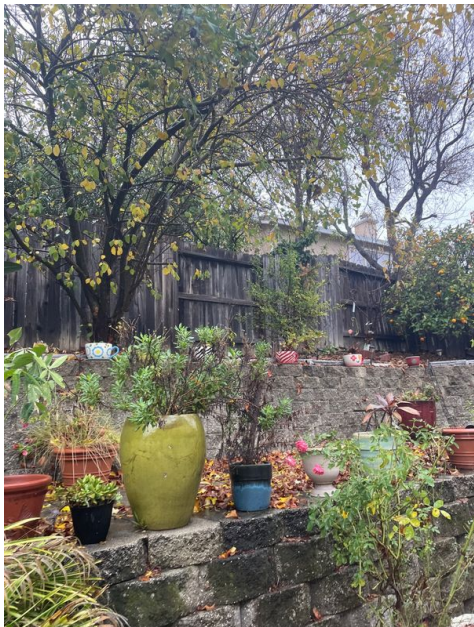
NO VIS FENCE

Unable to fully inspect due to landscape, grading, terrain, and/or cover.

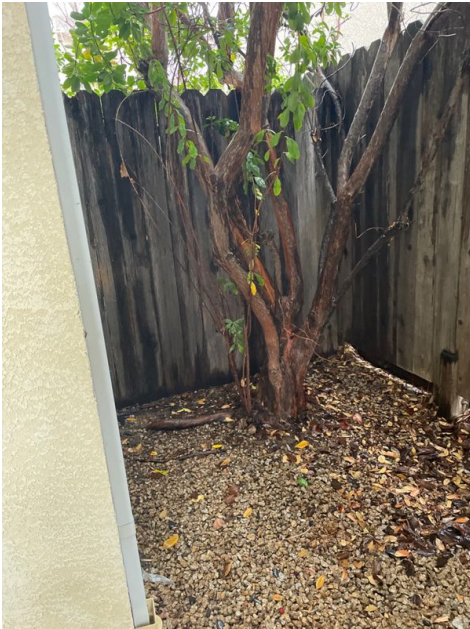
2.3.2 Landscaping

TREE CLOSE

Trees are planted close to the structure. Certain types of tree roots have been known to damage foundations, walkways, and other landscaping elements. Removal may be needed.

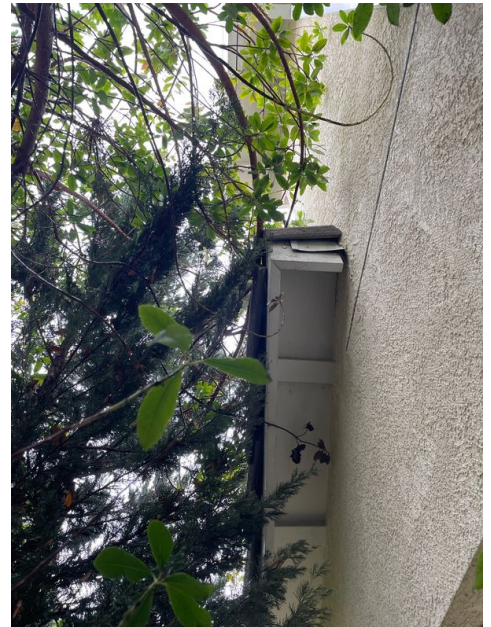
2.3.3 Landscaping

TREE HANG

Trees are touching or overhanging the roof. Tree branches and leaves can damage roofing materials and clog gutters and downspouts. Recommend removing any branches that are in close proximity or in contact with the roof and cleaning the gutters as annual homeowner maintenance.

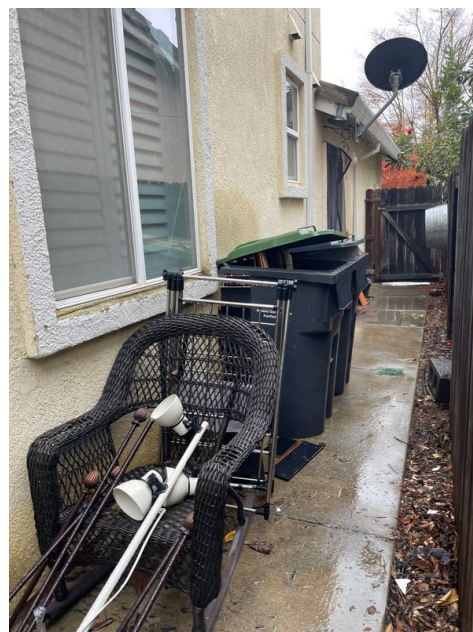
OWNERS POSSESSION'S

Parts of the exterior wall covering were inaccessible due to homeowners' possession. Unable to fully inspect these areas.

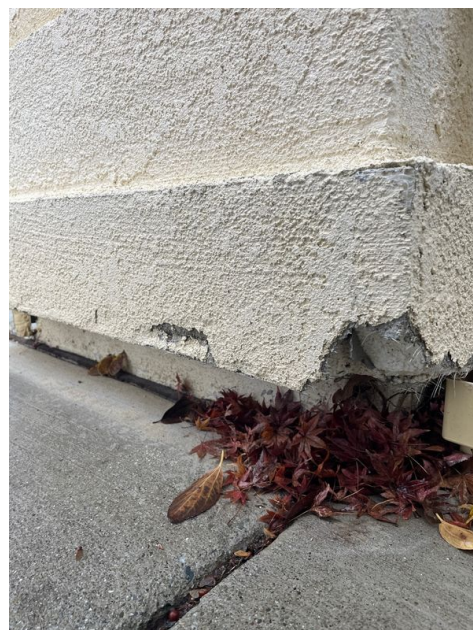
3.1.1 Exterior Walls

MINOR DAMAGE

Minor damage to the siding was noted. We recommend repairing the damaged areas.

Contact a qualified professional.

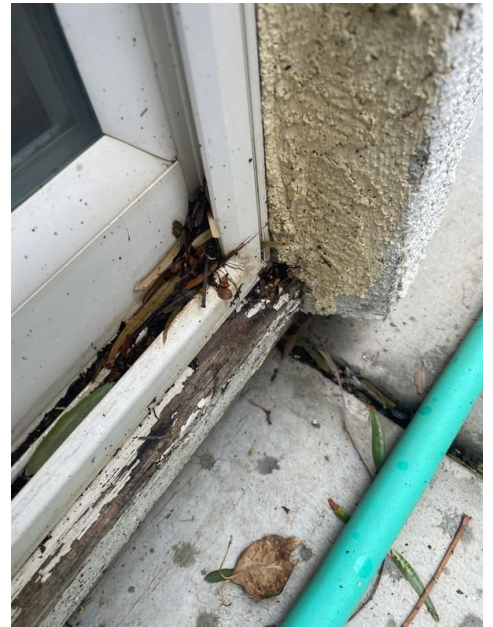
3.7.1 Exterior Doors

Items Needing Attention**MOISTURE DAMAGE**

Moisture damage was found at one or more exterior *doors/door jambs*. Recommend that a qualified person repair as necessary. All rotten wood should be replaced.

Contact a qualified professional.

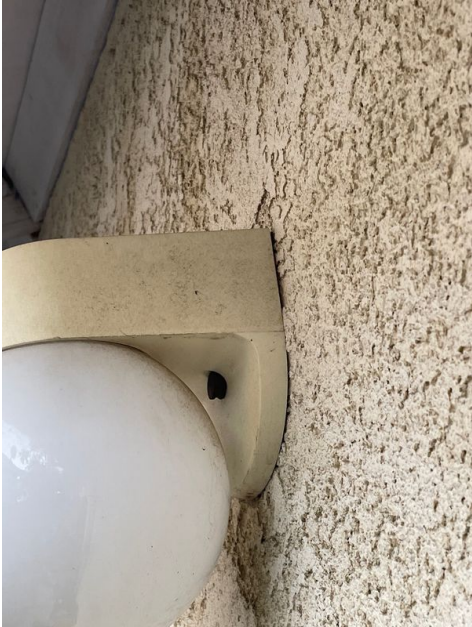
3.10.1 Fixture & Fans

One or more fixtures are not caulked to the exterior wall. This condition may allow moisture into the wall cavity. Recommend caulking the base of the fixture to the wall allowing a 1/2in gap at the bottom for moisture to escape.

Contact a qualified professional.

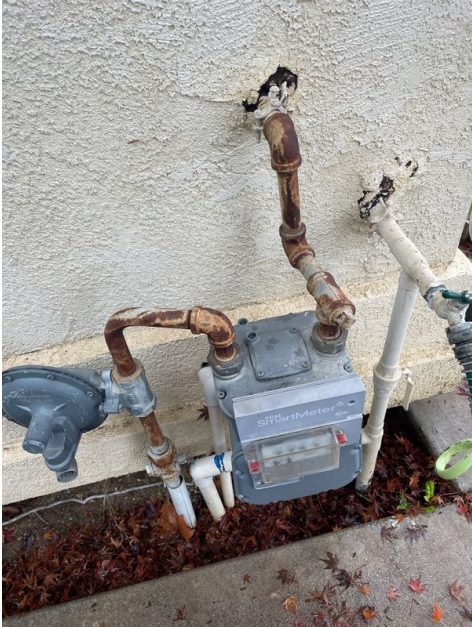
MAJOR CORROSION

Major corrosion is noted. Noted corrosion is considered excessive or more than what is normally excepted as part of the aging process of this type of supply pipe. Recommend further review and possible repair by the utility company.

Contact a qualified professional.

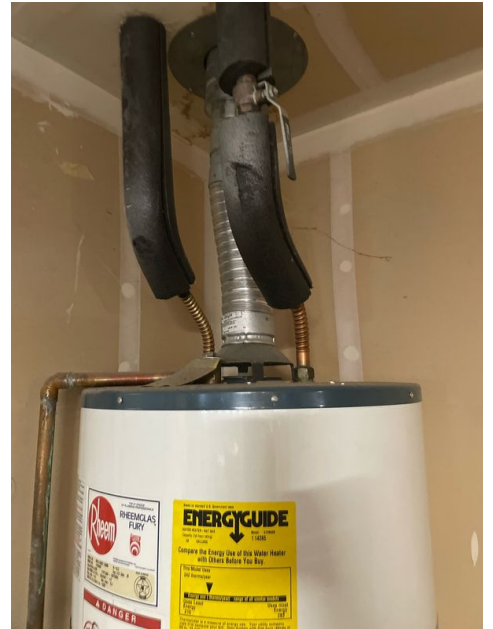
5.7.1 Expansion Tank

EXPANSION TANK MISSING

The required expansion tank is not installed. Expansion tanks are installed on the cold supply side to regulate pressure changes in the plumbing system. Some water districts do not require an expansion tank. Recommend calling the water district and inquire as to if it is required. If it is, recommend installing the required expansion tank to comply to building standards.

Contact a qualified professional.

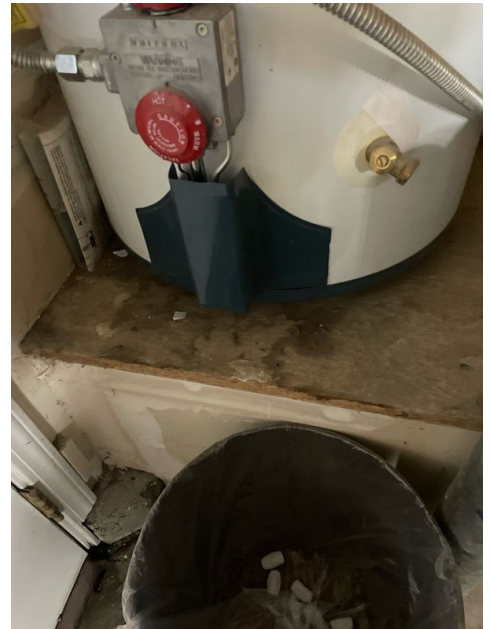
5.10.1 Overflow Pan

MISSING NOT REQUIRED

An emergency overflow pan is not installed. Though not required at the time of construction or replacement, modern building standards require an overflow pan for water storage units in use wherever secondary damages are possible if the unit fails. Recommend installing an overflow pan as an upgrade.

Contact a qualified professional.

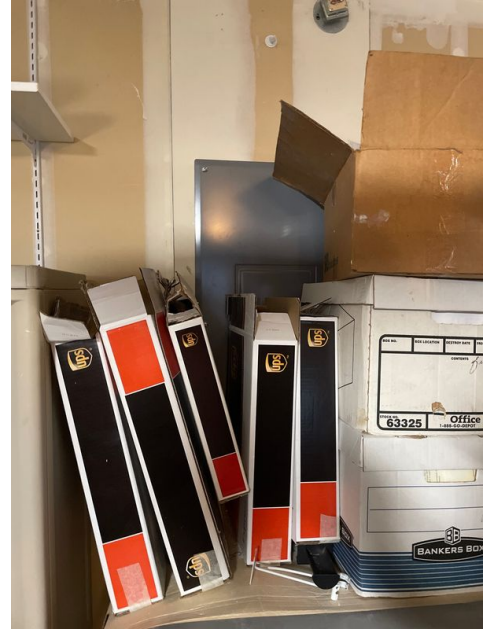
PANELS NOT OPENED

The inspector was unable to open and evaluate this panel because items were blocking access/paint, caulk or wallpaper would be damaged / of arcing noises inside / panel or equipment was energized / of standing water on the floor by panel / of water leaking into panel/panel (s) were locked. These panel(s) are excluded from this inspection. Recommend that repairs, modifications and/or cleanup should be made as necessary so panels can be opened and fully evaluated.

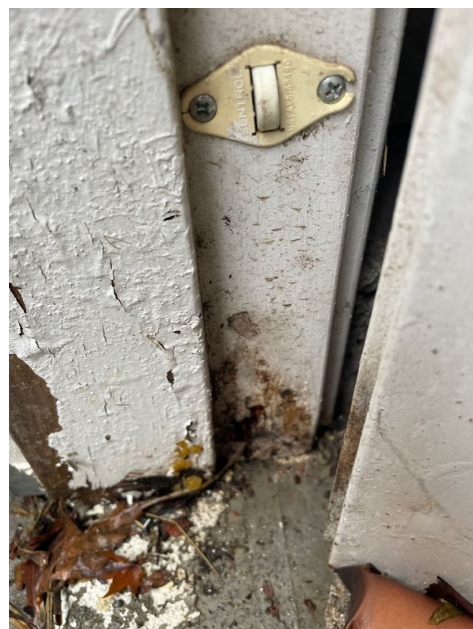
7.4.1 Service/Side Door

JAMB DAMAGED - MOISTURE

Moisture damage noted to the door jambs and/or interior trim. State law prohibits any further comment on this finding. Recommend consulting your pest inspection report for more detail and needed repairs.

Contact a qualified professional.

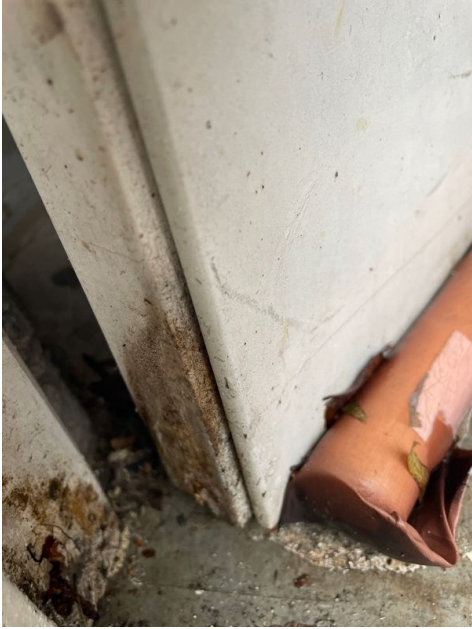
7.4.2 Service/Side Door

DOOR DAMAGED - MOISTURE

Damage/rot from moisture noted to the door. Due to restriction in state law, we are unable to comment further on this finding. Refer to your pest report for specific areas, required repairs and associated costs as they are the authority on this finding.

Contact a qualified professional.

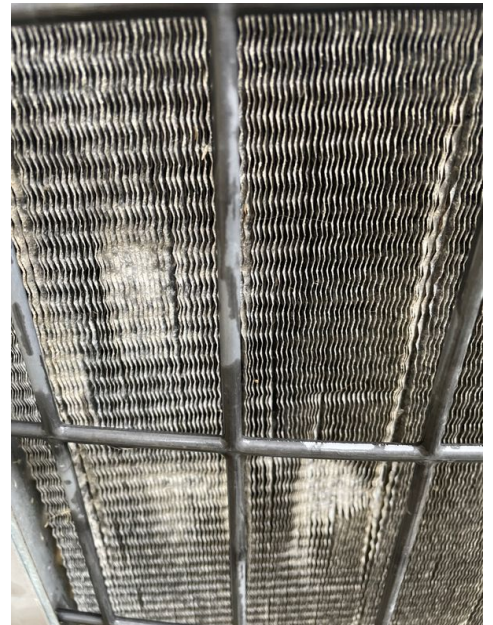
FINS DAMAGED - MINOR

Minor fin damage to the condenser coil noted. This may effects the overall efficiency and operation of the condenser. If excessive, a comb can be purchased at a local hardware store to straighten the coils or a professional can be contacted to perform the necessary repairs.

Contact a qualified professional.

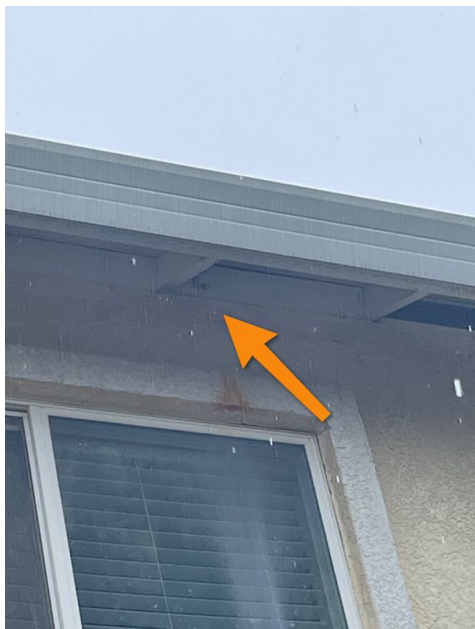
8.5.1 Condensation System

RUST AT SECONDARY

Rust stains noted at the secondary condensate lines. Rust stains indicate that at some point the primary drainage was not acting as designed. There is no way to determine if repairs have been made on a visual home inspection. Recommend asking the current owners as to history of leakage and any repairs or service performed on the unit.

Contact a qualified professional.

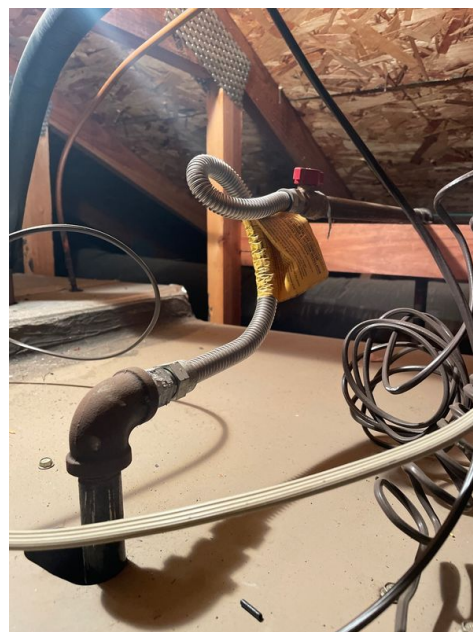
8.7.1 Location and Type

NO DRIP LEG

Recommend installing the necessary drip with the supply entering the top and the drip leg extending 3" off the bottom of the supply.

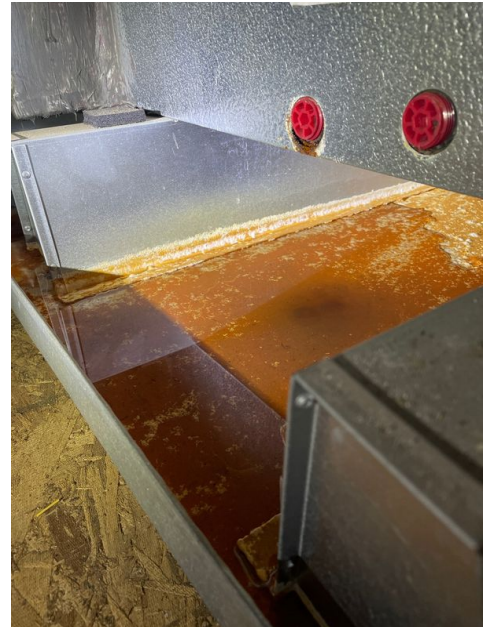
8.11.2 General Cabinet Condition

Moisture noted in the emergency overflow pan beneath the FAU/A coil. Further inspection and repairs are needed by a qualified contractor.

Contact a qualified professional.

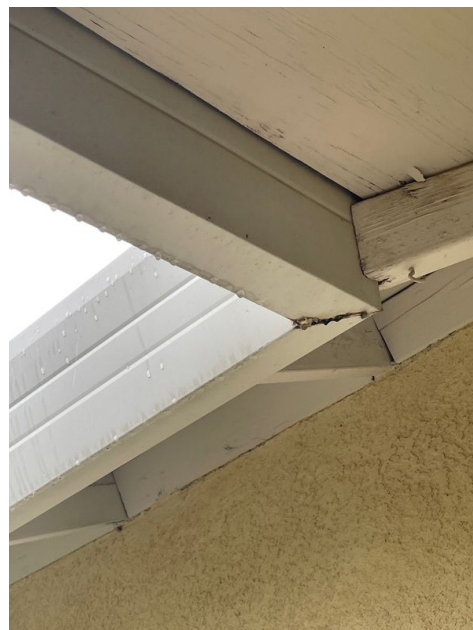
10.1.2 Gutters / Downspouts / Extensions

SEAMS LEAKING

The gutters appear to be leaking at the seams. This is a normal homeowner maintenance item.

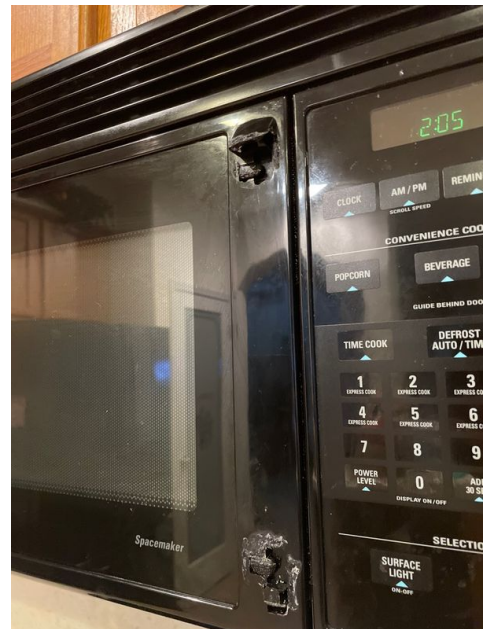
12.6.1 Microwave

HANDLES

The microwave door pull is damaged/missing.

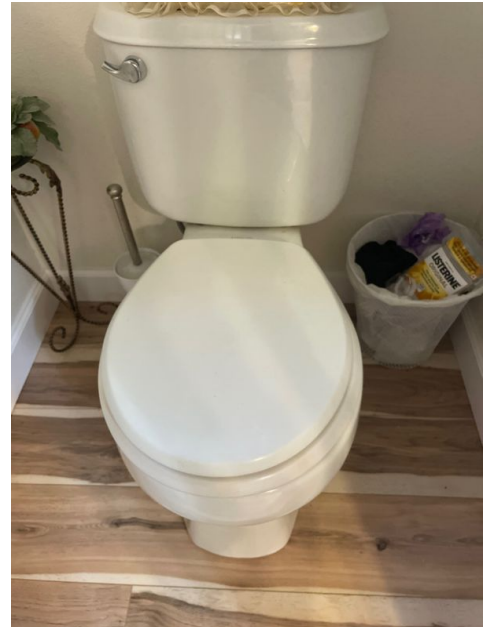
13.4.1 Toilets

LOOSE, EVALUATE, REPAIR

Contact a qualified professional.

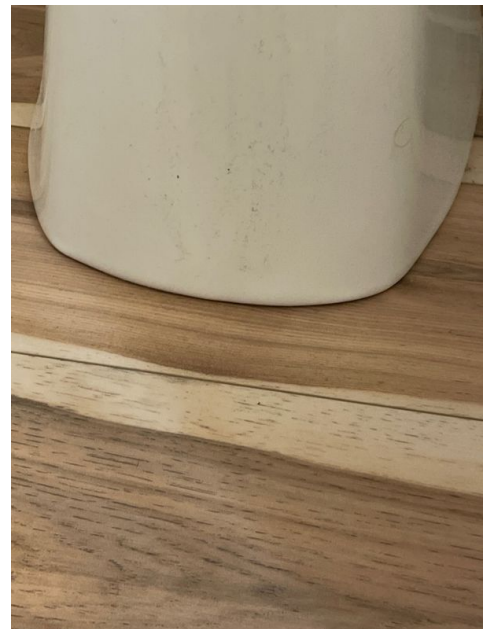
13.4.2 Toilets

NO OR BAD CAULK AT BASE

Contact a qualified professional.

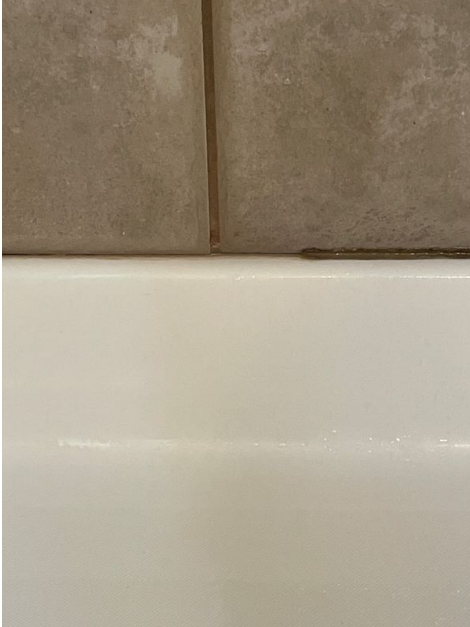
13.6.1 Showers

SURROUND/PAN - TILE/GROUT REPAIR

Contact a qualified professional.

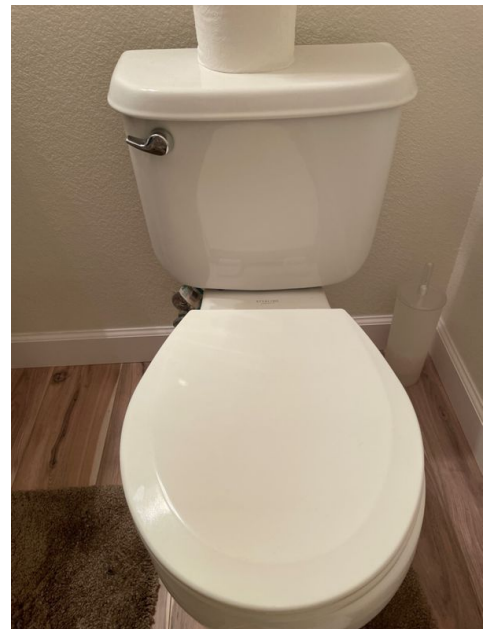
14.3.1 Toilets

LOOSE, EVALUATE, REPAIR

Contact a qualified professional.

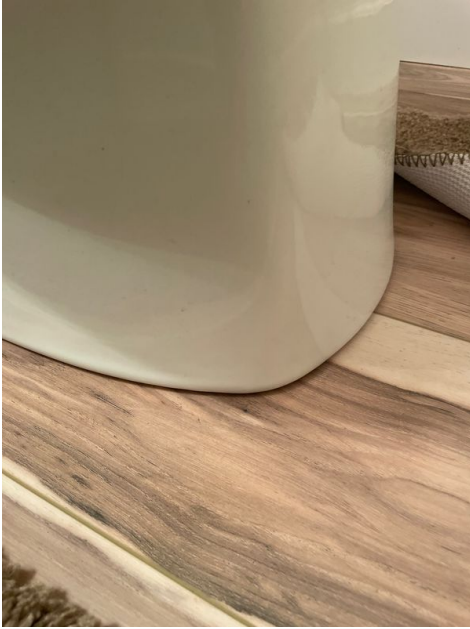
14.3.2 Toilets

NO OR BAD CAULK AT BASE

Contact a qualified professional.

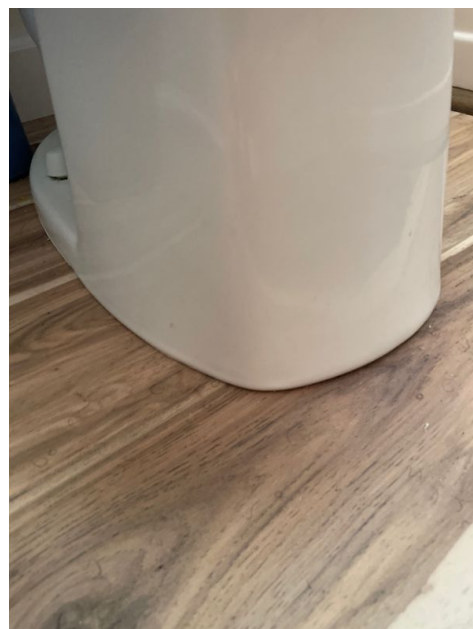
15.4.2 Toilets

NO OR BAD CAULK AT BASE

Contact a qualified professional.

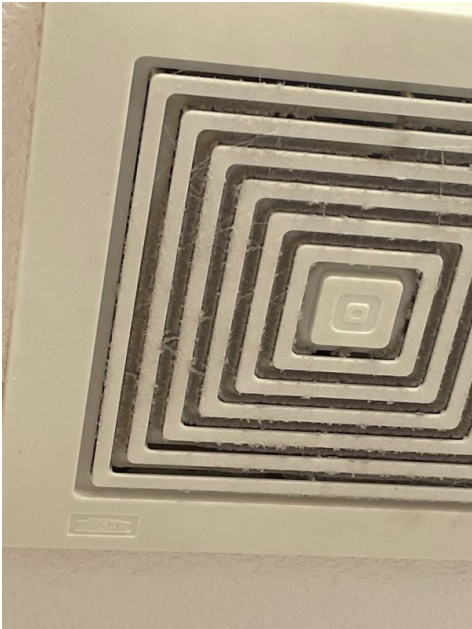
15.8.1 Ventilation

FAN - DIRTY

Contact a qualified professional.
