PAUL E. JONES
NAPI CERT. # 30667

INSPECTION DATE: May 9, 2023

REPORT NUMBER: A71271

PROPERTY INSPECTED: 107 Glacier Cir
Vacaville, CA 95687

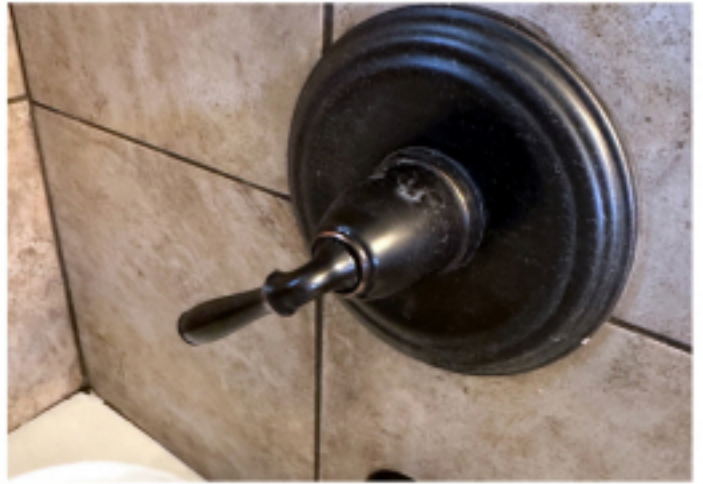
PHOTO #7

2. The bathroom sink faucet mixer valve is inoperable. Suggest the sink faucet be repaired or replaced by a qualified licensed contractor as found needed. (See Photo #7)
3. The bathtub faucet valve appears improperly installed and is difficult to operate. Suggest the bathtub faucet be repaired or replaced by a qualified licensed contractor as found needed. (See Photo #8)
4. The seams at the base of the bathtub surround are poorly sealed near the bathtub faucet. Suggest the seams be sealed with grout by a qualified licensed contractor as found needed. (See Photo #9)
