WOOD DESTROYING PESTS AND ORGANISMS INSPECTION REPORT

Building No. 107	Street Glacier Circle	City Vacaville	Zip 95687	Date of Inspection May 9, 2023	Number of Pages 6
---------------------	--------------------------	-------------------	--------------	--	----------------------

Company Report
 # R9510

General Description: Single story home on raised foundation with attached garage.	Inspection Tag Posted: Garage
	Other Tags Posted:

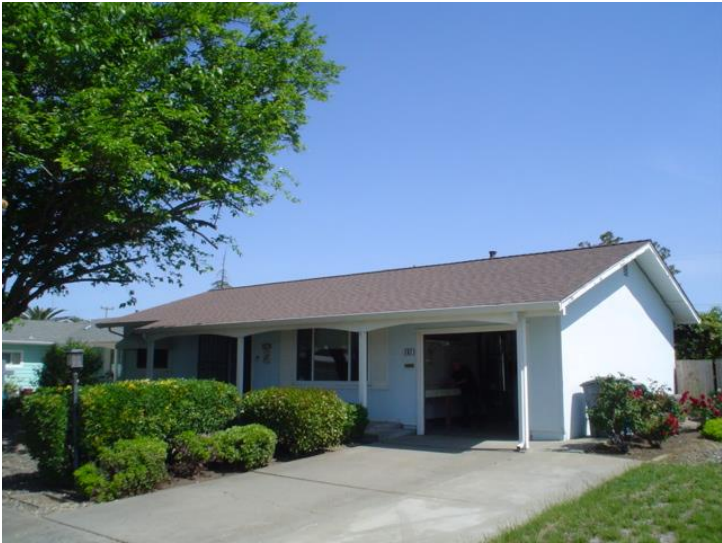
1 Finding: Fungi (wood-rot) damage found at posts. Indicated on the diagram by “1”, and some areas shown in Fig.1 images on the back pages of this report.

2 Finding: Fungi (wood-rot) damage found in the base of garage door jamb. Indicated on the diagram by “2”, and some areas shown in Fig.2 images on the back pages of this report.

3 Finding: Fungi (wood-rot) damage found in the roof eaves. Indicated on the diagram by “3”, and some areas shown in Fig.3 images on the back pages of this report.

4 Finding: Fungi (wood-rot) damage found in the exterior trim. Indicated on the diagram by “4”, and some areas shown in Fig.4 images on the back pages of this report.

5 Finding: Fungi (wood-rot) damage found in the exterior siding. Indicated on the diagram by “5”, and some areas shown in Fig.5 images on the back pages of this report.

10 Finding: Insufficient clearance prevents full access of subarea. Rigid ducting was also noted, which would appear to prevent access of areas. A visual inspection revealed the presence of cellulose debris (scrap wood) at soil. Indicated on the diagram by “10”, and some areas shown in Fig.10 images on the back pages of this report.
