1725 Landana Drive unit #2, Concord , CA 94519  
Inspection prepared for: Patricia Ballisteri  
Date of Inspection: 9/16/2022

Inspector: Scott Schildknecht  
InterNACHI#NACHI22051815  
1485 Maria Avenue , Concord , CA 94518  
Phone: (707)649-8700  
Email: [scott@northbayinspection.com](mailto:scott@northbayinspection.com)  
[Northbayinspection.com](http://Northbayinspection.com)

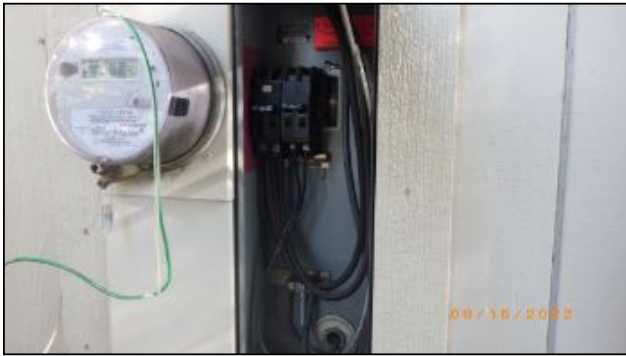
**The inner protective panel is missing on the main panel. This is a potential safety hazard as persons could touch the energized interior of the service box. We recommend having a qualified electrician install the missing inner panel on this device.**

Sylvania GTE panels

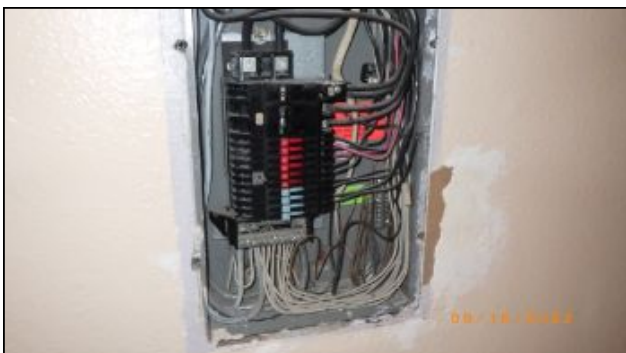
The screws securing the sub panel are sharp, improper, or missing. Sharp screws can damage energized wires within the service panel and cause a short. Missing screws may allow the energized wires to become exposed to unauthorized persons. To achieve the intended level of safety the electrical service panel would benefit from having the proper screws installed.

There is at least one double-lugged breaker inside the electrical sub panel. Double lugging is where more than one branch circuit is connected to a single circuit breaker. The breakers in this panel are not designed to accommodate more than one circuit. There is presently only one brand of breaker that is. We recommend correction by a qualified electrician.

Sylvania GTE panel

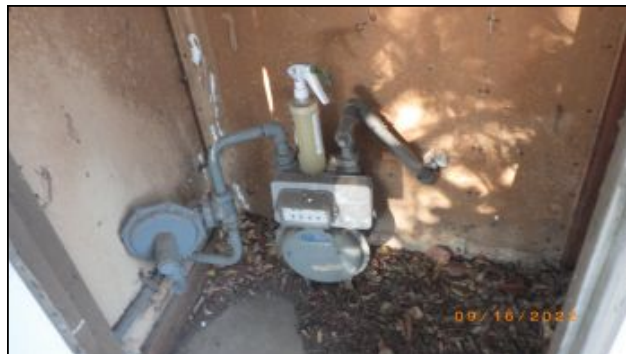
The main house gas meter is located at the right side of the home. The main gas valve to the home is located to the left of the meter. We suggest having the proper (dedicated) wrench "zip tied" to the gas meter for easy access in the event of an emergency. These wrenches are now available at a home supply store.

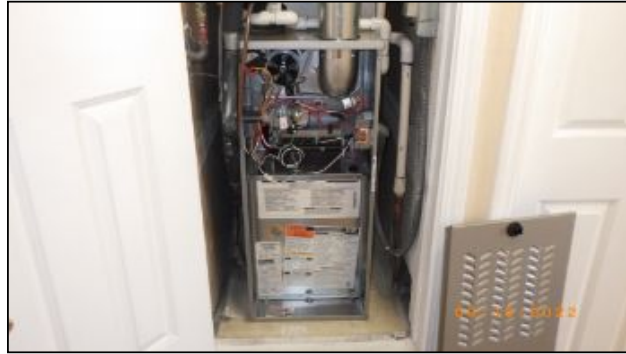
newer furnace

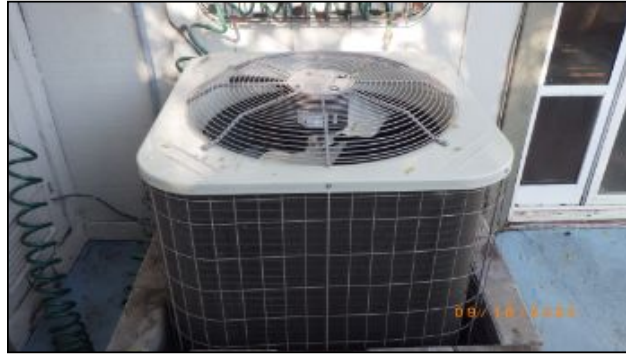
The installation of the AC sub panel(s) appears to have been completed by qualified personnel. A comprehensive analysis of the electrical system is a specialized and lengthy process that exceeds the scope of a standard general building inspection. If further examination of the system is desired, the client is referred to the services of a certified electrician or electrical engineer.

newer AC unit

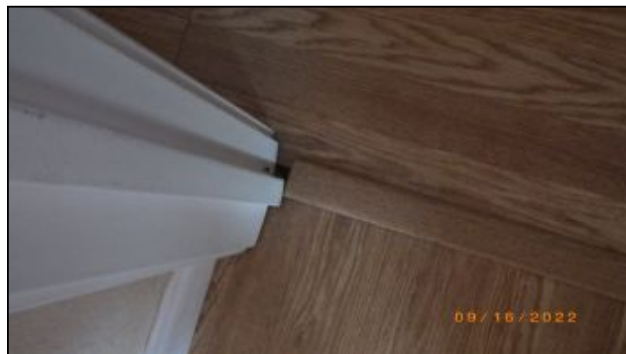
The floors of this home are uneven at several places. In general, the uneven floors in this home are considered typical for a home of this age. This may be the result of foundation settlement, outdated framing, and heaving sub-floors or finish flooring that has been improperly installed. If further information is desired and if a complete survey of all floors is needed, a flooring/specialty contractor should be retained. Note: It is very common for older homes to have slightly uneven floors due to older construction techniques and normal settlement.

There are several floor squeaks in this home. Squeaks could be the result of improperly installed or inadequately secured sub flooring. If any structural defects were found they would be identified in the Structural section of this report. These types of squeaks are annoying and are normally not structurally significant. It is possible to eliminate floor squeaks with a variety of repair techniques. If more information is required we recommend consulting a flooring professional to discuss options and cost. Note: If re-carpeting we recommend having time between when the old one is removed and new installed that these squeaks be addressed - ask your carpet installer for a day between. Sometimes a nail that secures the subfloor rubs the floor joist. Simply screwing the offending section with a single screw will stop the squeak.

cosmetic blemishes

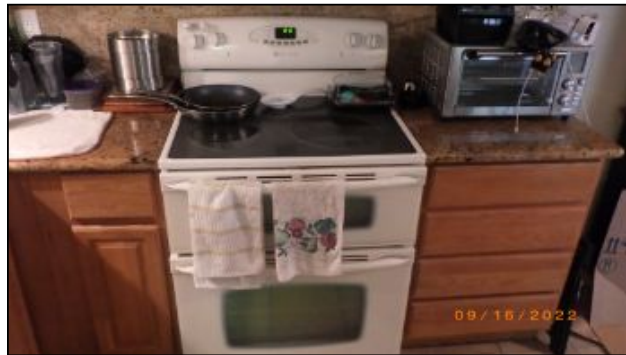
The oven and range were tested and functioned normally. It is beyond our scope of inspection to test for temperature accuracy or other functions such as self-cleaning, convection fans, timers, etc.

The range is in moderately worn condition. The stove was functional at the time of this inspection.

tested ok

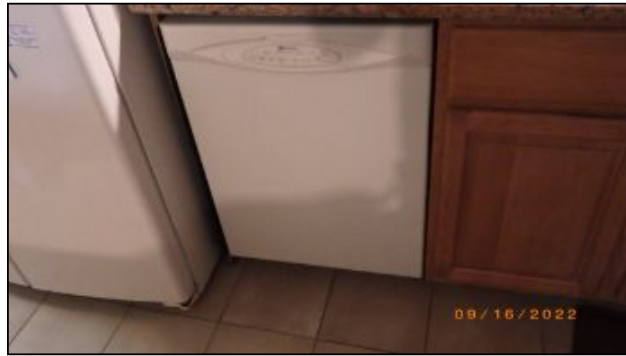
There is no air gap installed between the discharge line from the dishwasher to its waste receptacle. This is a newer style dishwasher and some models have built in back flow prevention devices. We recommend asking the owner for the installation instructions of this particular model to check the specifications of this particular unit. If not equipped with an air gap device older models can allow dirty contaminated water from the plumbing to be siphoned back into the dishwasher where it will contaminate the dishes. Correction will require installation of an air gap device at the kitchen sink, or wall, or necessitate looping the discharge line up over the top of the dishwasher so that it is above the flood rim of the adjacent sink and plumbing and cannot siphon waste backward. Note: Even if equipped with an internal air gap device most state residential codes require installation of this safety device.

tested ok

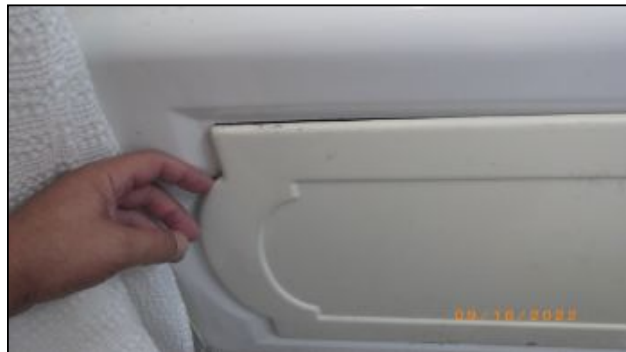
There is a spa/tub in the main bathroom. The pump, plumbing, and wiring is located below the unit and was not accessible due to the possibility of damaging the access door. We recommend providing access to this area and further inspection by a qualified inspector.

**The spa (hydrotherapy tub) in the primary bathroom does not appear to be properly protected with a dedicated GFCI outlet or breaker. This is a potential shock/safety hazard now, we recommend further evaluation and repairs by a qualified electrician.**

no access

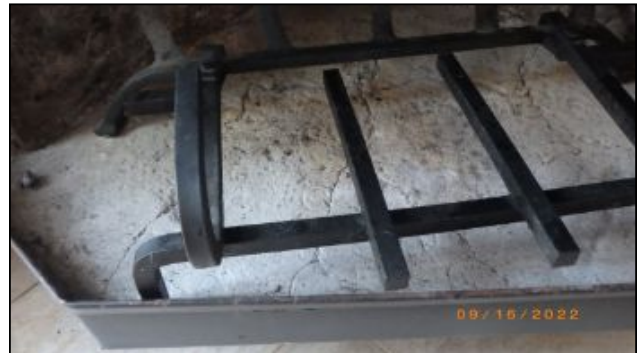
moderatley worn

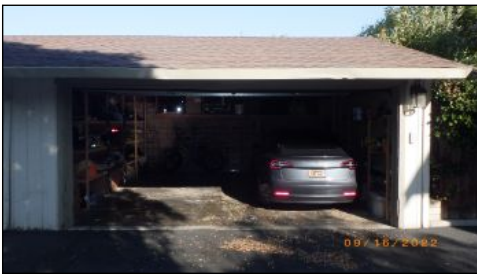
There is insufficient clearance between the garage siding and grade. There needs to be at least six inches of clearance to minimize damage caused by rainwater splashing against the structure and to make it easier to spot activity by wood destroying insects. We recommend adjusting the exterior grading where necessary to achieve this clearance.

There is scattered moisture/fungus damage at the exterior of this garage at several places. We recommend further evaluation and repairs by a Class 3 Structural Pest Control Operator.

detached garage

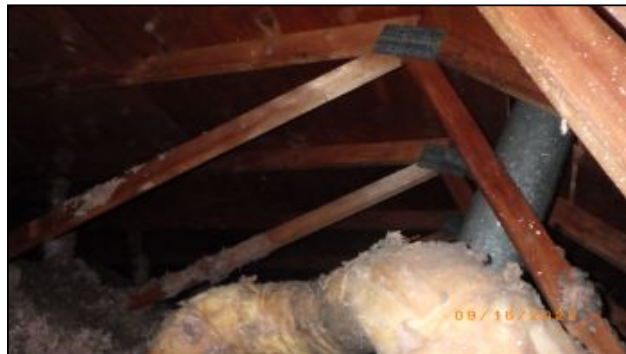
The visually accessible areas of the attics framing appeared normal with no obvious defects.

Some staining of wood members in the attic was visible. The area was dry at the time of this inspection. These stains may have been the result of a past or intermittent leak. We recommend asking the owner about any history of leaks, repairs, or water related damage. For a specialized roof inspection we recommend retaining the services of a qualified roofing contractor. Note: This is not an unusual condition in older homes with shingle or shake roofs under layers of other roofing.

manufactured truss
