# SELLER PROPERTY QUESTIONNAIRE

Seller makes the following disclosures with regard to the real property or manufactured home described as 1725 Landana Dr #2, Assessor's Parcel No. 114-660-002-6, situated in Concord, County of Contra Costa California ("Property").

1725 Landana Drive unit #2, Concord , CA 94519  
Inspection prepared for: Patricia Ballisteri  
Date of Inspection: 9/16/2022

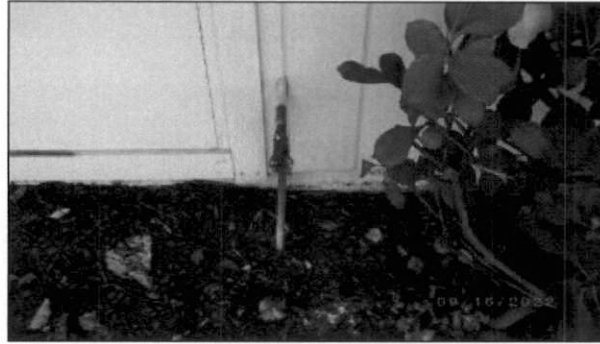
main shutoff

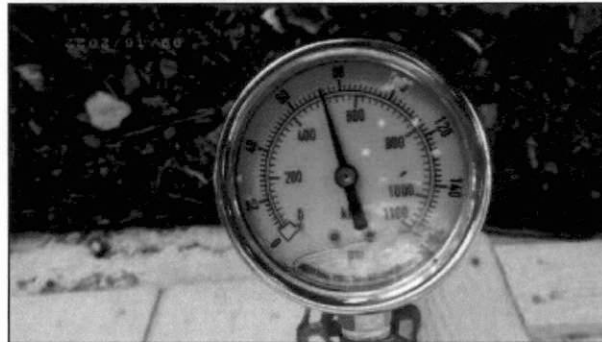
Note: Water pressure between 45 and 65 PSI is considered normal. Pressure in excess of about 80 PSI is considered excessive.

water pressure 72 PSI

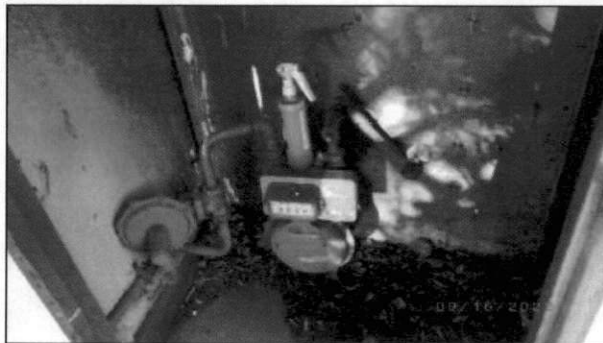
gas meter

The main house gas meter is located at the right side of the home. The main gas valve to the home is located to the left of the meter. We suggest having the proper (dedicated) wrench "zip tied" to the gas meter for easy access in the event of an emergency. These wrenches are now available at a home supply store.

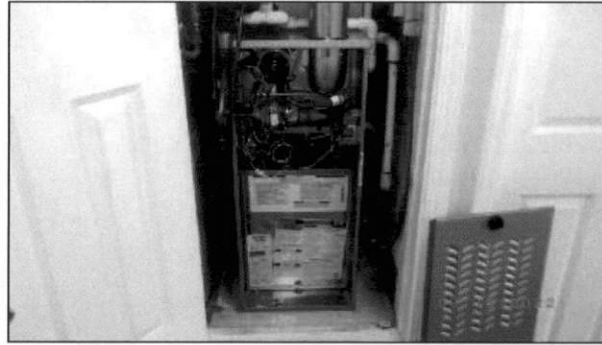
newer furnace

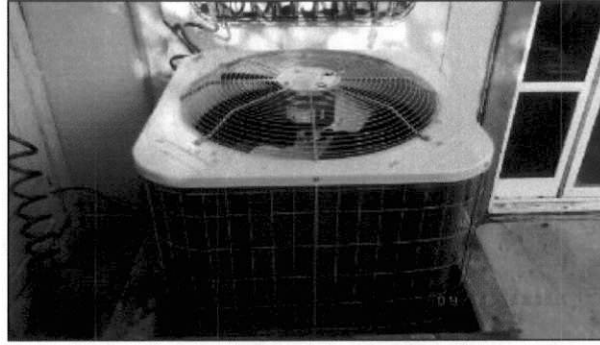
newer AC unit

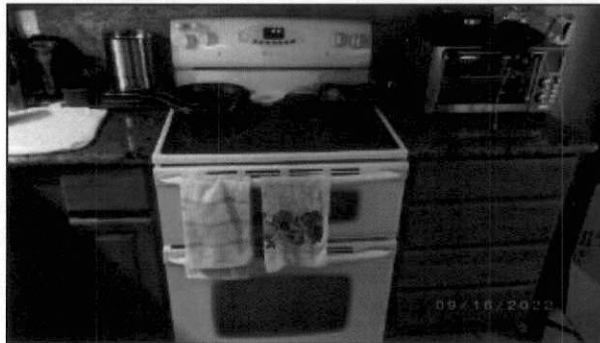
The range is in moderately worn condition. The stove was functional at the time of this inspection.

tested ok

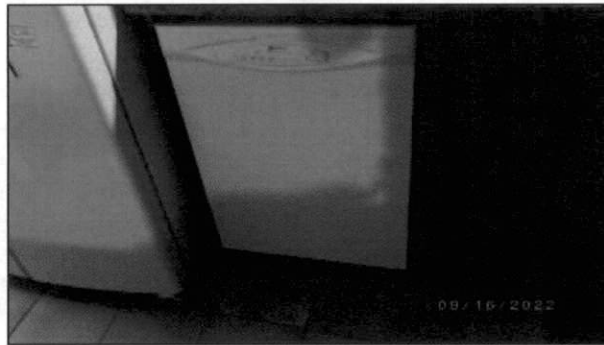
There is no air gap installed between the discharge line from the dishwasher to its waste receptacle. This is a newer style dishwasher and some models have built in back flow prevention devices. We recommend asking the owner for the installation instructions of this particular model to check the specifications of this particular unit. If not equipped with an air gap device older models can allow dirty contaminated water from the plumbing to be siphoned back into the dishwasher where it will contaminate the dishes. Correction will require installation of an air gap device at the kitchen sink, or wall, or necessitate looping the discharge line up over the top of the dishwasher so that it is above the flood rim of the adjacent sink and plumbing and cannot siphon waste backward. Note: Even if equipped with an internal air gap device most state residential codes require installation of this safety device.

tested ok

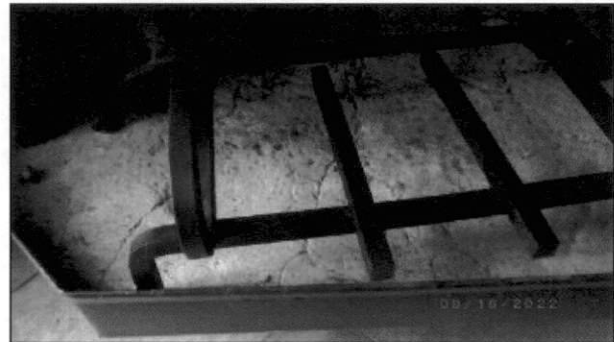
moderatley worn

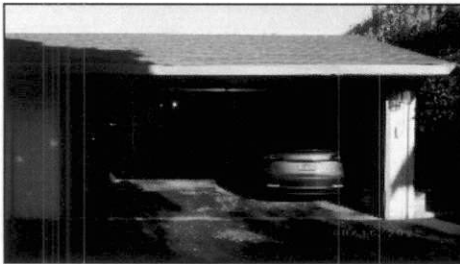
There is insufficient clearance between the garage siding and grade. There needs to be at least six inches of clearance to minimize damage caused by rainwater splashing against the structure and to make it easier to spot activity by wood destroying insects. We recommend adjusting the exterior grading where necessary to achieve this clearance.

There is scattered moisture/fungus damage at the exterior of this garage at several places. We recommend further evaluation and repairs by a Class 3 Structural Pest Control Operator.

detached garage

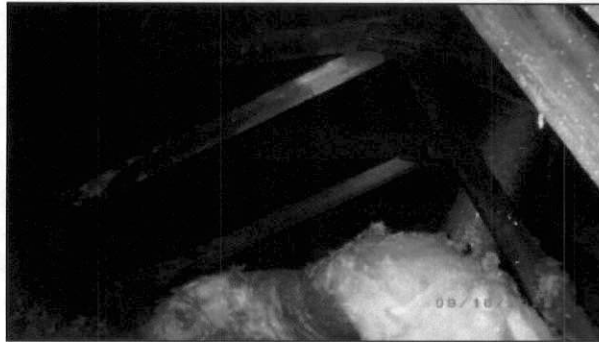
Some staining of wood members in the attic was visible. The area was dry at the time of this inspection. These stains may have been the result of a past or intermittent leak. We recommend asking the owner about any history of leaks, repairs, or water related damage. For a specialized roof inspection we recommend retaining the services of a qualified roofing contractor. Note: This is not an unusual condition in older homes with shingle or shake roofs under layers of other roofing.

manufactured truss
