**PAUL E. JONES**
NAPI CERT. # 30667P.O. BOX 981071
W. SACRAMENTO, CA 95798
(916) 752-0275
e-mail: pjones21@comcast.net**INSPECTION DATE:** December 12, 2024**REPORT NUMBER:** A12721**CLIENT:** Jenine Fortney & Scott Ohlhausen**PROPERTY INSPECTED:** 350 Walnut Ave
Vacaville, CA 95688

The property inspected is a 4 bedroom, 2 bath single family home. The weather at the commencement of the inspection was raining with a temperature reading of approximately 56 degrees Fahrenheit.

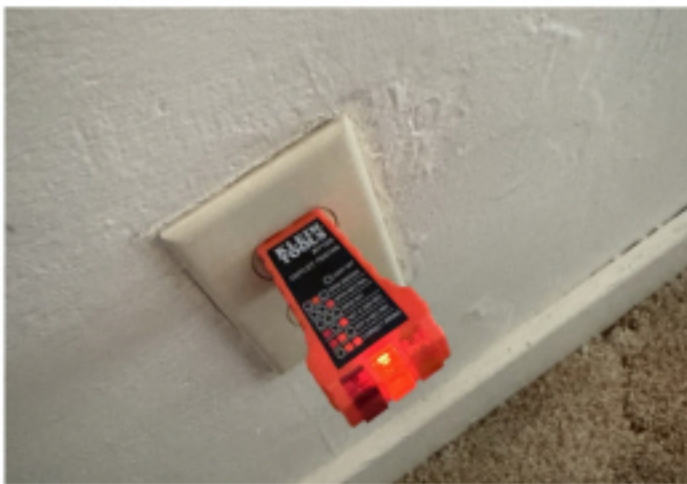
PHOTO #4

1. The electrical outlet near the kitchen sink is improperly wired (hot/neutral wires are reversed). Suggest the electrical outlet be rewired by a licensed electrician. (Safety Concern, See Photo #4)

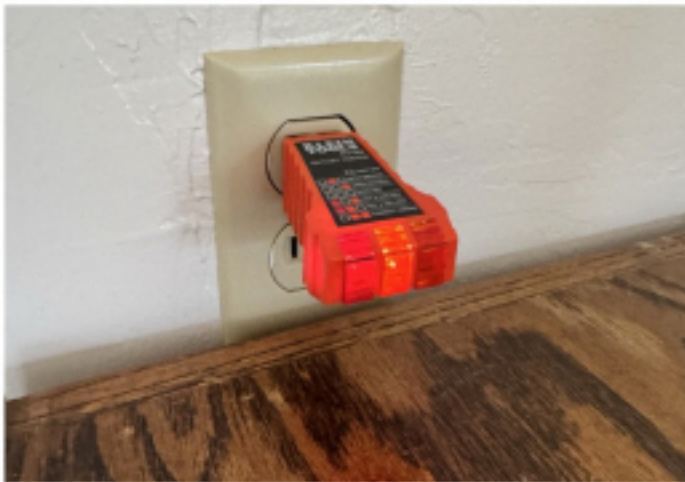
PHOTO #6

1. The electrical outlet at the South wall is improperly wired (hot/neutral wires are reversed). Suggest the electrical outlet be rewired by a licensed electrician. (Safety Concern, See Photo #6)

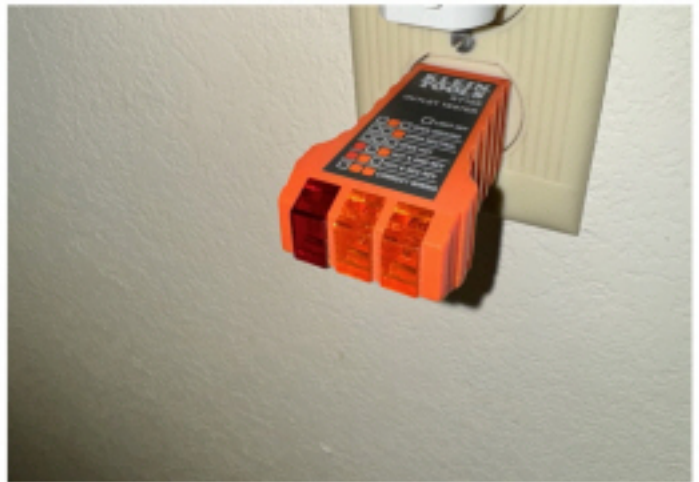
PHOTO #7

1. One electrical outlet at the South wall is not grounded. Suggest the electrical outlet be grounded by a licensed electrician. (Safety Concern, See Photo #7)

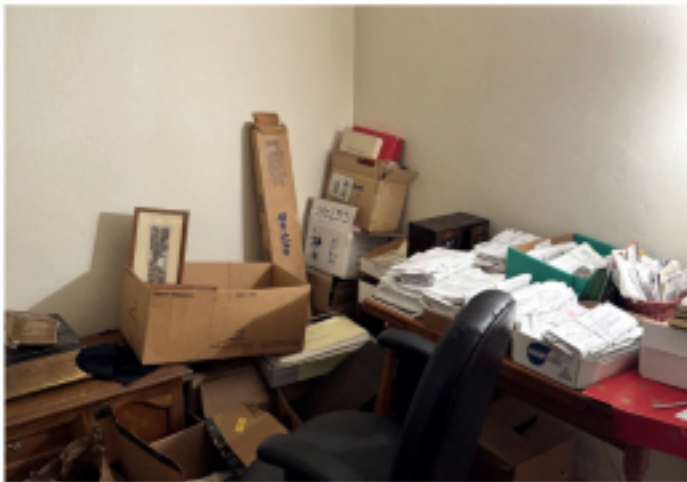
PHOTO #12

1. The bedroom was not inspected due to the placement of furnishings and storage items. Suggest the items be removed and the bedroom be inspected. (See Photo #12 and Photo #13)

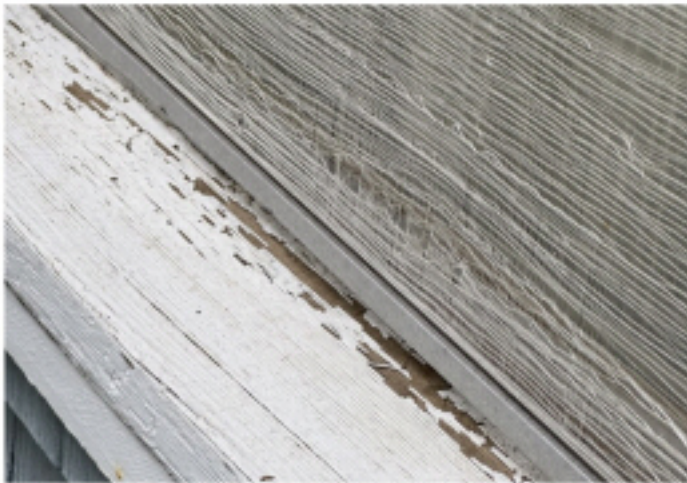
PHOTO #14

1. The paint at the wood shingle siding and wood trim is weathered. Suggest the wood members be painted by a qualified licensed contractor to prolong the life of the wood. (See Photo #14 and Photo #15)
