WOOD DESTROYING PESTS AND ORGANISMS INSPECTION REPORT

Building No. 943	Street Stillspring Court	City Vacaville	Zip 95687	Date of Inspection August 16, 2021	Number of Pages 4

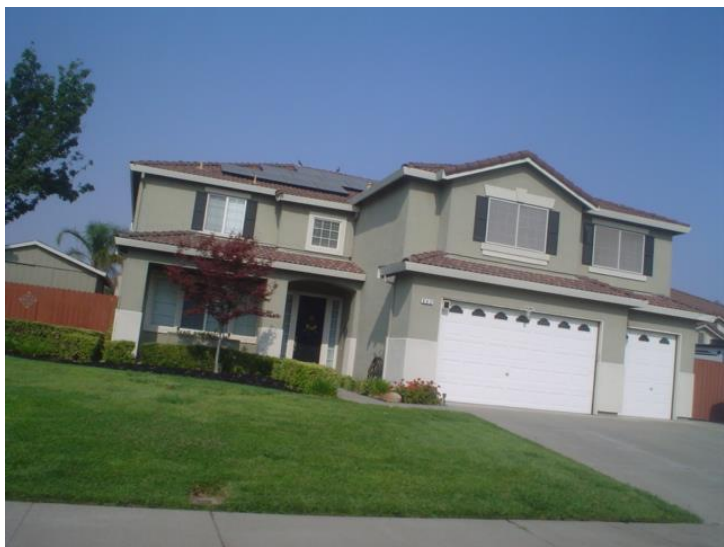
1 Finding: Fungi (wood-rot) damage found in the fascia rafter areas. Indicated on the diagram by “1”, and some areas shown in Fig.1 images on the back pages of this report.

Recommendation: Repair/replace fungi damaged wood members as needed.
